# **EXAMPLES OF CYPRESS SAPWOOD RESISTING ATTACK BY THE COMMON HOUSEHOLD WOOD BORER (*ANOBIUM PUNCTATUM*) IN NEW ZEALAND**

**A Report Prepared by Dean Satchell for the NZS 3602 Standards committee, 21<sup>st</sup> February 2017.**

**This report documents examples showing cypress sapwood timber to have resistance to household borer, both in internal applications and those protected from weather but exposed to exterior or ground atmosphere.**

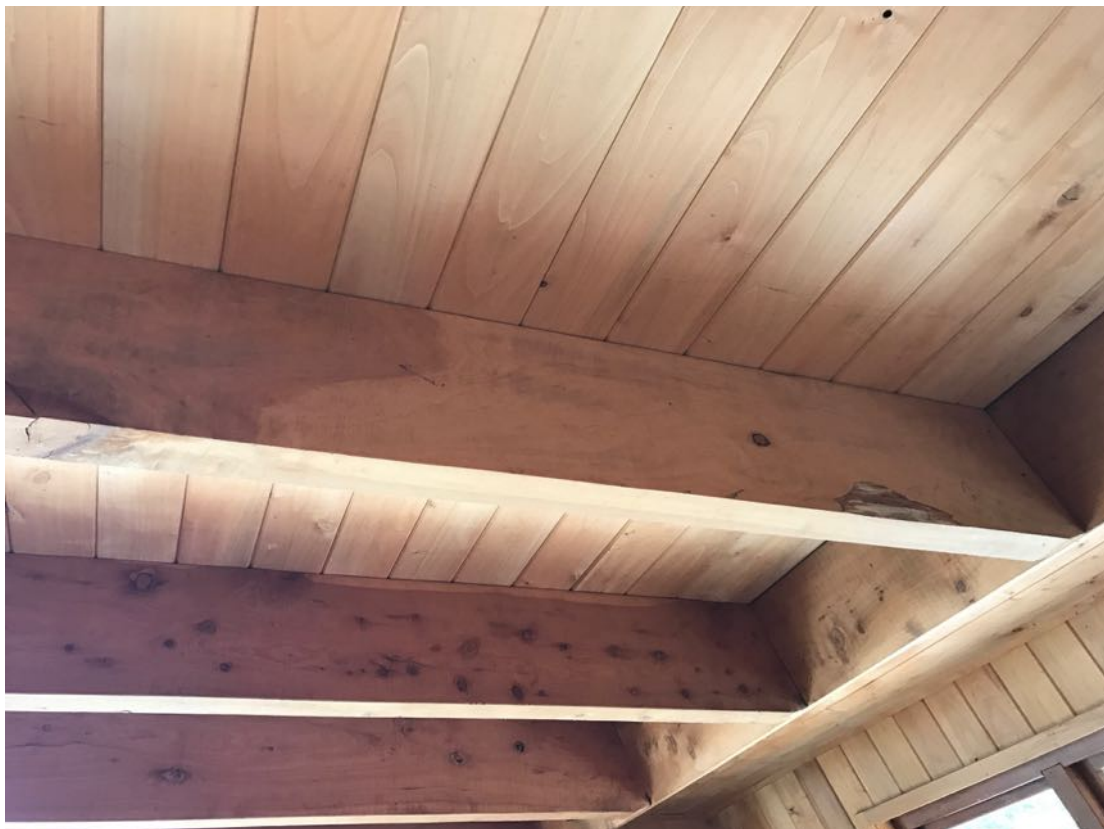
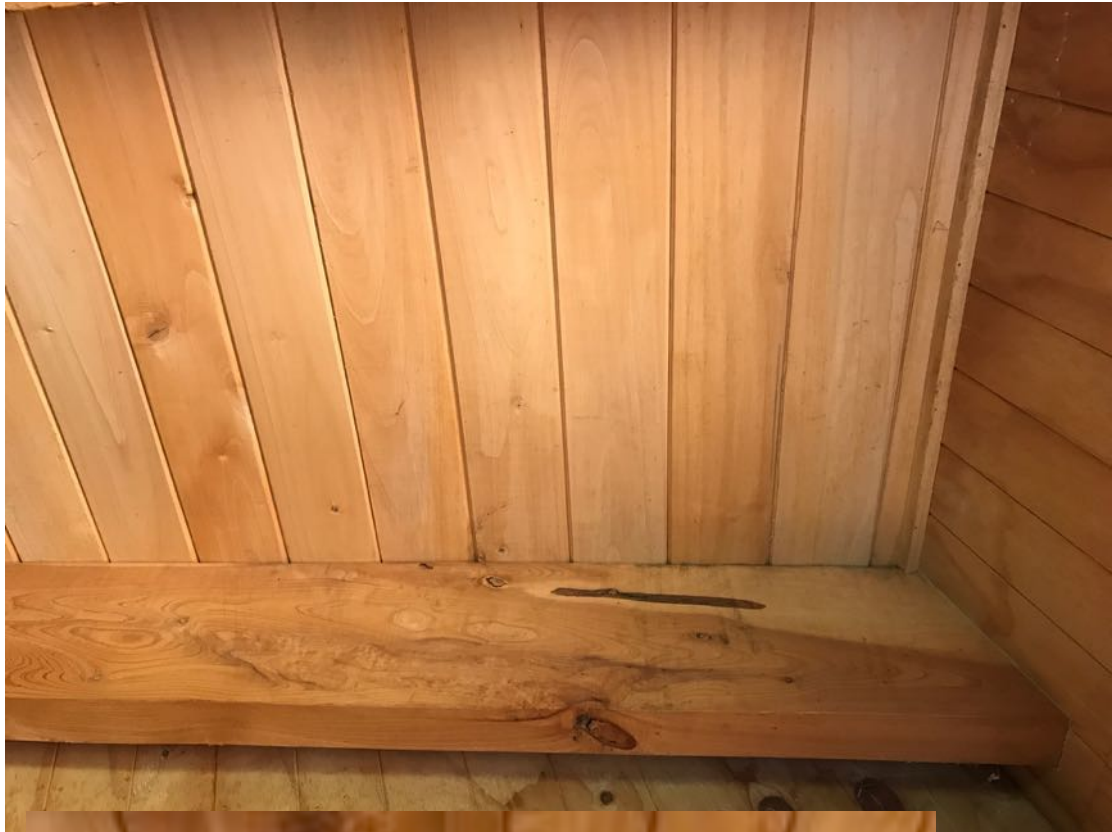
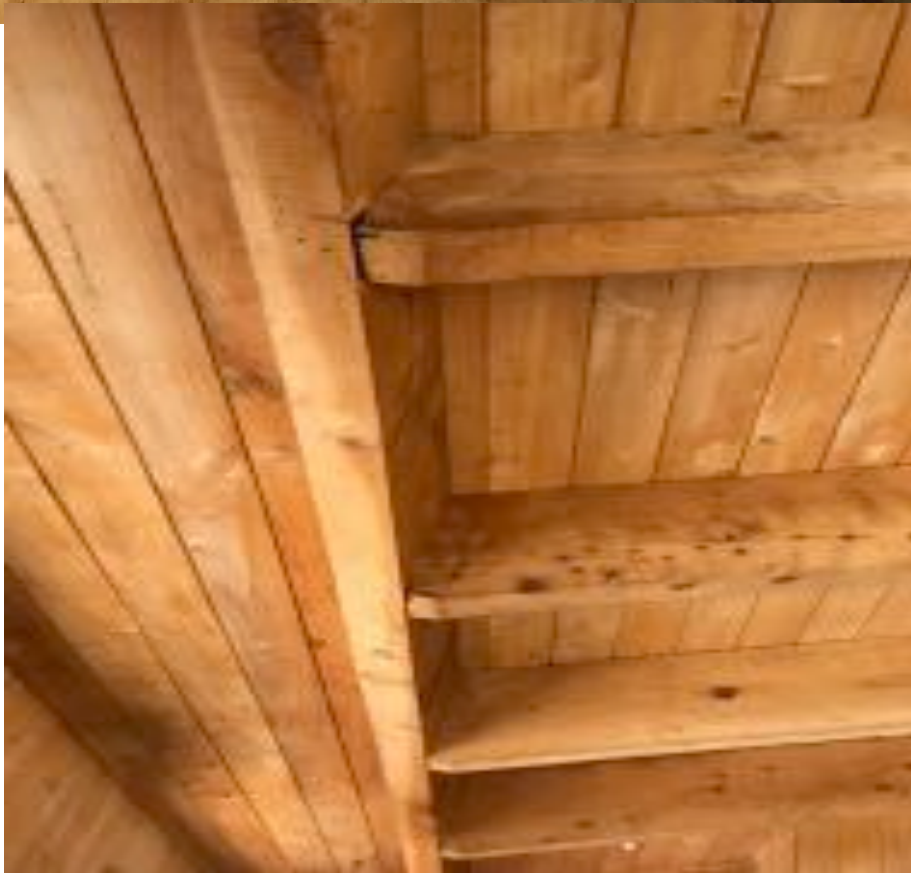
**Example 1: Gabrielle Walton, Bay of Plenty**

Sapwood Cypress in use as rafters, 12yrs interior use, no signs of borer or decay.

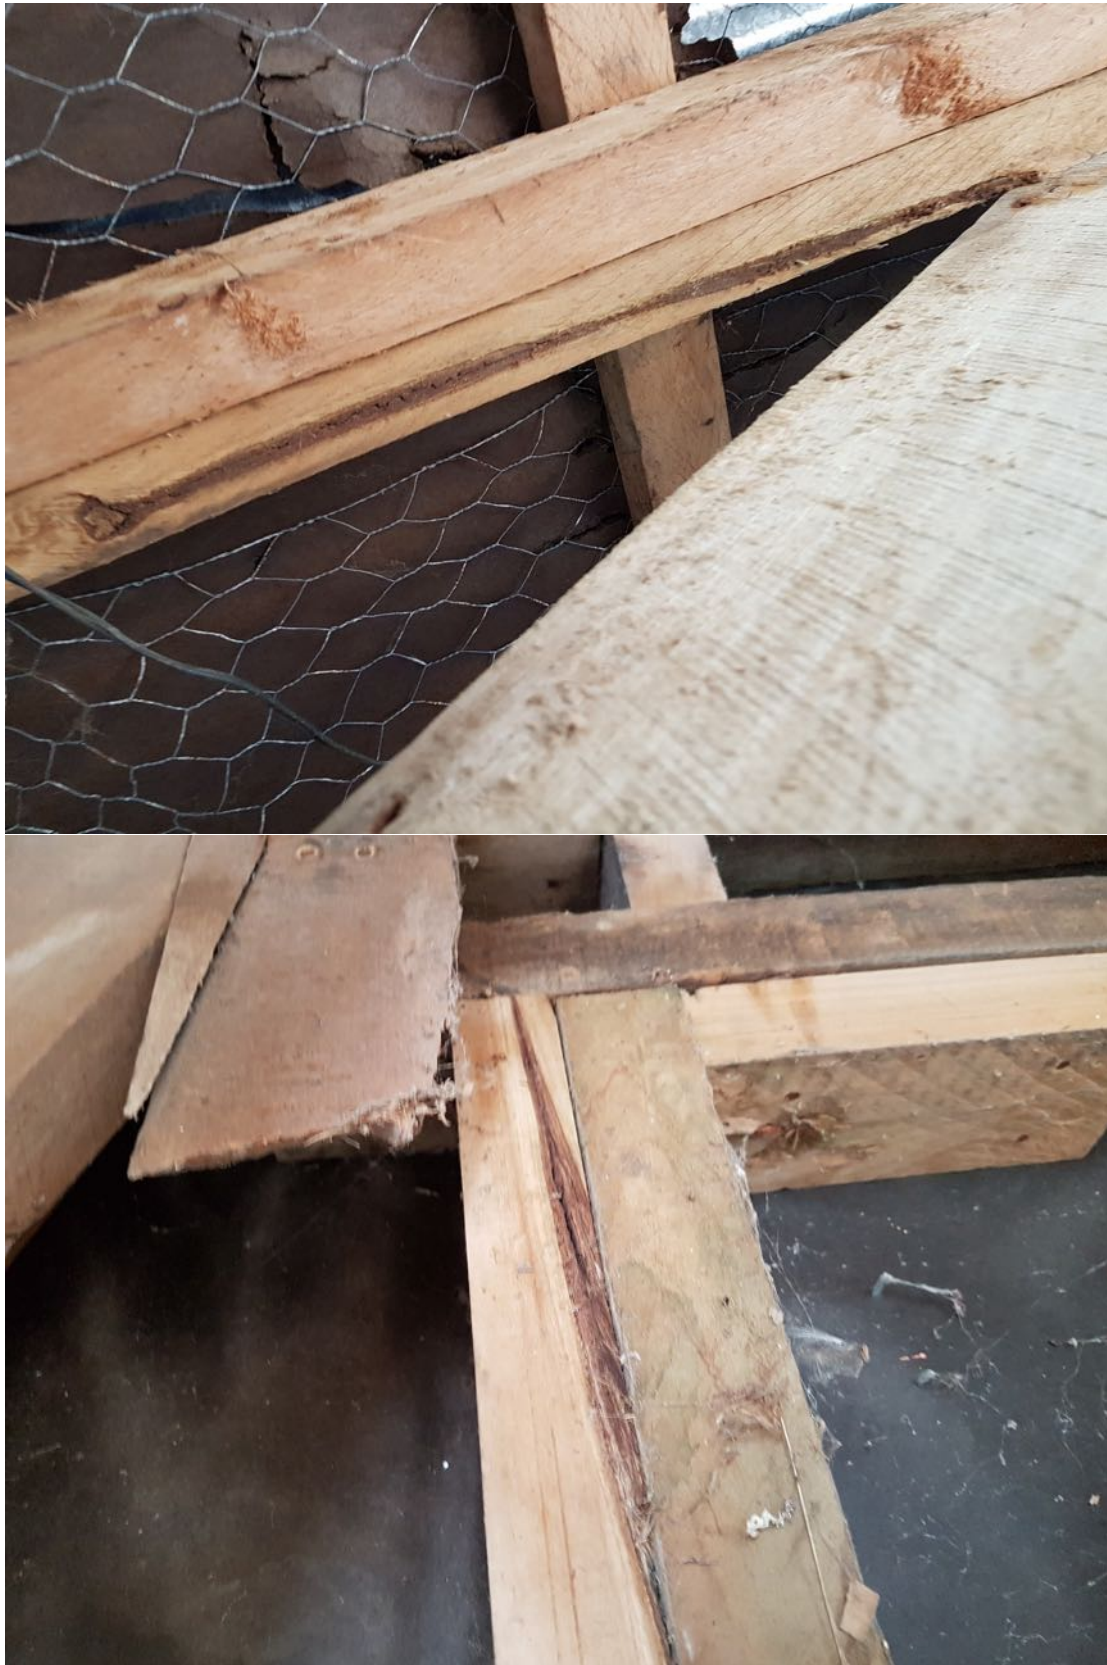
Macrocarpa sapwood showing bark encasement. No borer present.

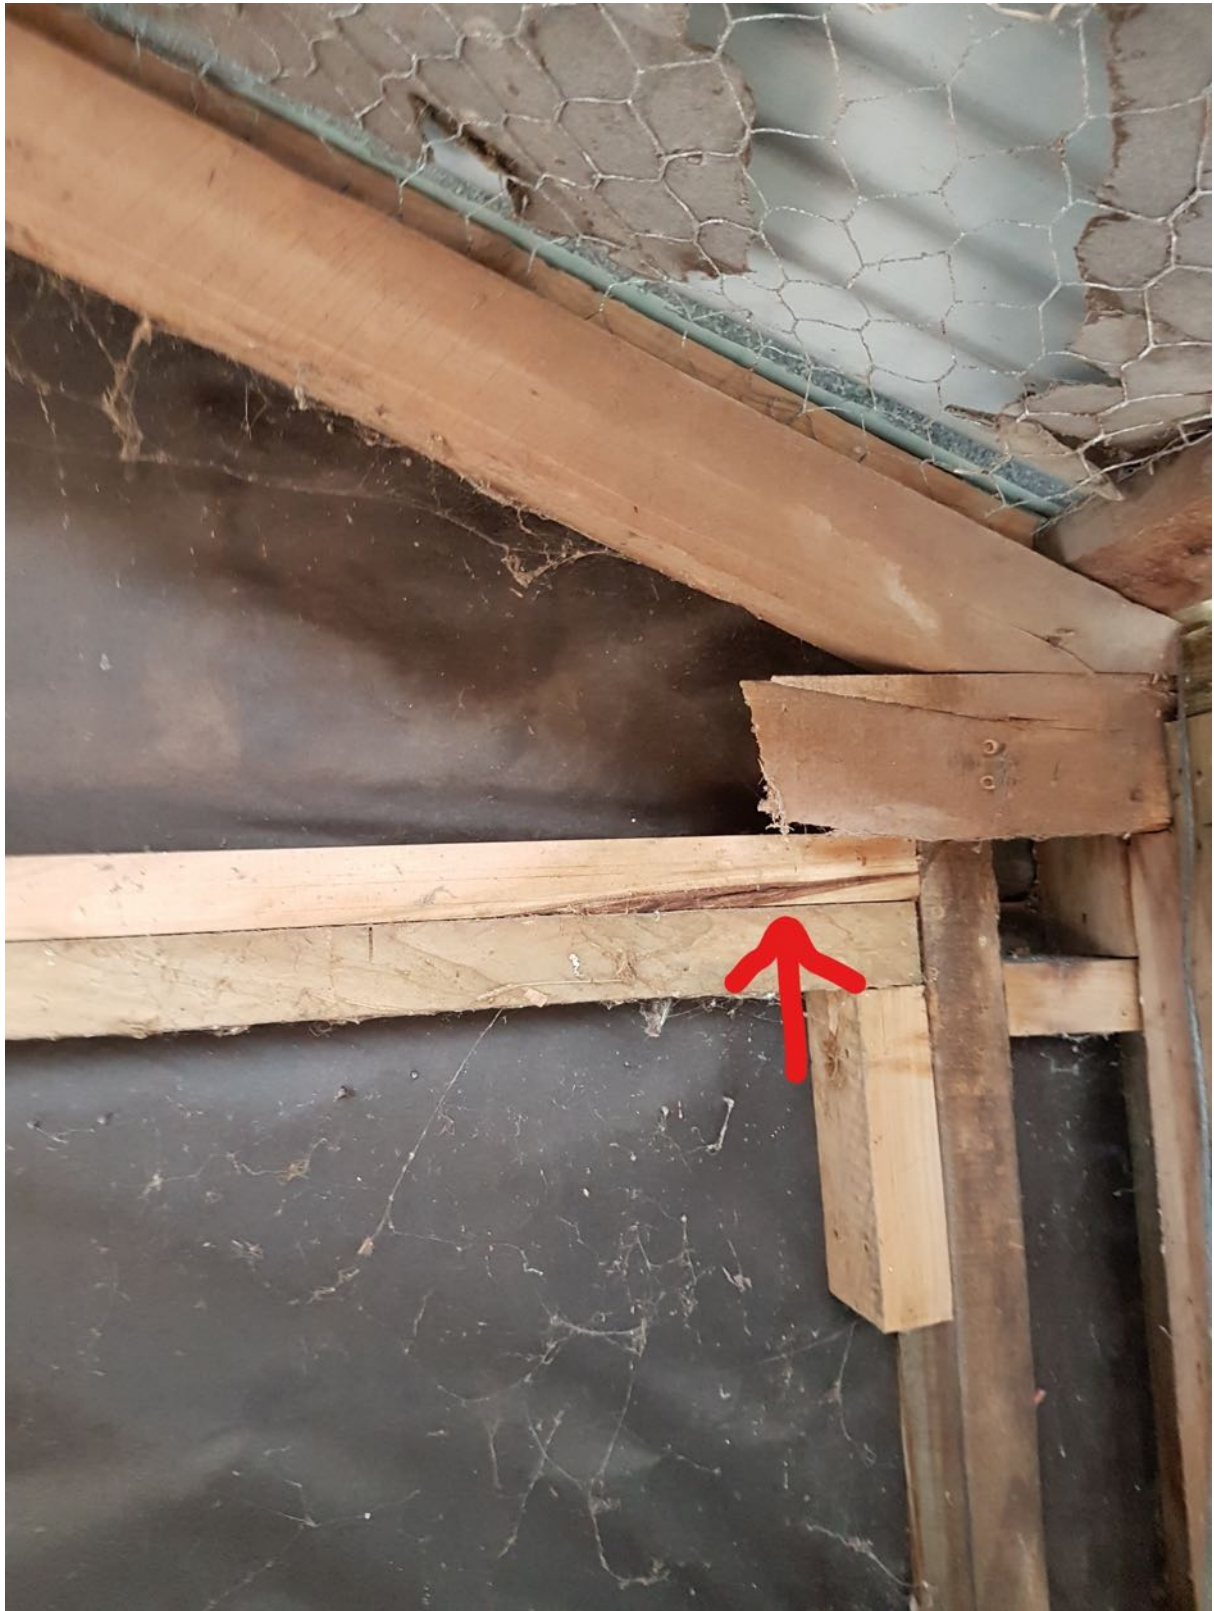
Macrocarpa sapwood showing bark encasement. No borer present.

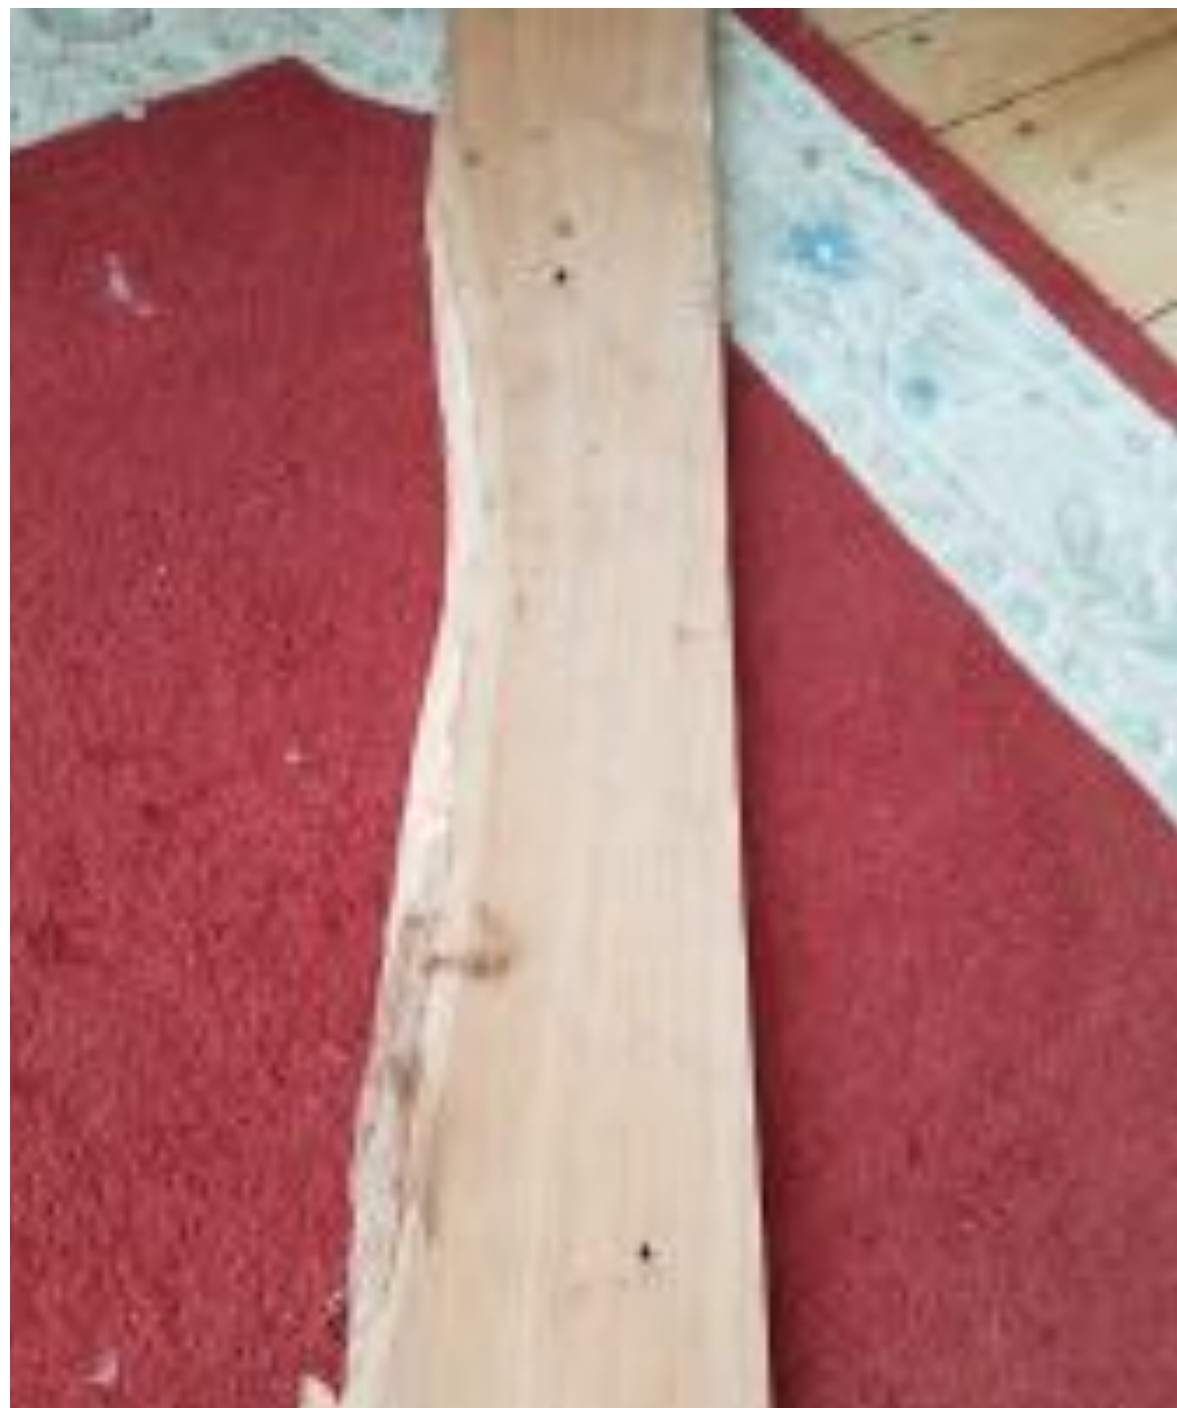
Macrocarpa sapwood removed from building for inspection. No borer present, just nail holes.

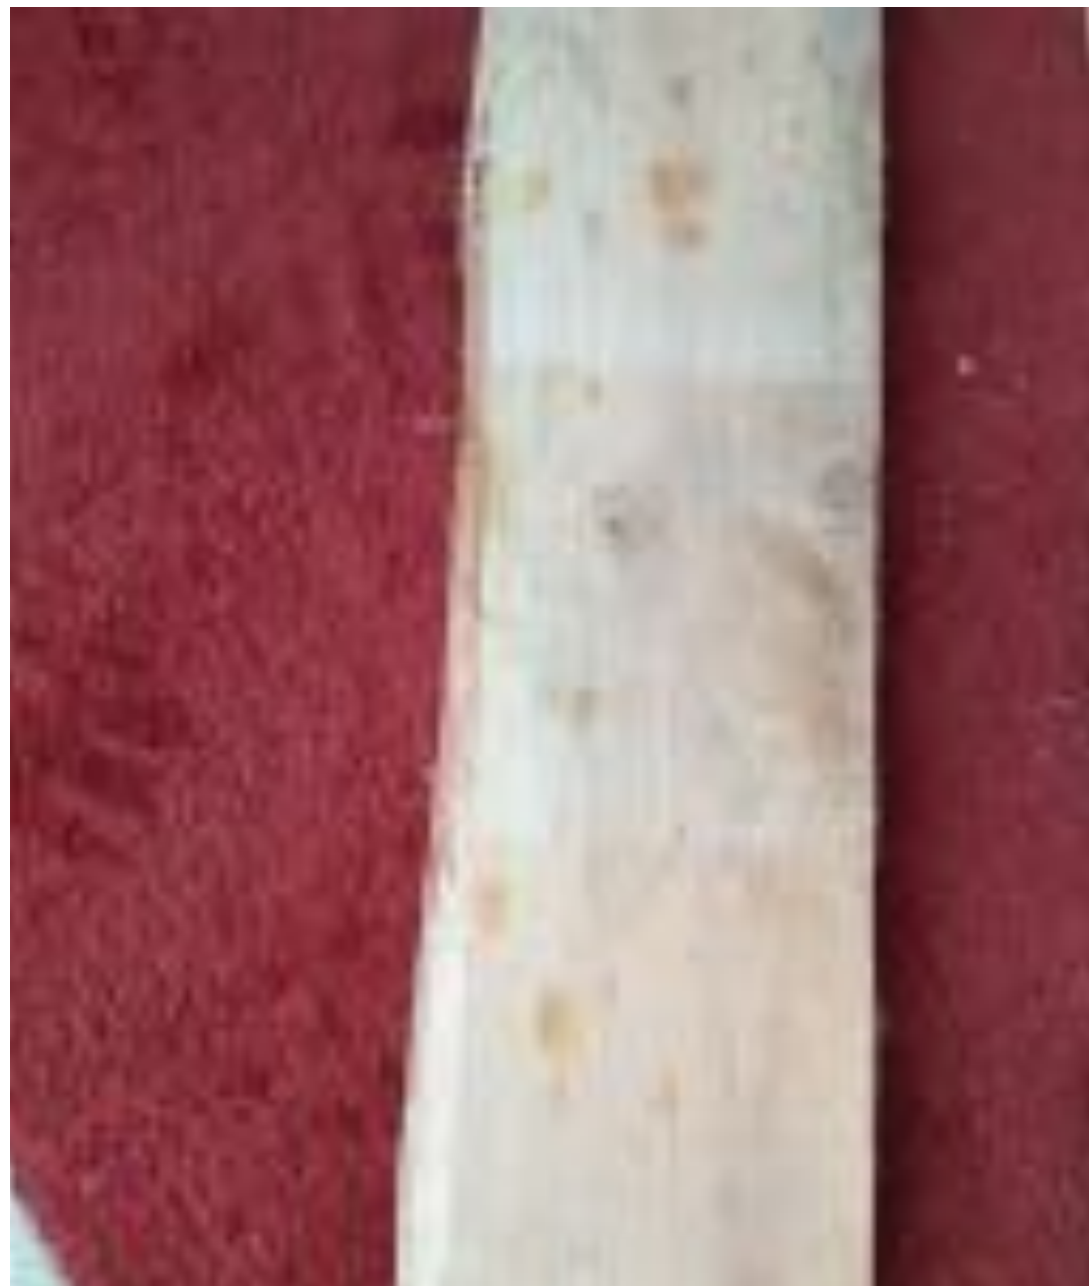
Lawsons cypress sapwood. No borer present.

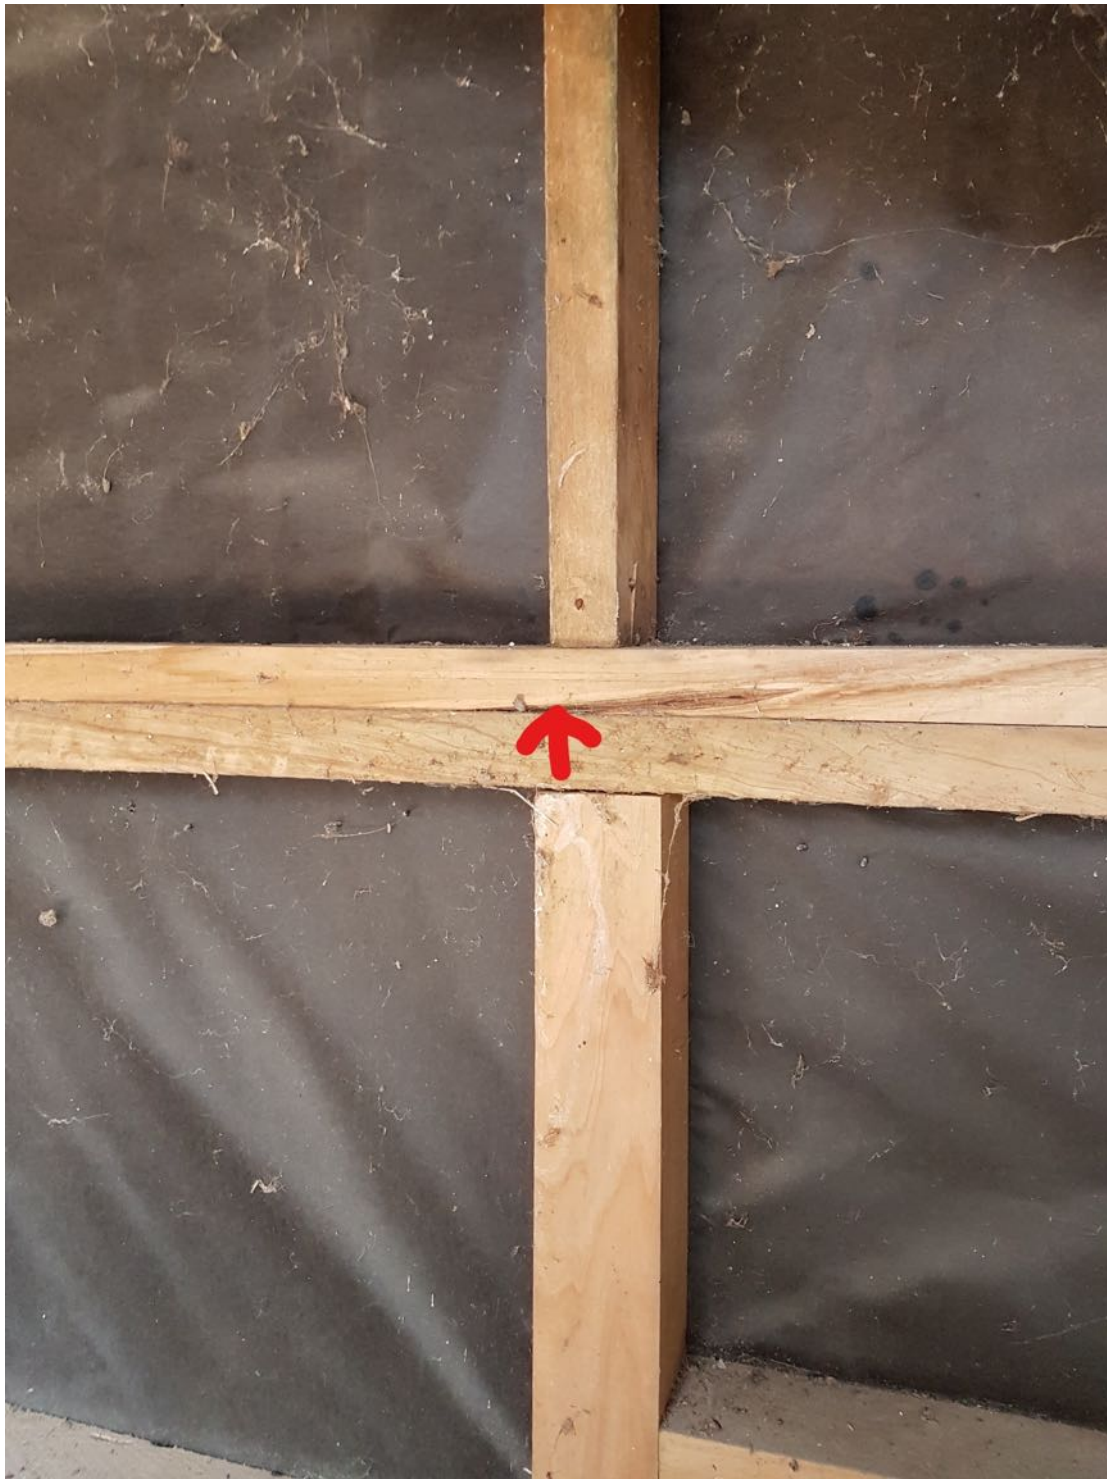
Cypress framing showing sapwood with bark encasement. No borer present.

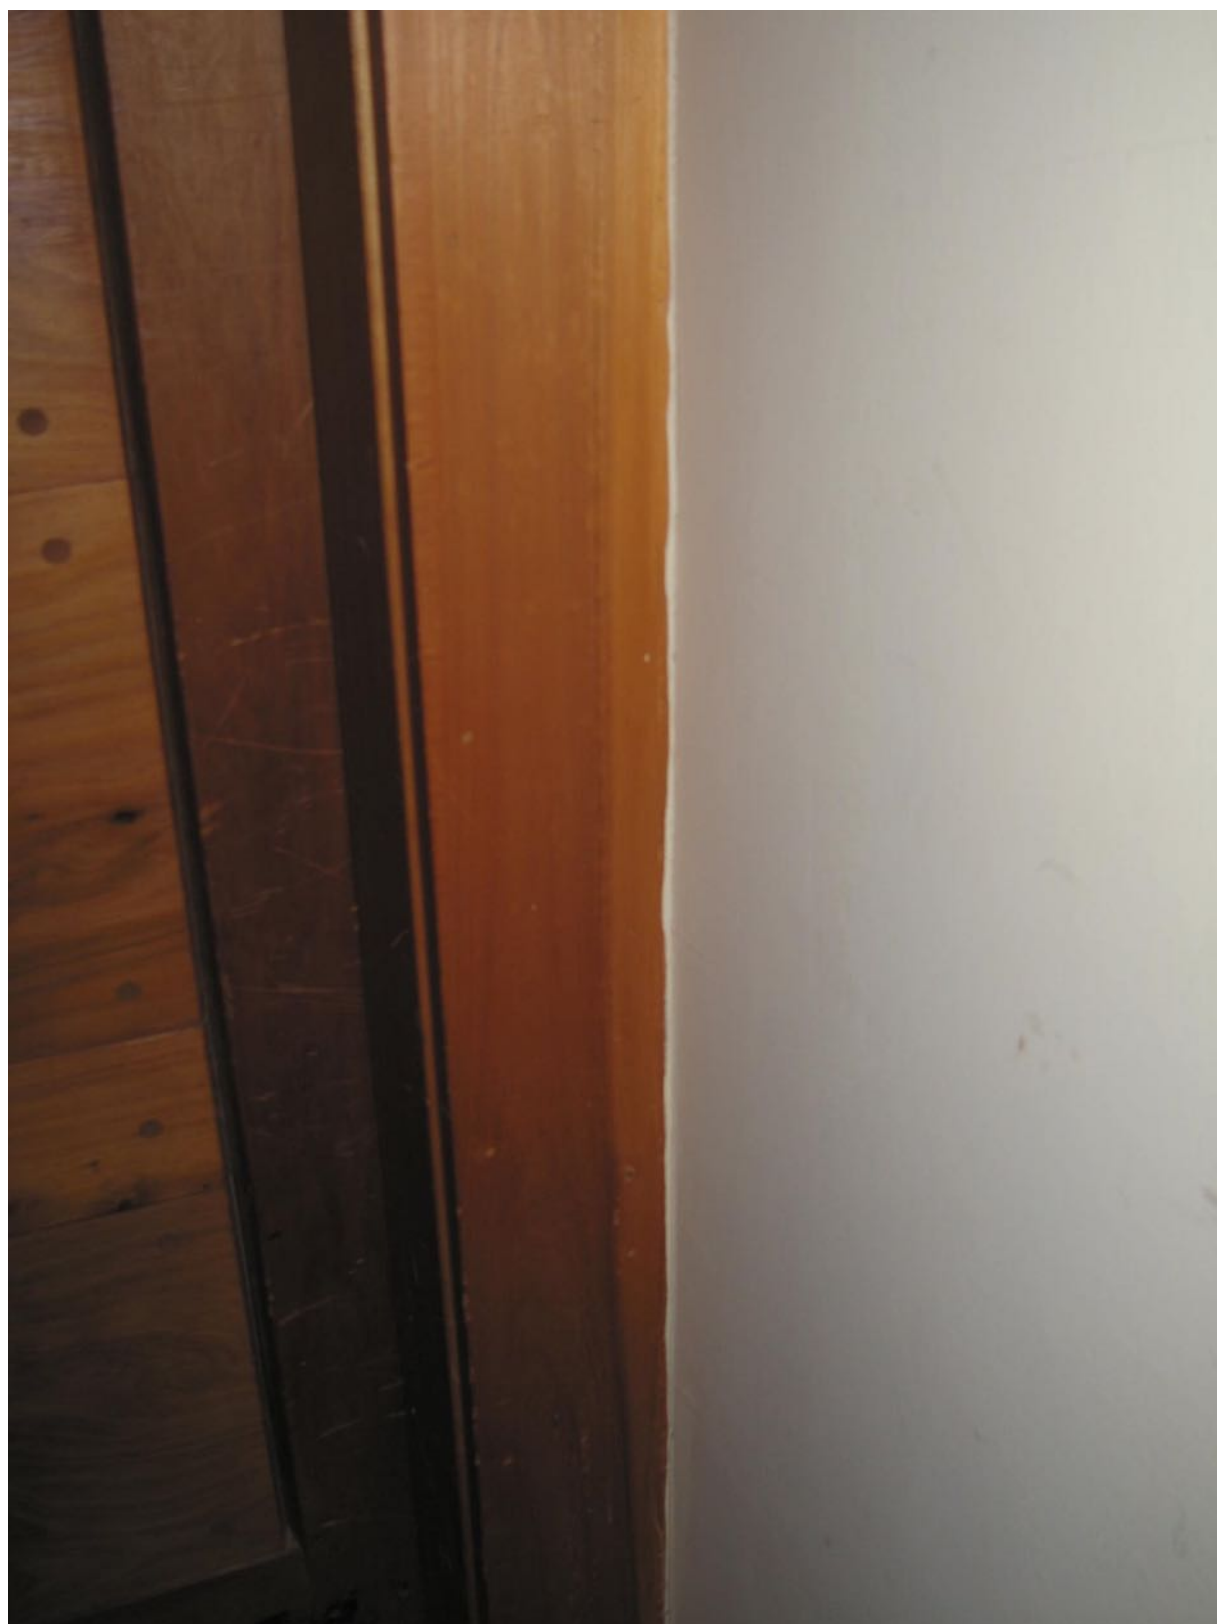
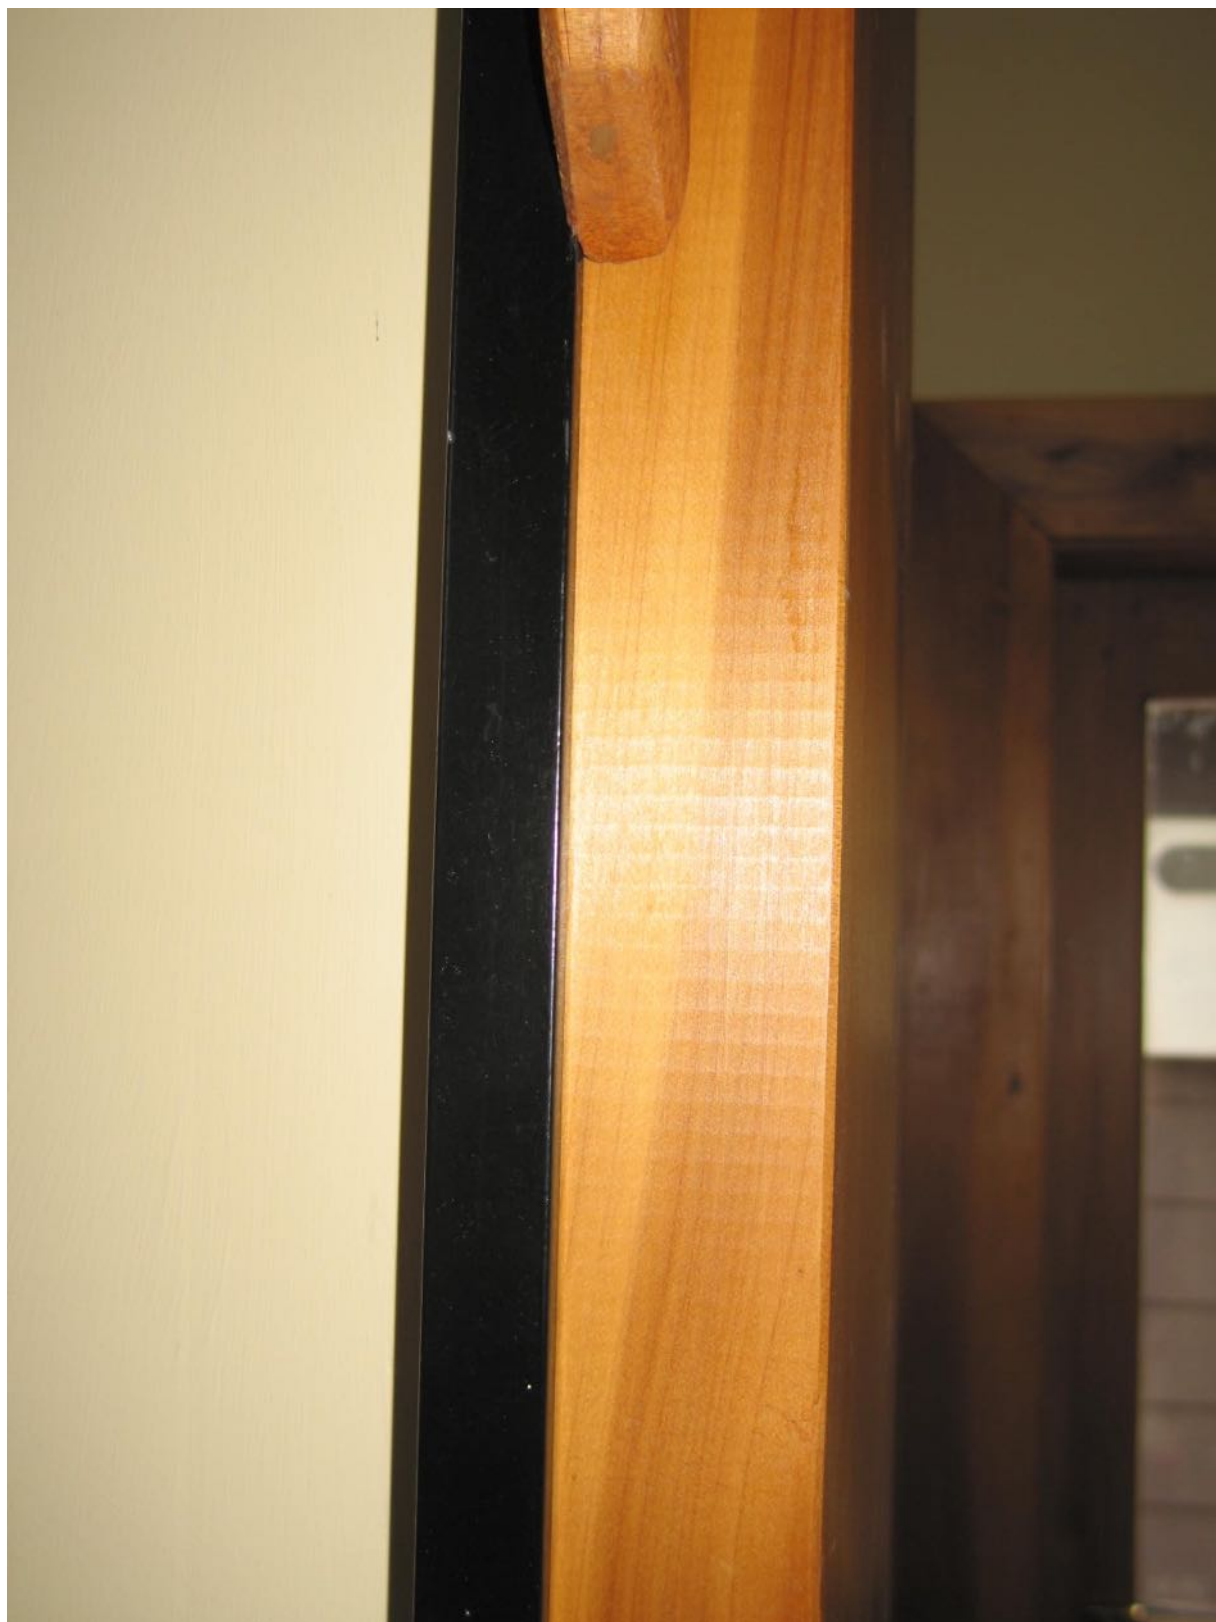
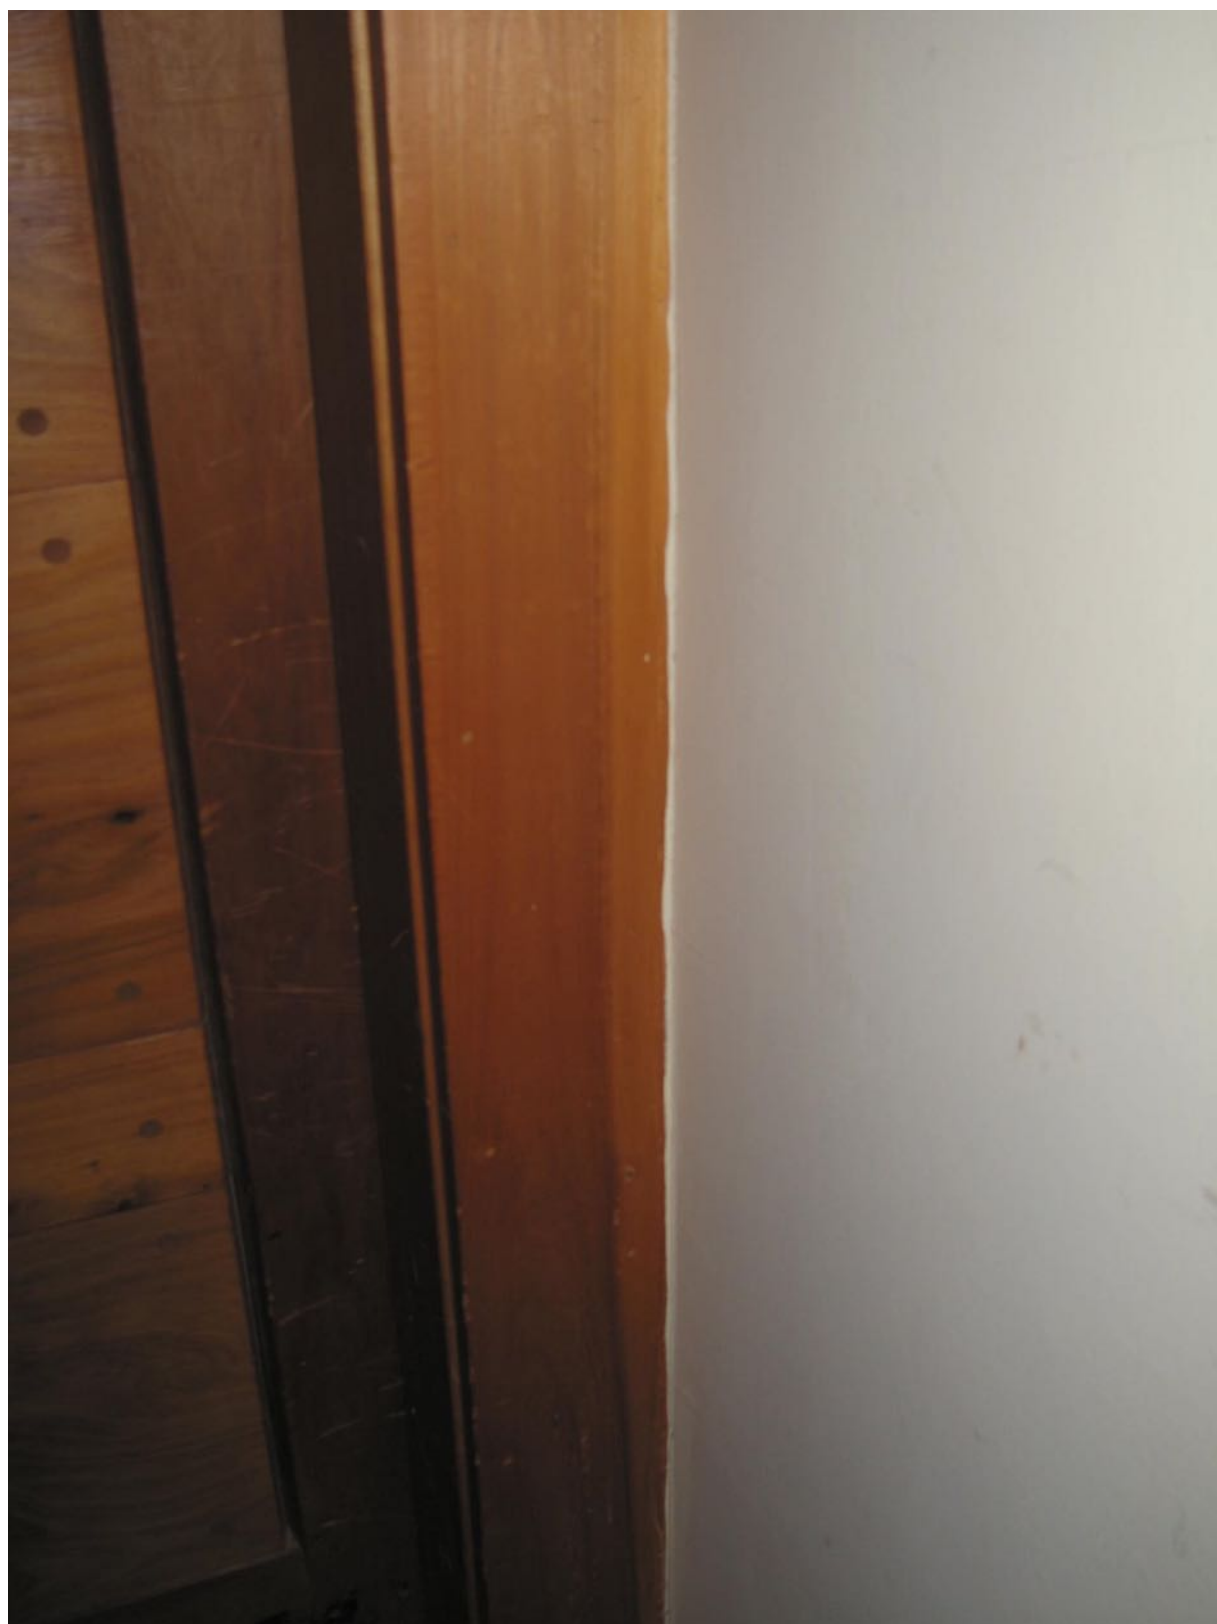
-----  
**Example 7: Matthew ter Borg, 70 Hill Road, LOWER  
HUTT**

Attached are photos of sapwood macrocarpa installed in my house in 2010. No borer present in any macrocarpa. This is in a house that was built in the 1930's which has high levels of borer in the rimu used extensively throughout the house. The macrocarpa was not treated.

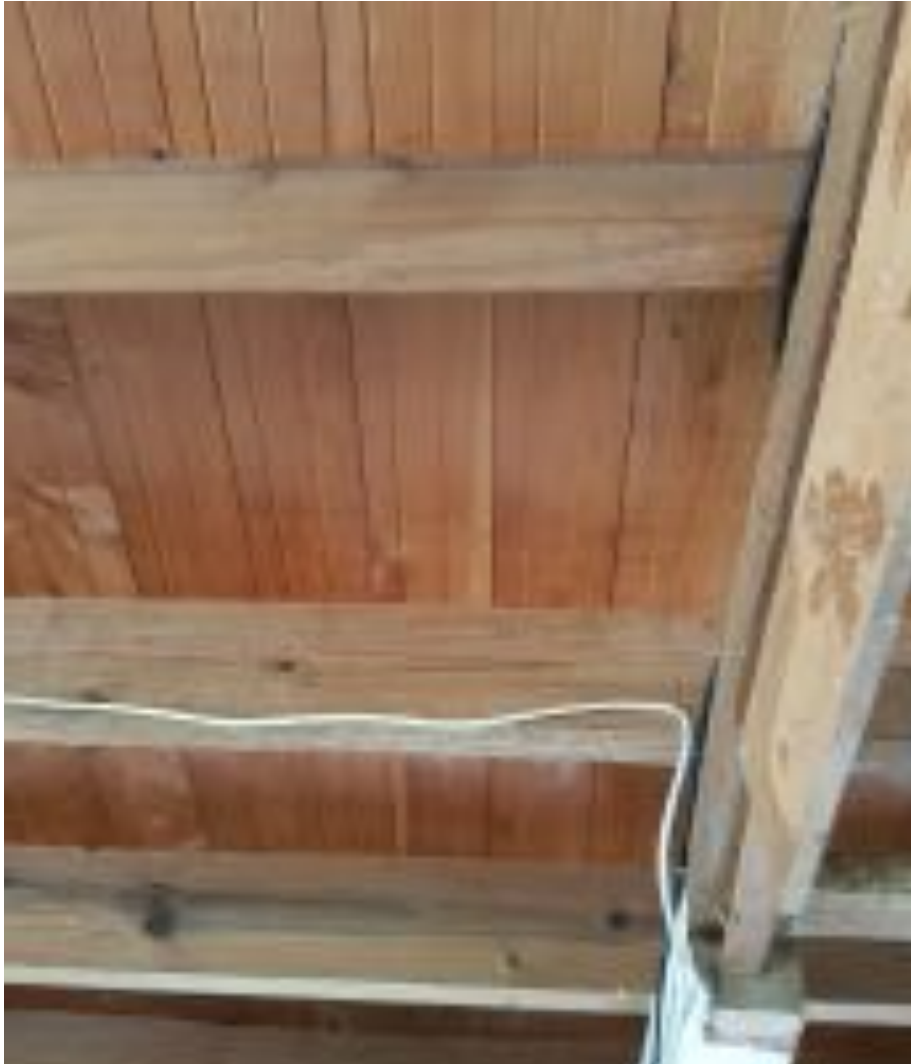
Macrocarpa upstairs floor from below showing sapwood

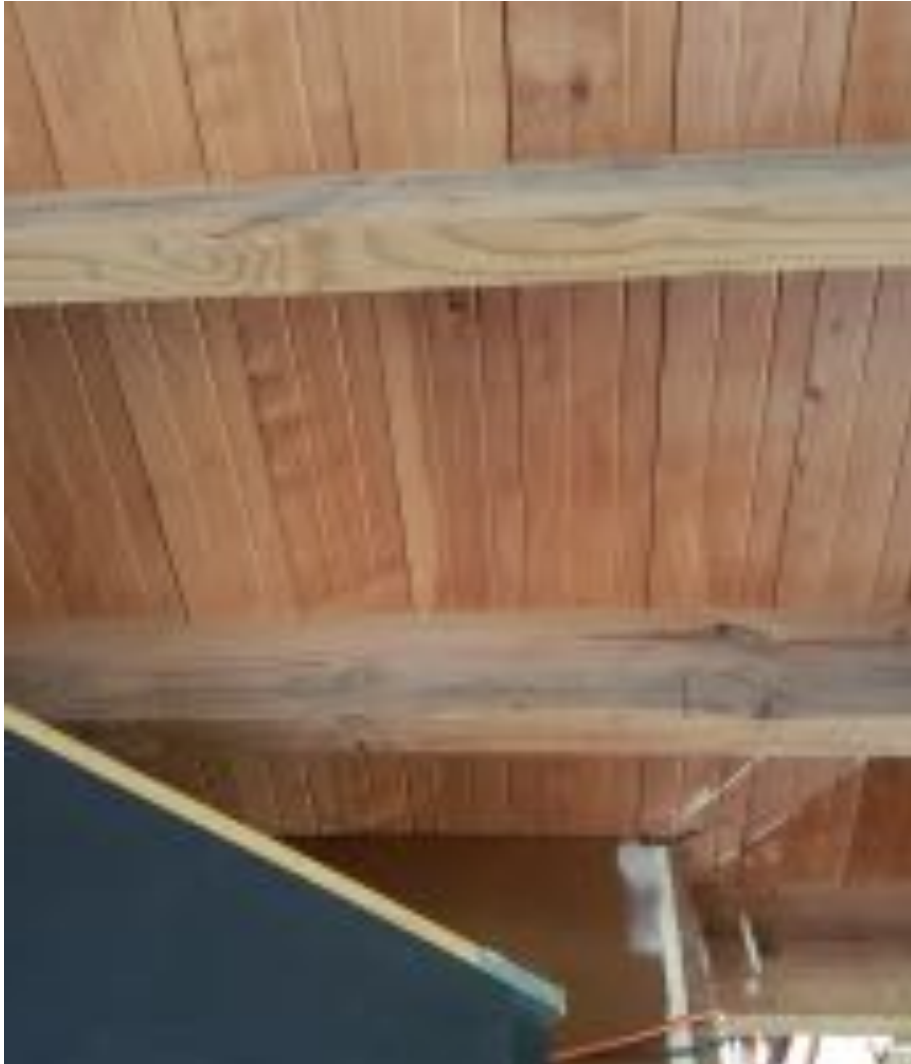
Macrocarpa upstairs floor from below showing sapwood

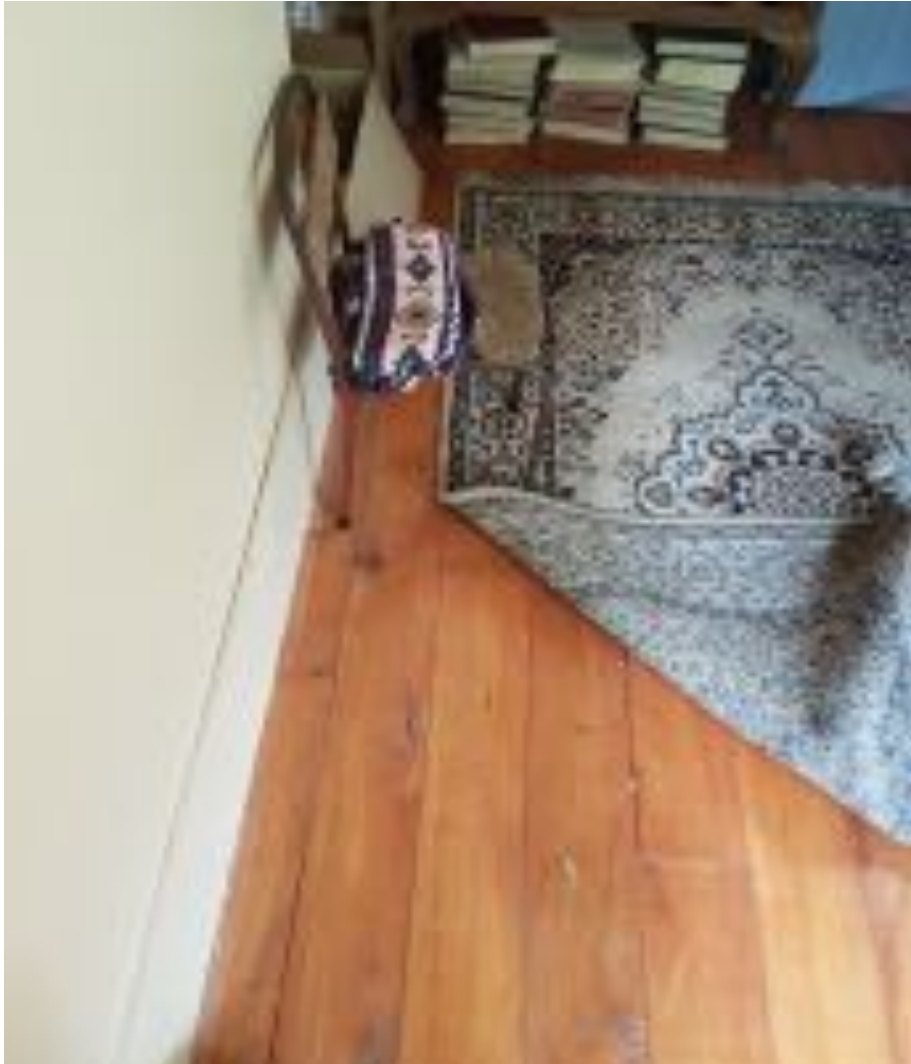
Macrocarpa floor over joists showing sapwood

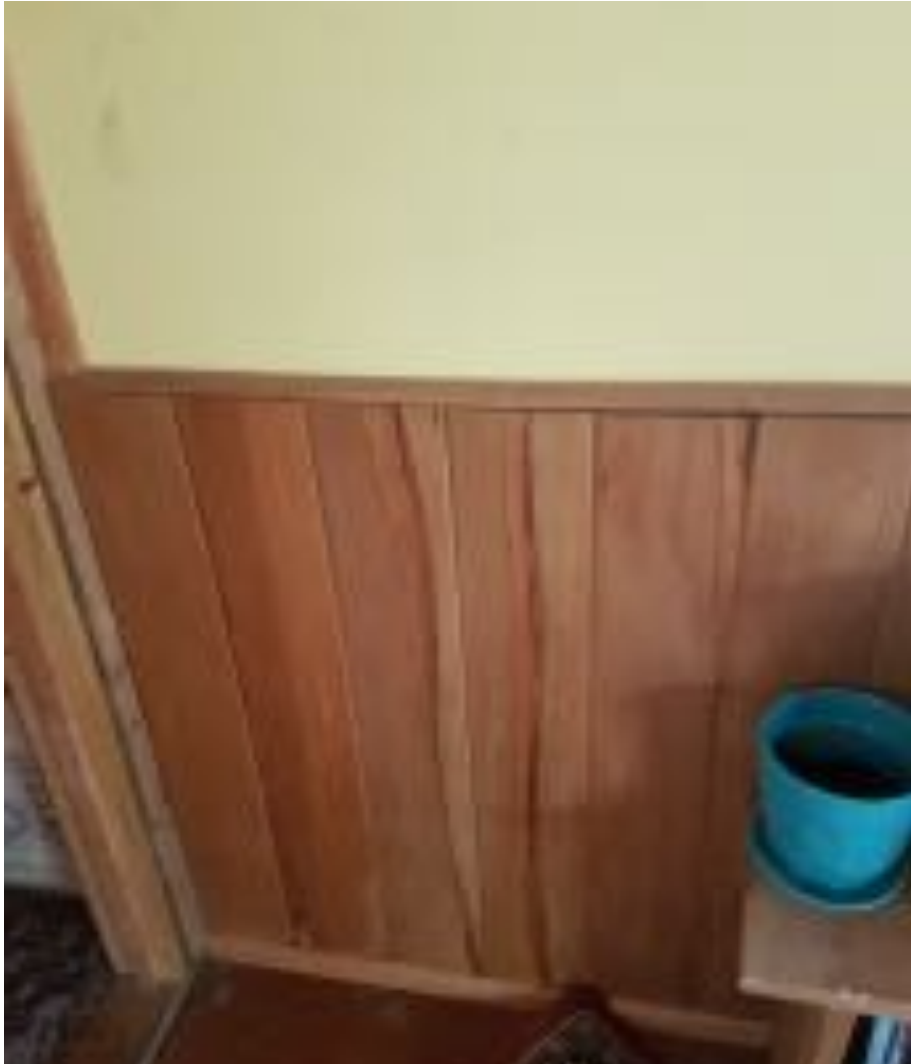
Rimu panelling showing borer

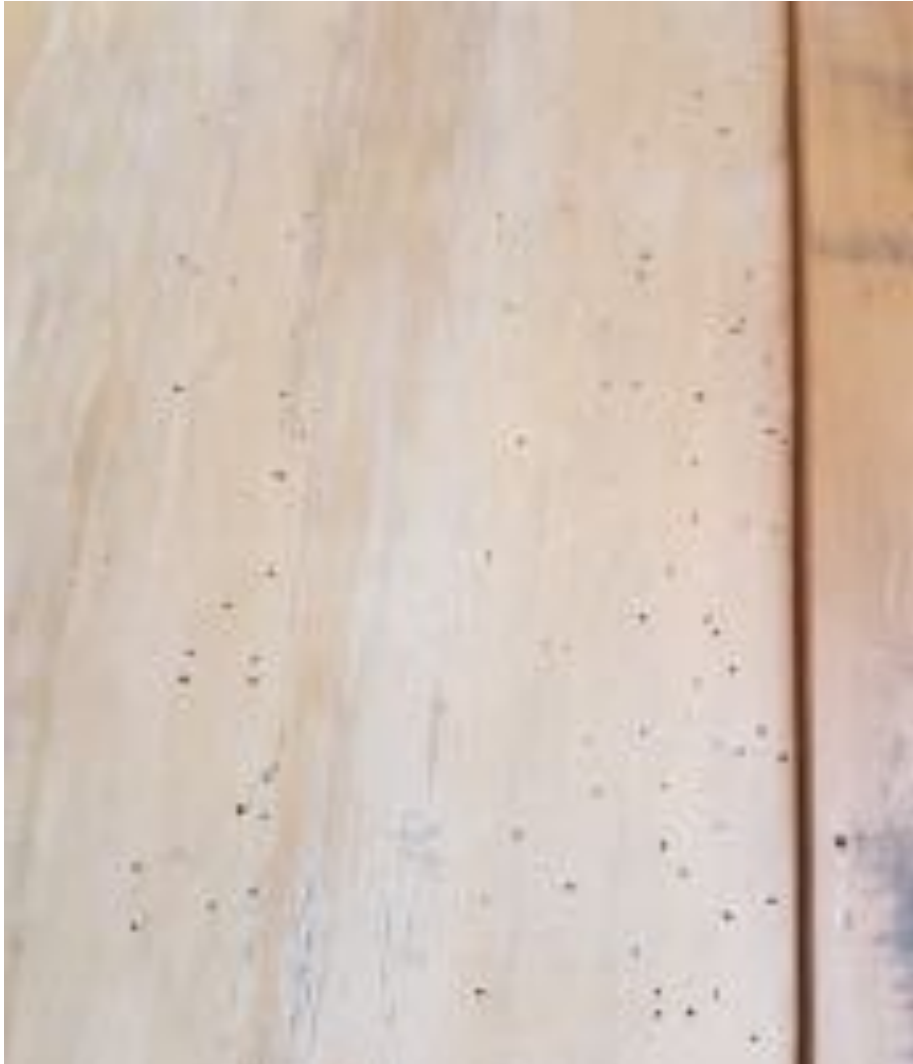
Old Rimu furniture showing borer
