# **EXAMPLES OF CYPRESS SAPWOOD RESISTING ATTACK BY THE COMMON HOUSEHOLD WOOD BORER (*ANOBIUM PUNCTATUM*) IN NEW ZEALAND**

**A Report Prepared by Dean Satchell for the NZS 3602 Standards committee, 21<sup>st</sup> February 2017.**

**This report documents examples showing cypress sapwood timber to have resistance to household borer, both in internal applications and those protected from weather but exposed to exterior or ground atmosphere.**

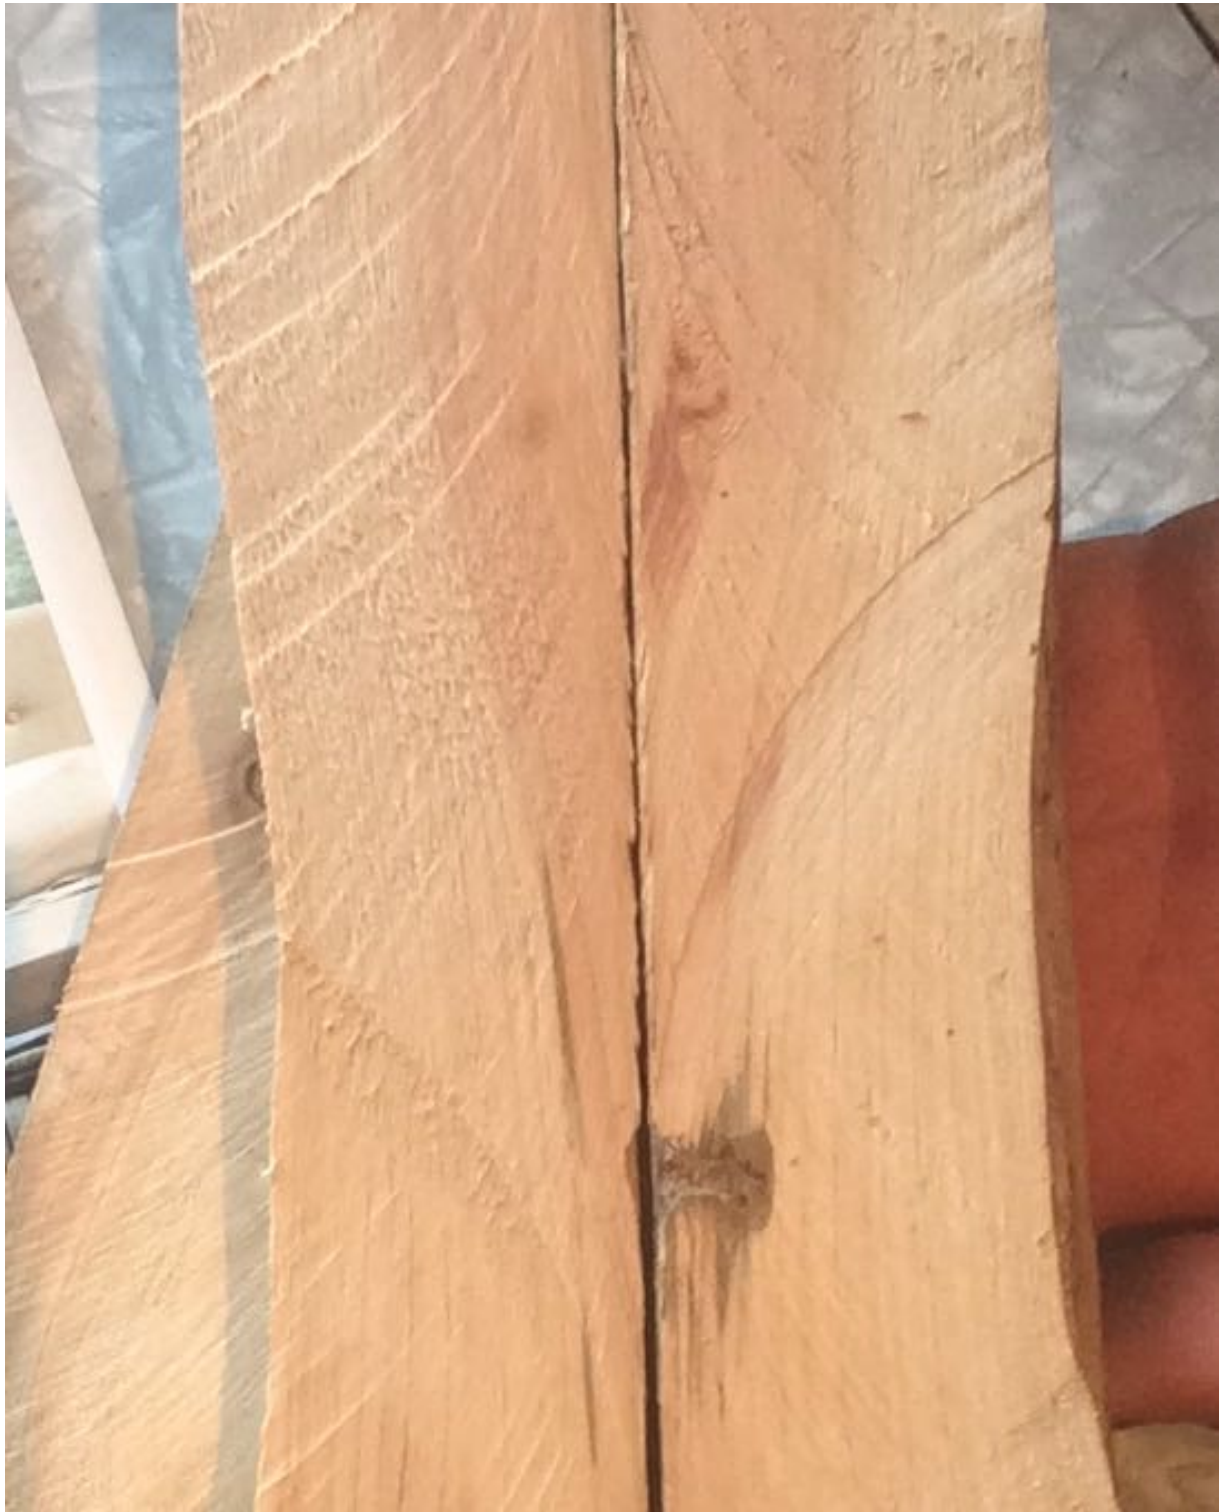
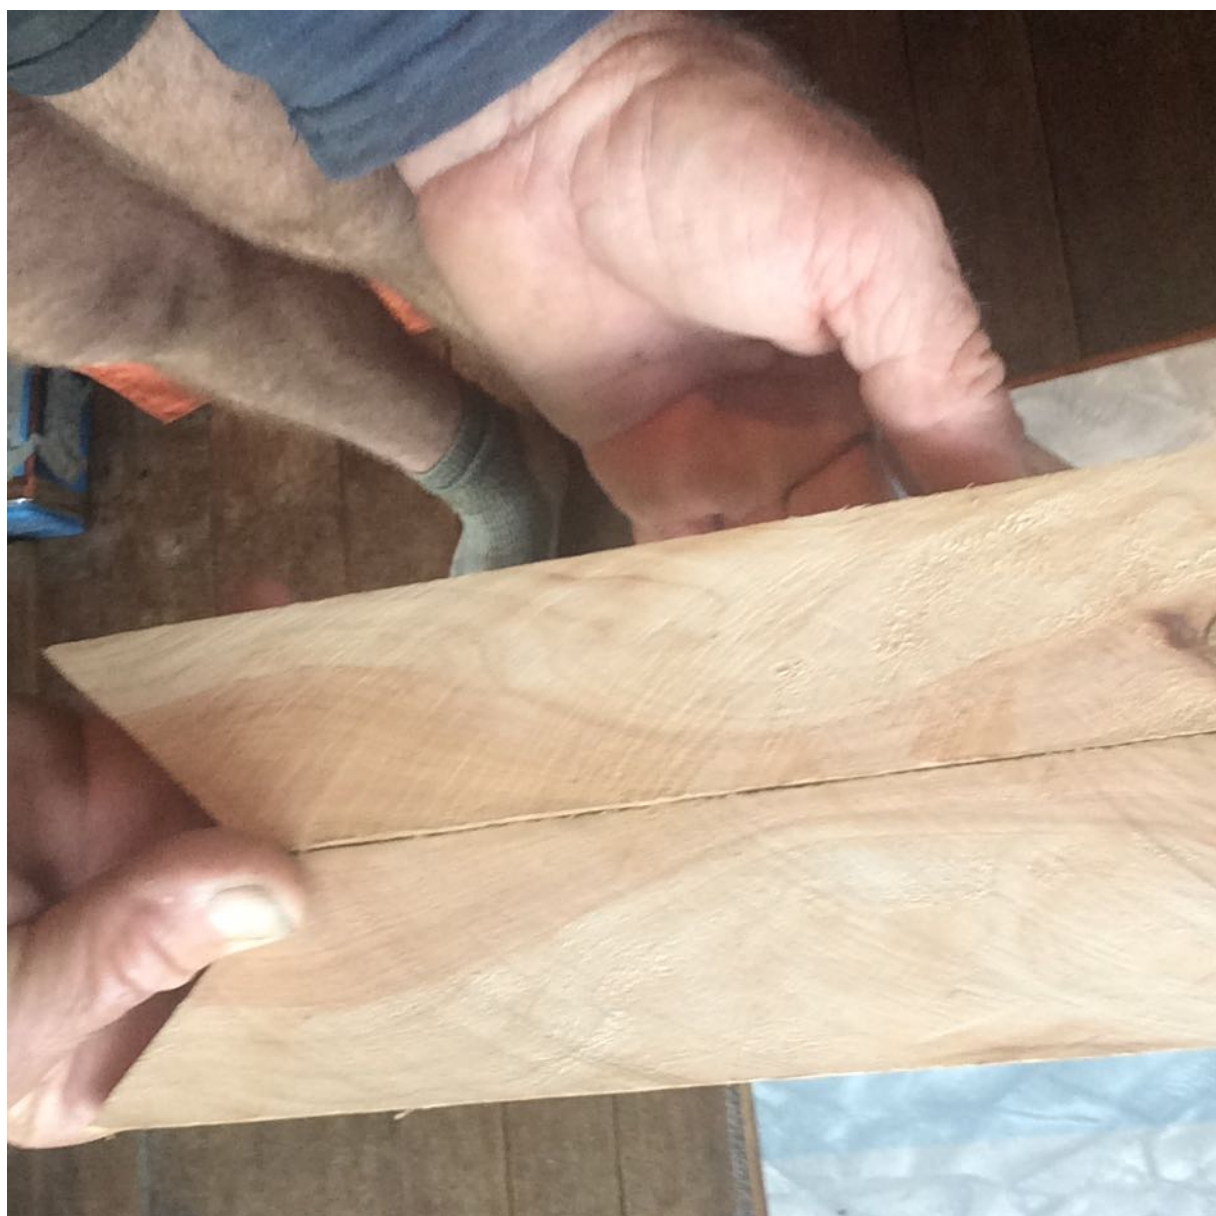
**Example 9: Mike Cole, 41 Wood Street Kakaramea,  
South Taranaki**

Below are photos of 2 dwangs that I have just cut out of the hut on the farm, and ripped through the sapwood to look for borer. This was built in 1989 and the walls clad in batten and board macrocarpa . There is no building paper and next to no eaves so the walls have been occasionally wet ever since. There is no borer to be seen. In no 1 there is a tiny amount of discolouration where a bright zinc cladding screw went in and was pretty rusty but still holding. My budget didn't stretch to copper or stainless or heavy galv screws in those days.

I also had a good look under Celesta's studio at home here. This was built in 1992 as a sleepout, all out of macrocarpa. There are waney edged boards in the floor joists so have a large amount of sapwood. Until 2016 this floor frame sat on 100x100 tanalised posts lying on the ground. Last year we put it up on piles and lined the building with plywood. The timber it was built from was 2<sup>nd</sup> grade leftovers from milling orders to sell, so there was a large amount of sapwood in the building. We removed quite a few cladding boards to put in larger windows and these boards were very sound. All the framing and floorboards were 100% sound. I would have no hesitation to use macrocarpa sapwood inside a building again and am sure it would have equivalent durability to H1 treated pine.

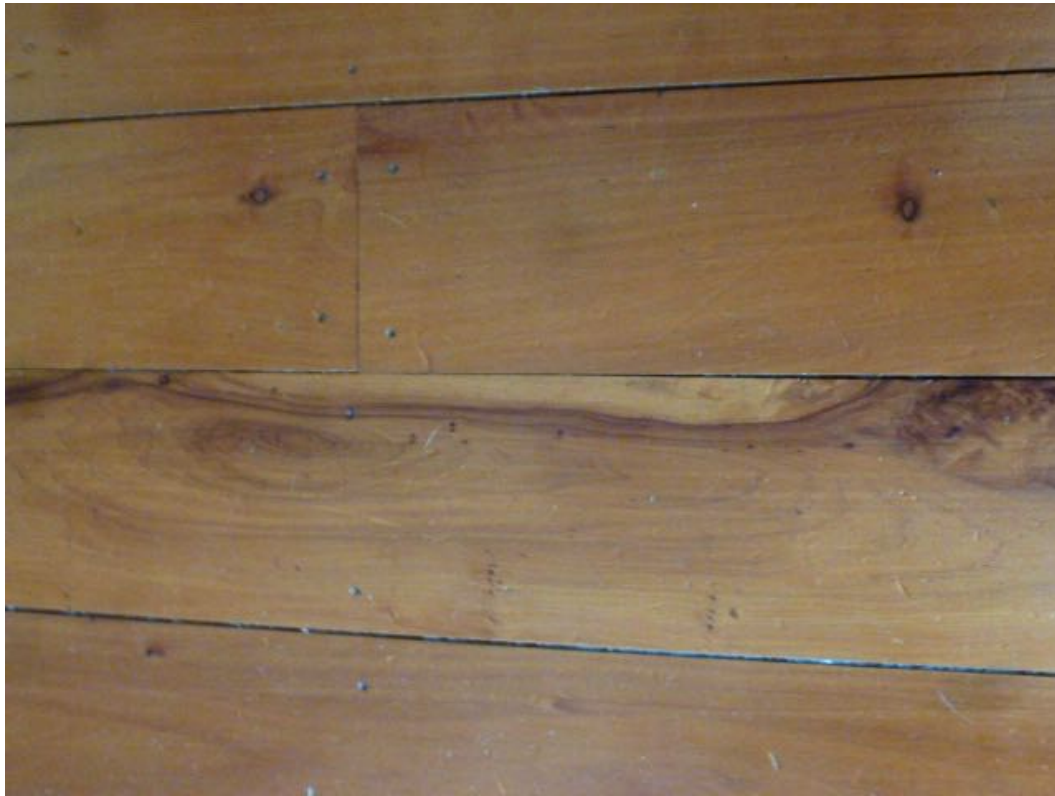
6" x 1" macrocarpa T & G flooring

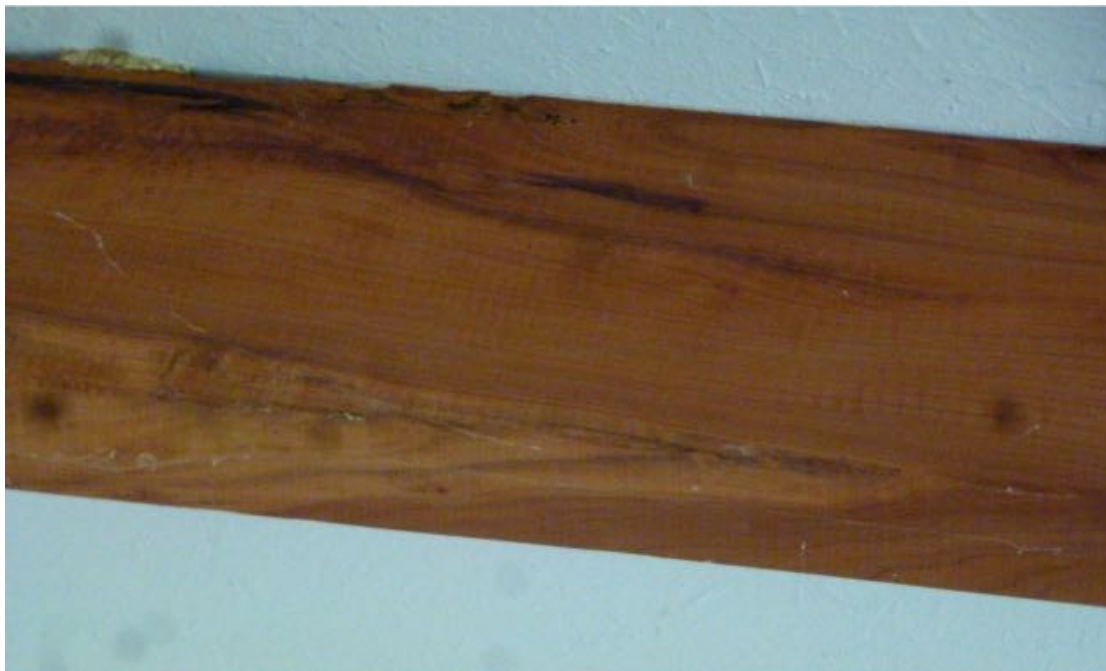
6" x 2" macrocarpa rafter showing sapwood

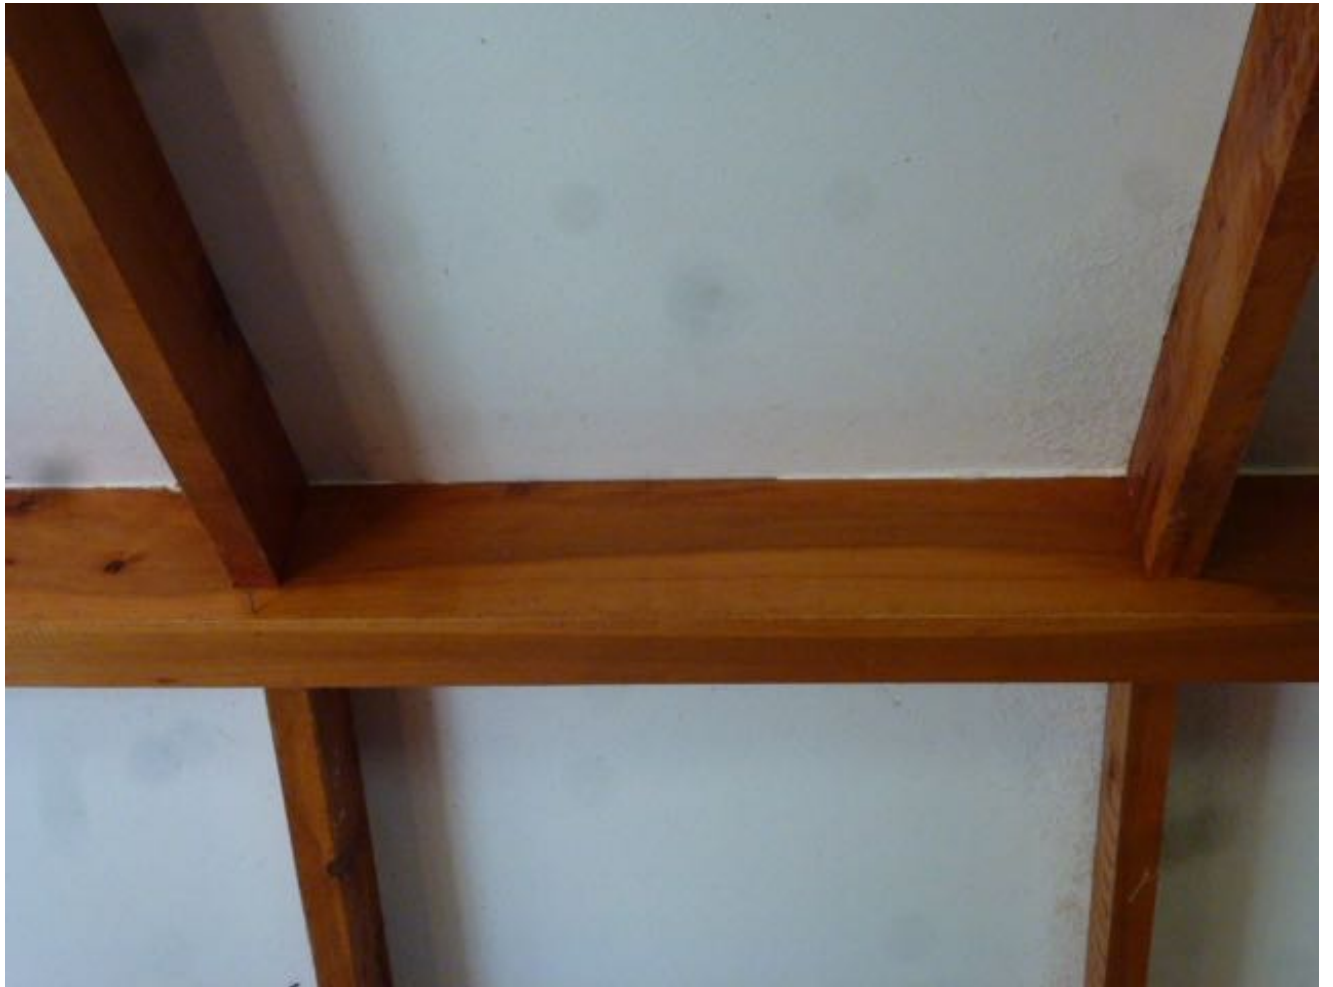
8" x 4" beam with rafters showing sapwood

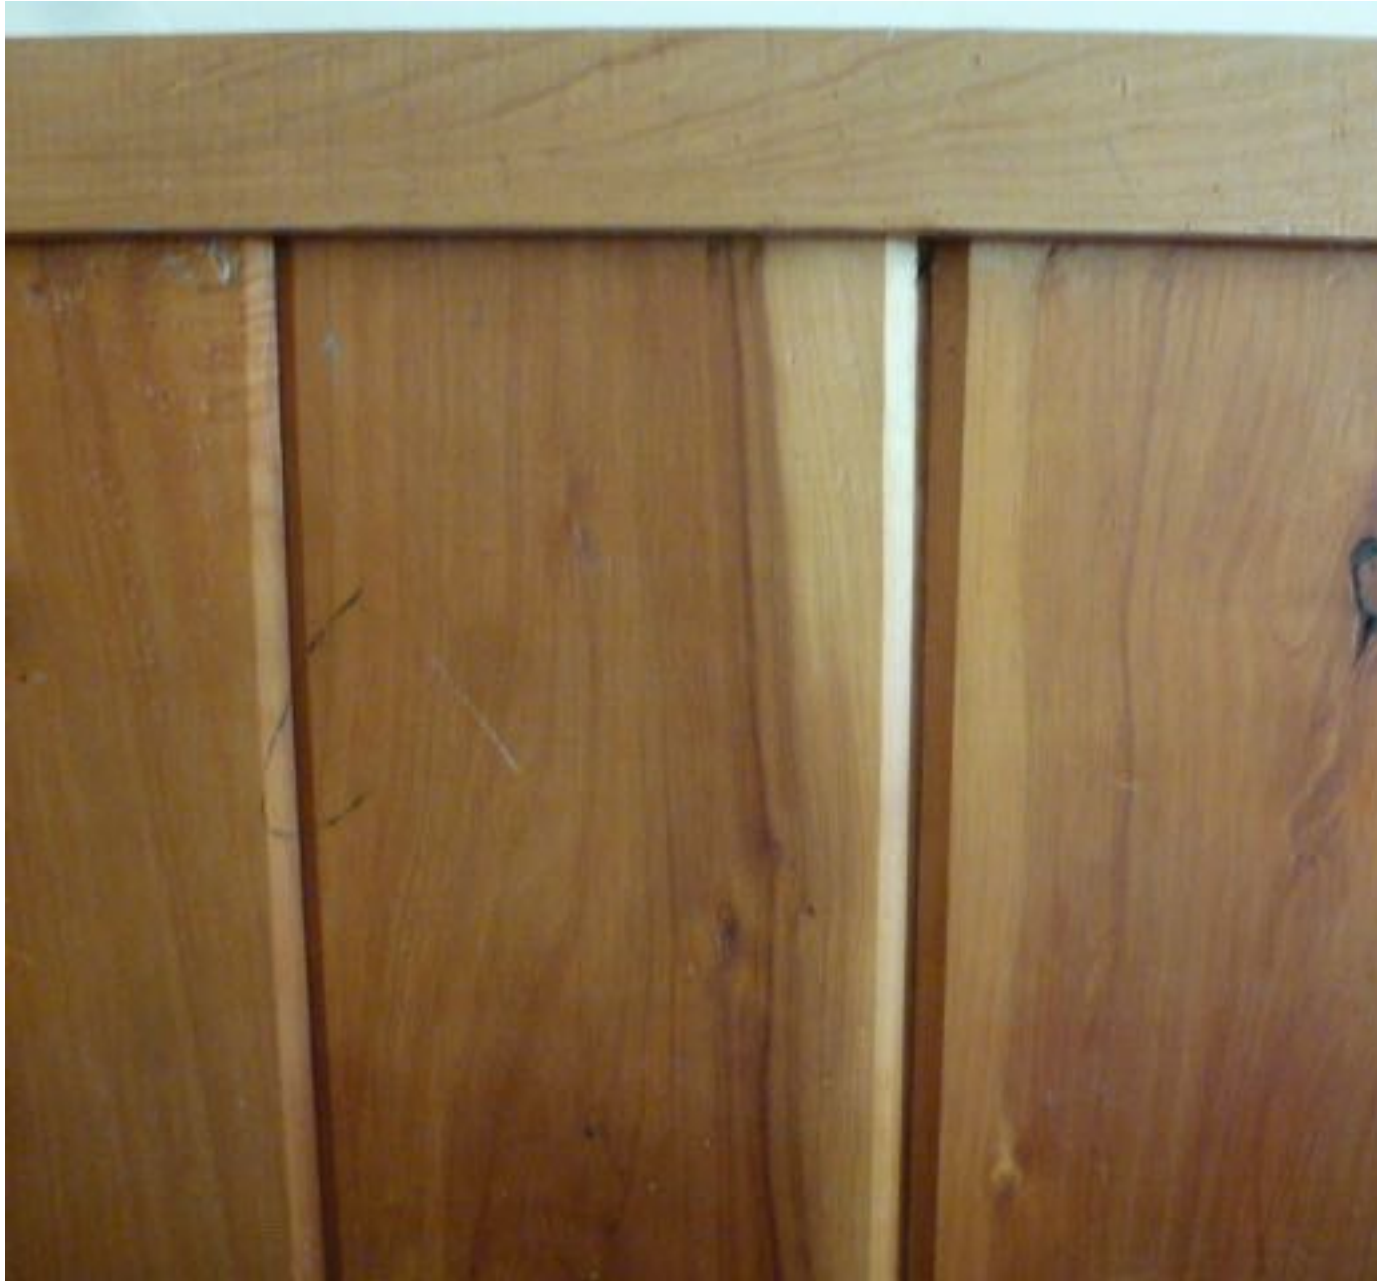
6" x 1" sarking / interior wall cladding showing sapwood

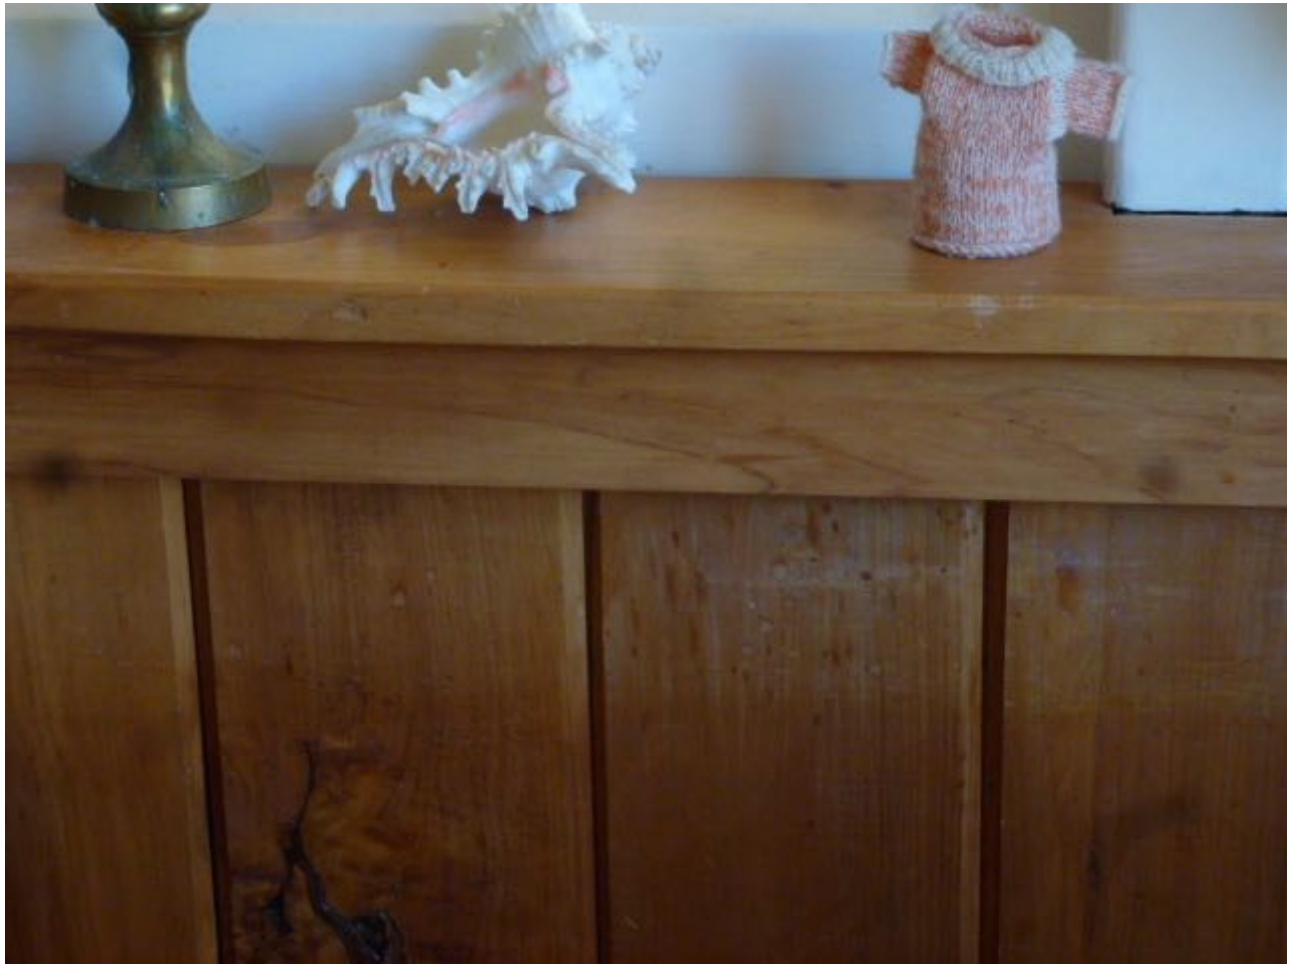
Interior shelving above sarking (with evidence of household activity but no borer)

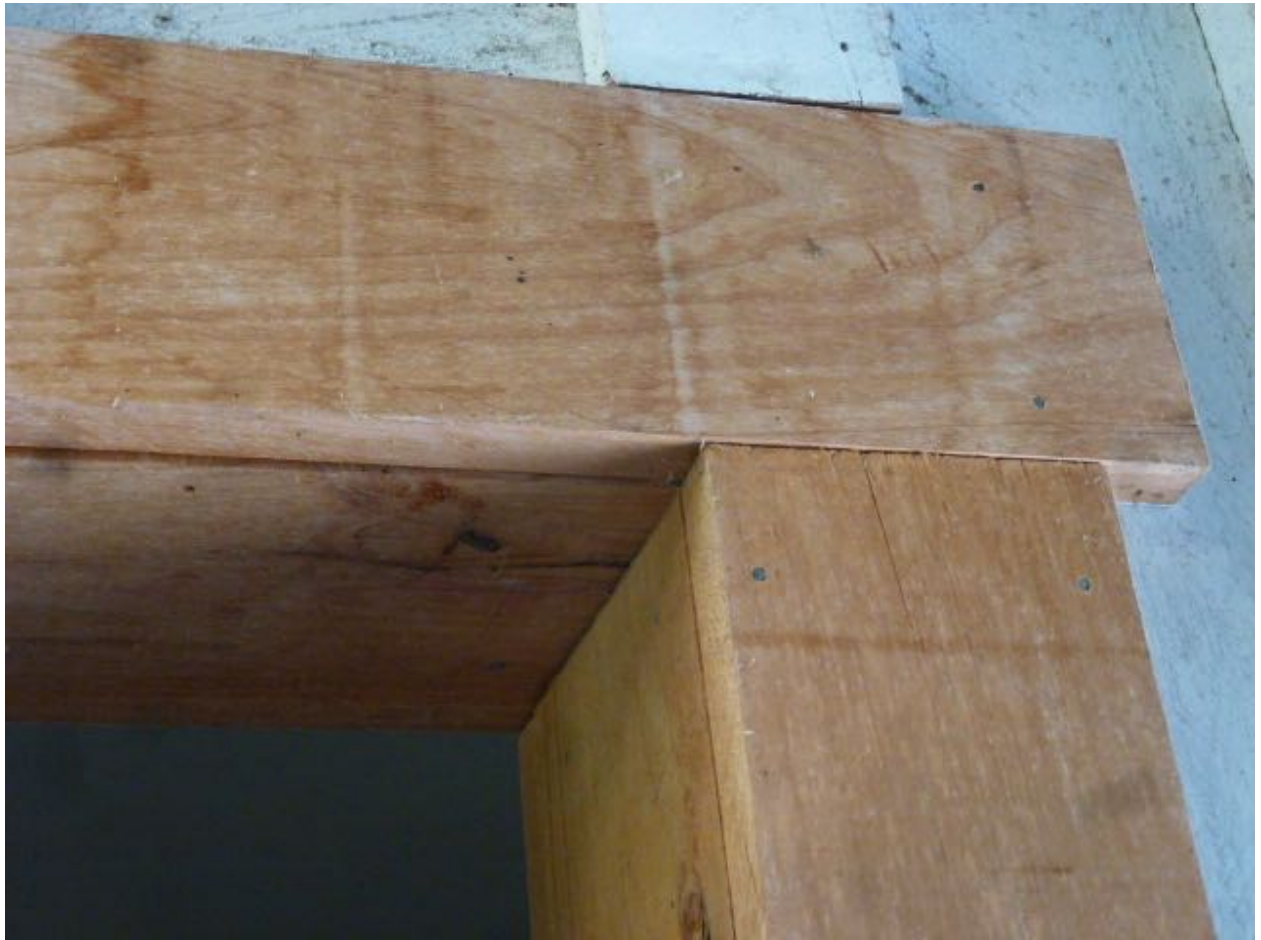
4" x 1" door surround of exterior washhouse (under partial cover, but note water stain as result of heavy wind during storms)

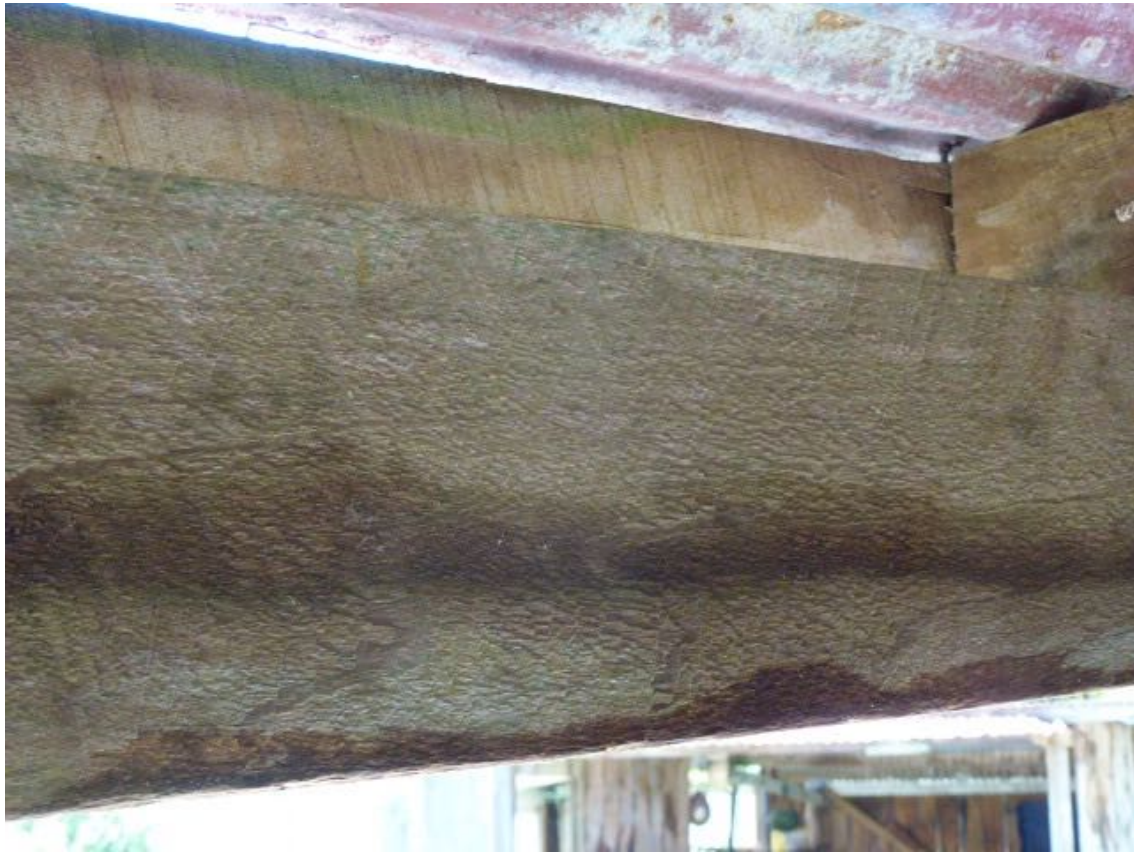
6" x 2" rafter for exterior shed. Again note water stain from rain blowing in during storms; no rot or borer seen.

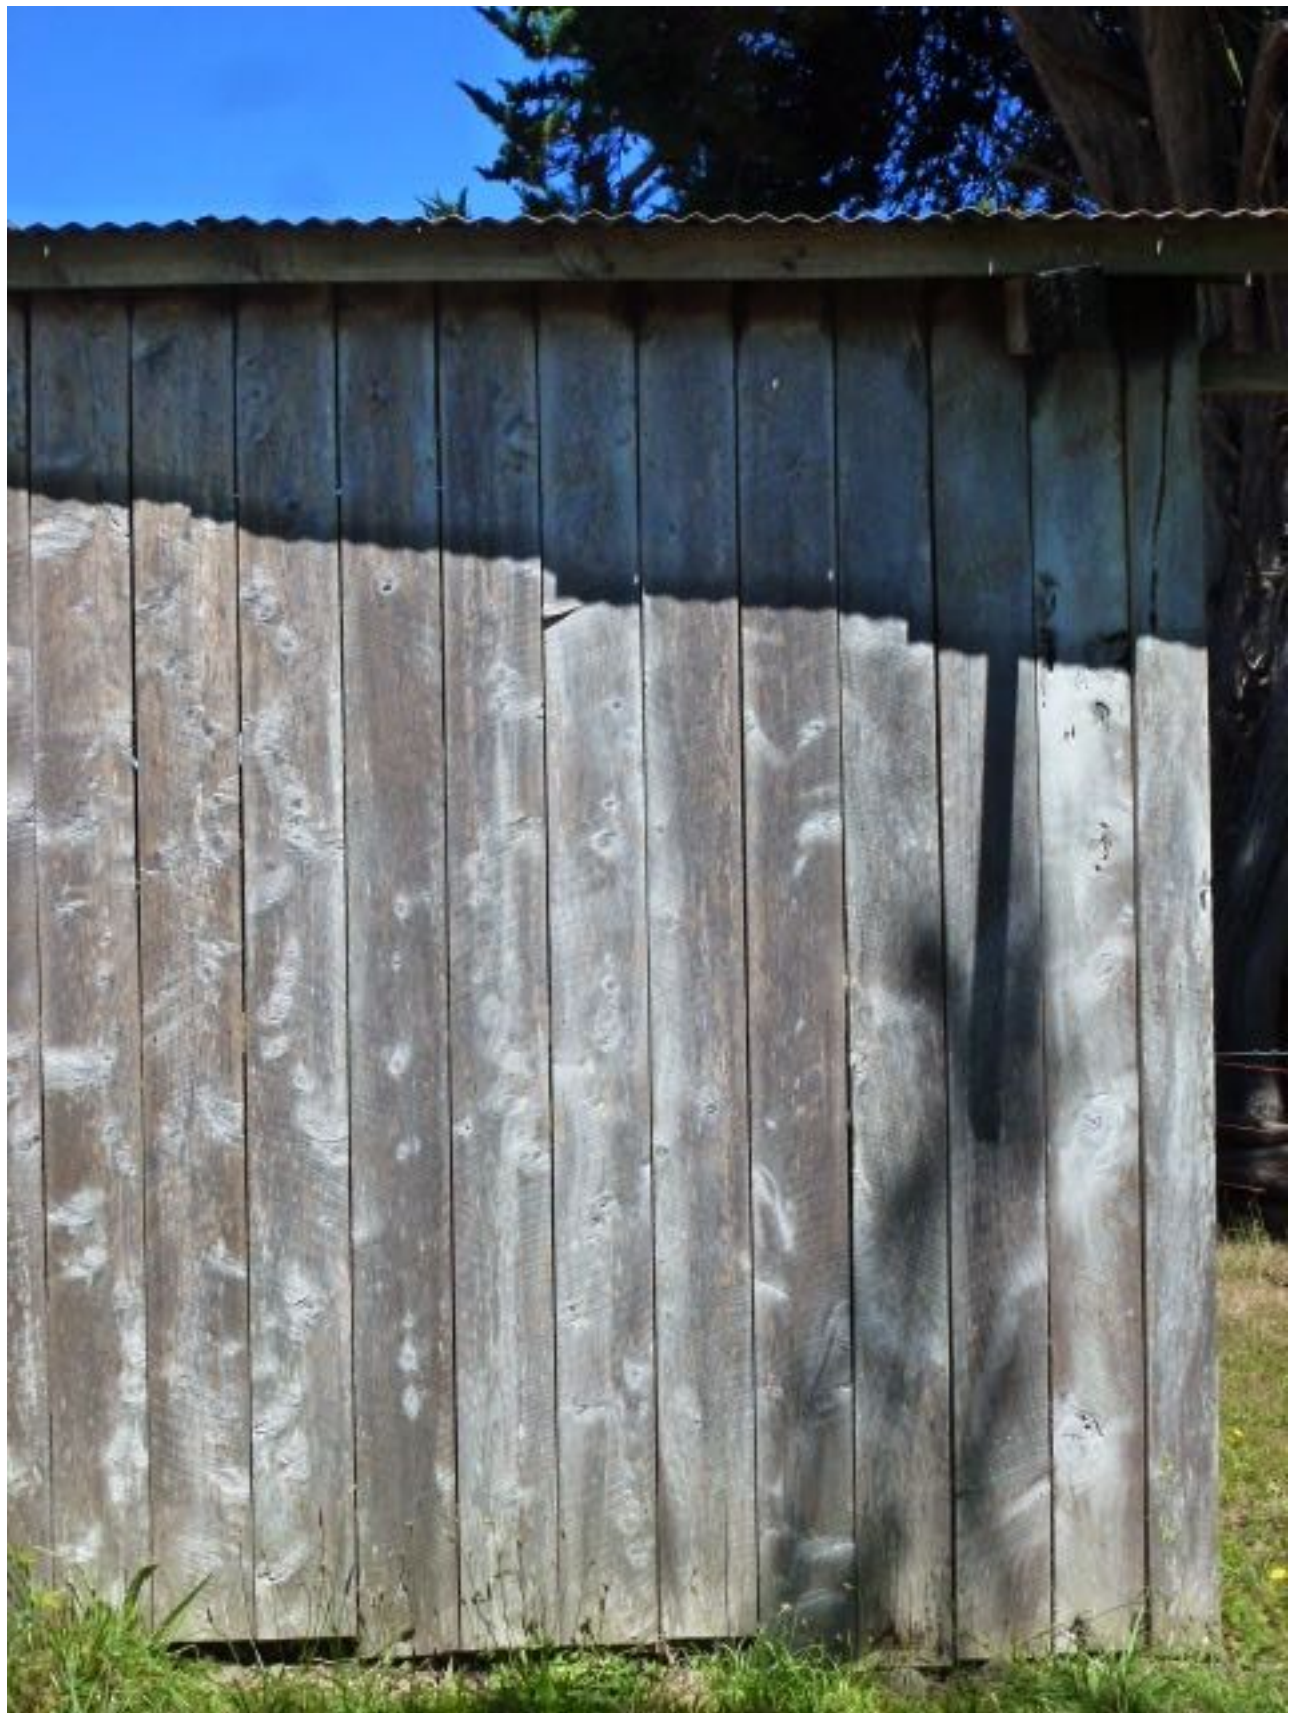
Outside shed erected in 1990 and clad with 8" x 1" *C. lusitanica* rough-sawn boards milled from 30 year old trees that were part of a shelter belt either side of a driveway in Okaihau, Northland. The wall faces north, both into the sun and major storm. The timber has had no dressing or treatment.

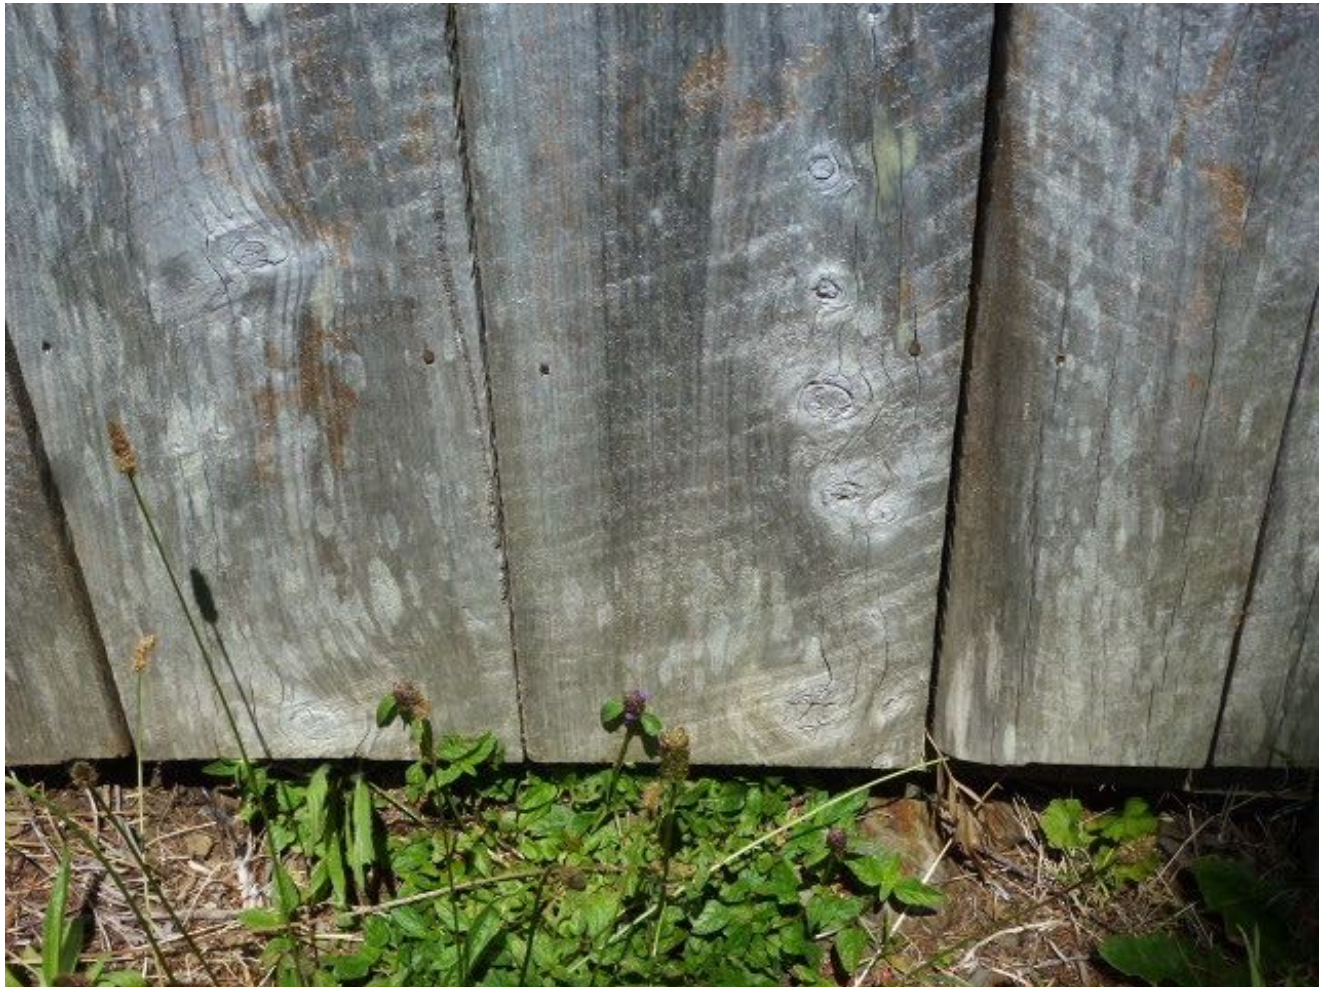
Detail of footing showing no rot.

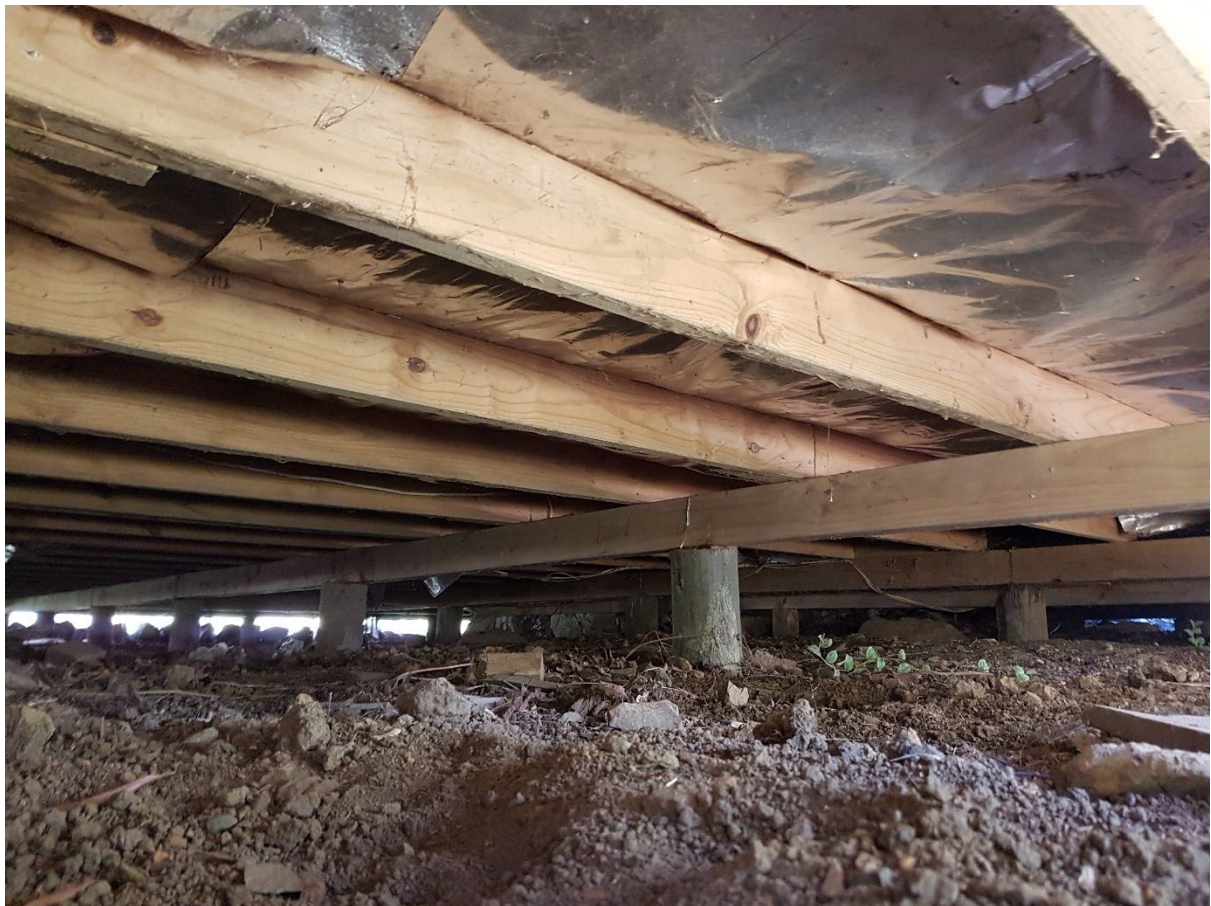
*Macrocarpa floor over joists. Piles under floor range from less than 300ml to 600ml above ground*

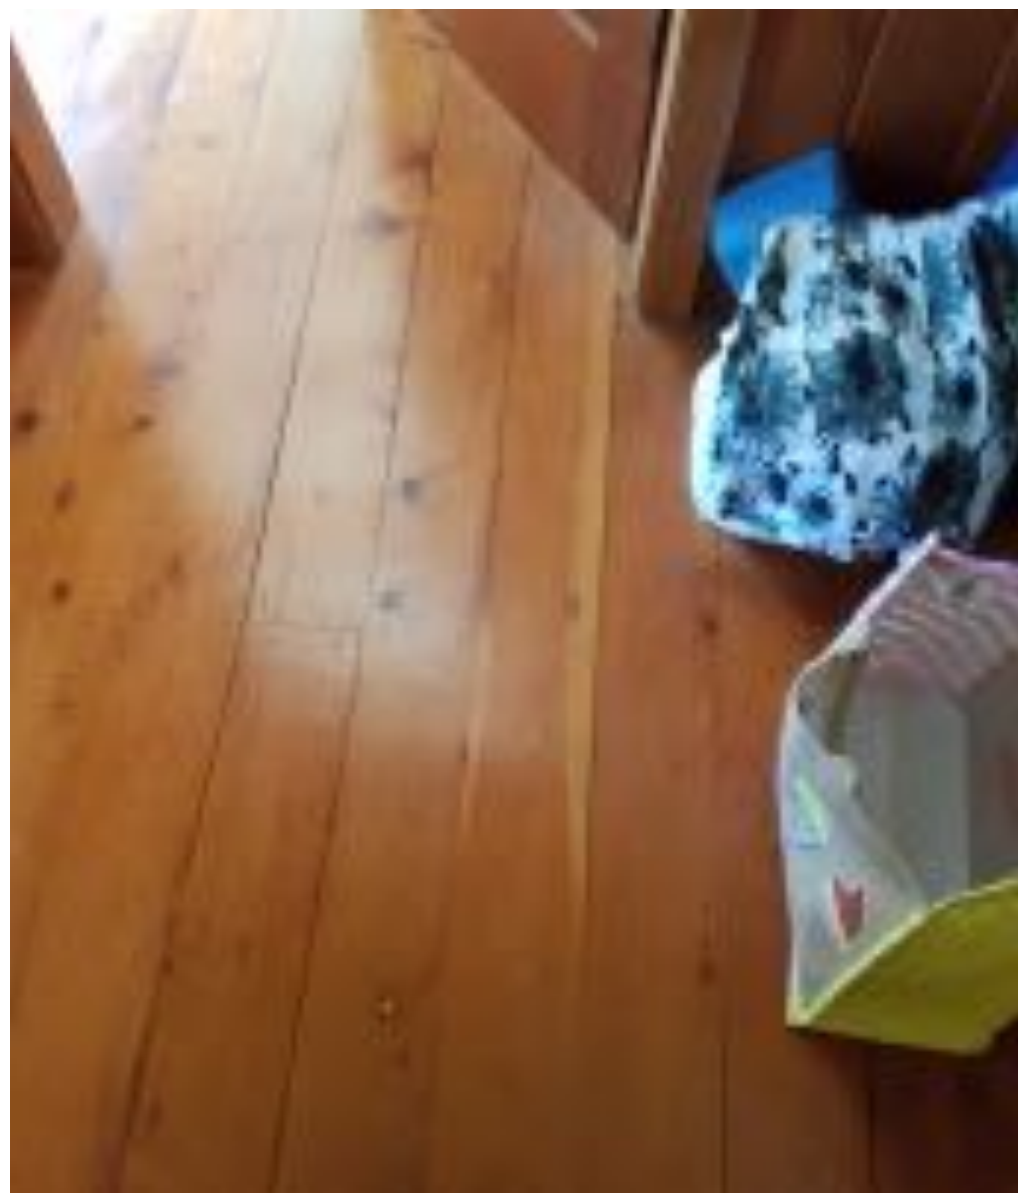
Macrocarpa floor over joists showing sapwood

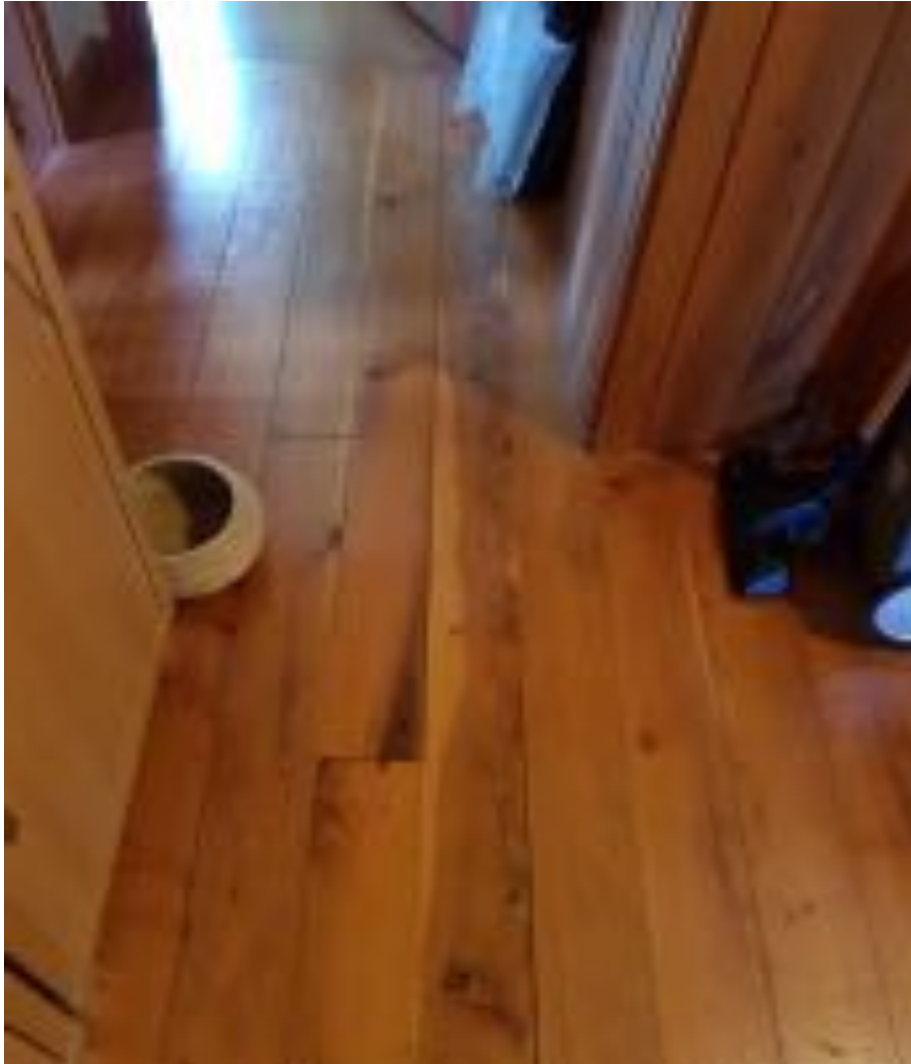
Macrocarpa floor over joists showing sapwood

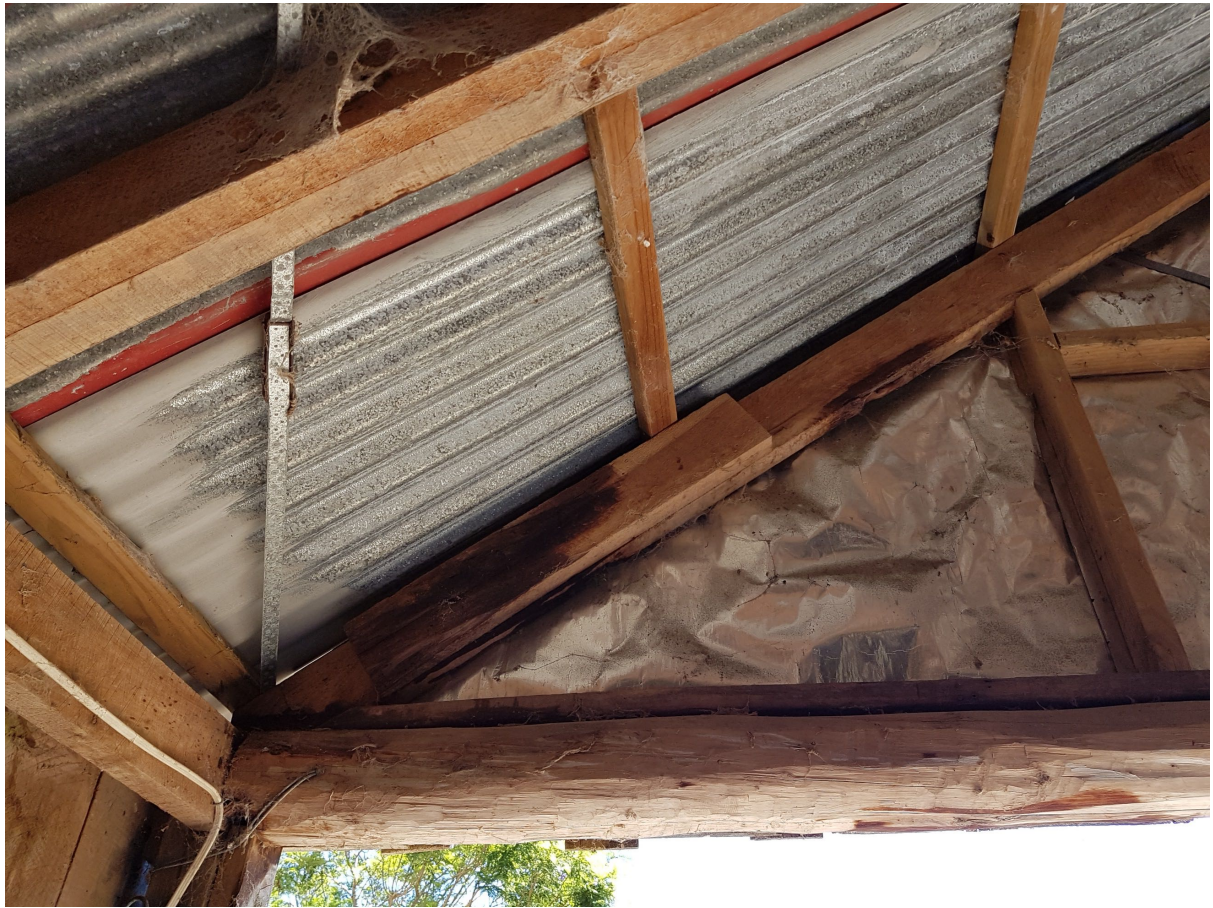
Macrocarpa beam from 50 year old tree, showing sapwood with no borer

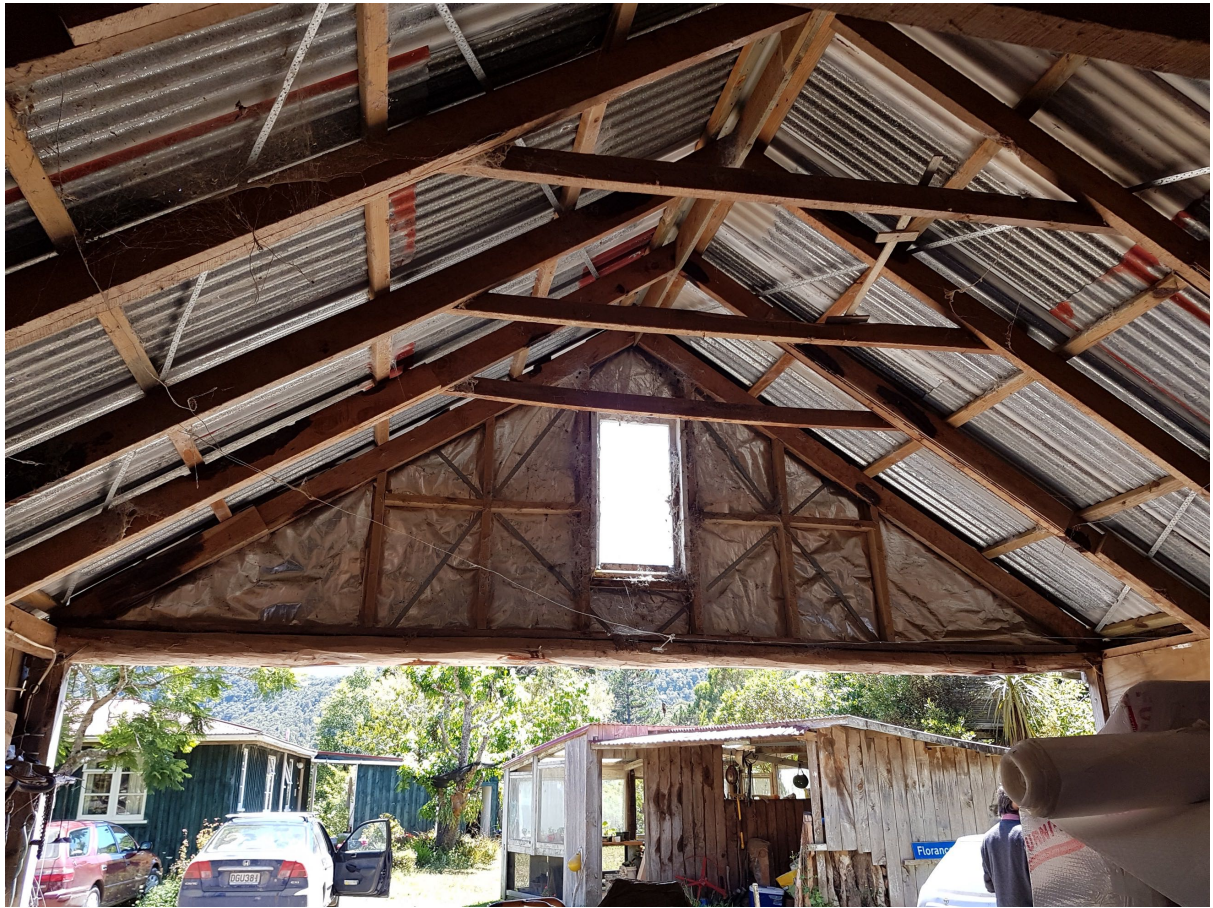
Macrocarpa beam from 50 year old tree.

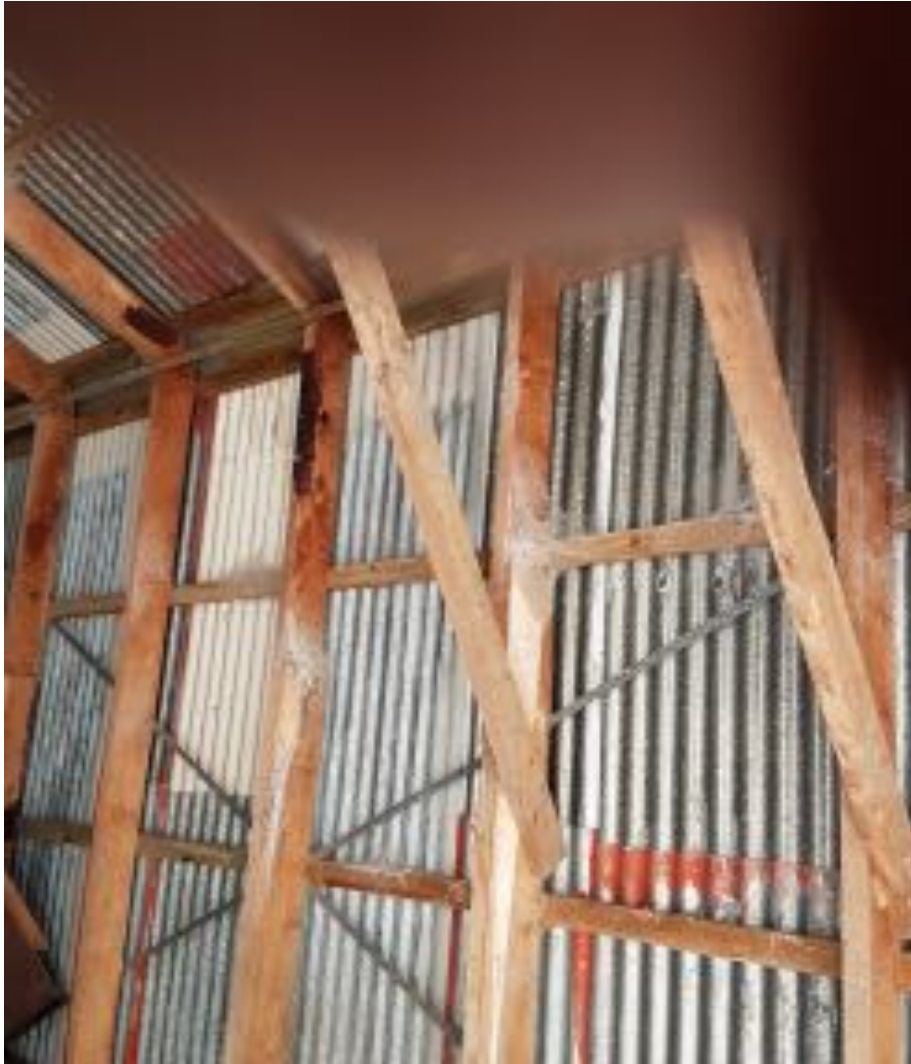
Macrocarpa framing in shed showing sapwood, no borer present.

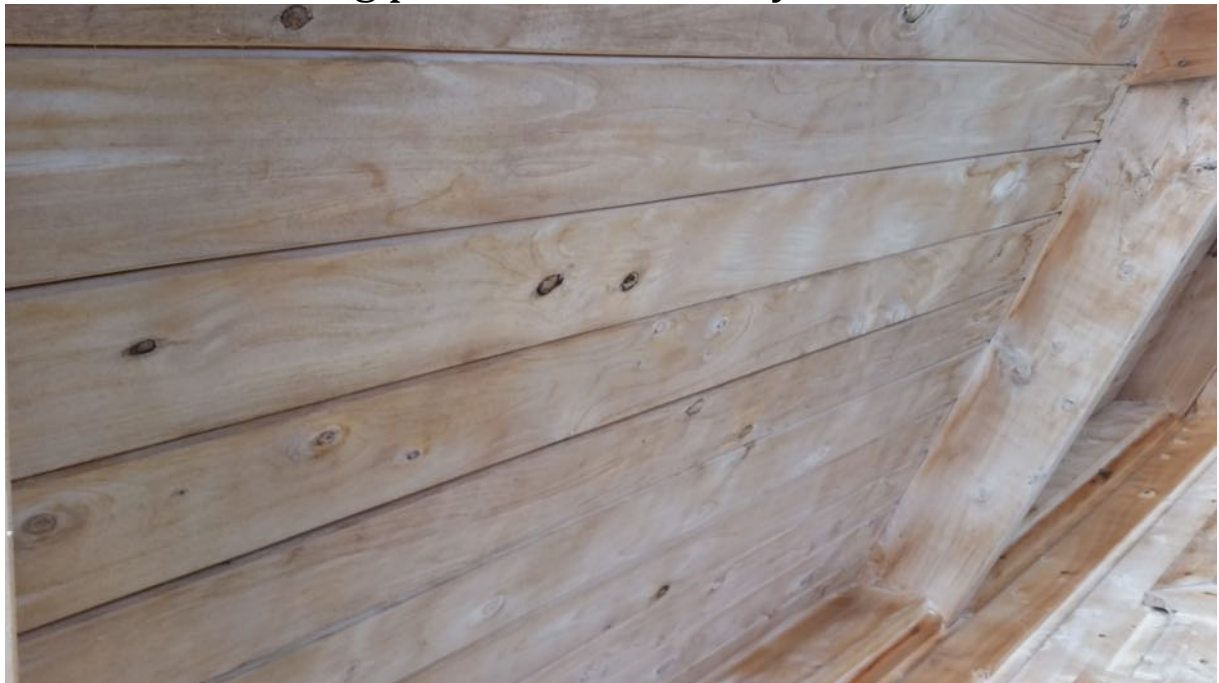
I built this house in Whangarei in 1999. Ceiling sarking was all 2<sup>nd</sup> grade lusitanica cypress with sap. No evidence of house borer being present in February 2017.
