# **EXAMPLES OF CYPRESS SAPWOOD RESISTING ATTACK BY THE COMMON HOUSEHOLD WOOD BORER (*ANOBIUM PUNCTATUM*) IN NEW ZEALAND**

**A Report Prepared by Dean Satchell for the NZS 3602 Standards committee, 21<sup>st</sup> February 2017.**

**This report documents examples showing cypress sapwood timber to have resistance to household borer, both in internal applications and those protected from weather but exposed to exterior or ground atmosphere.**

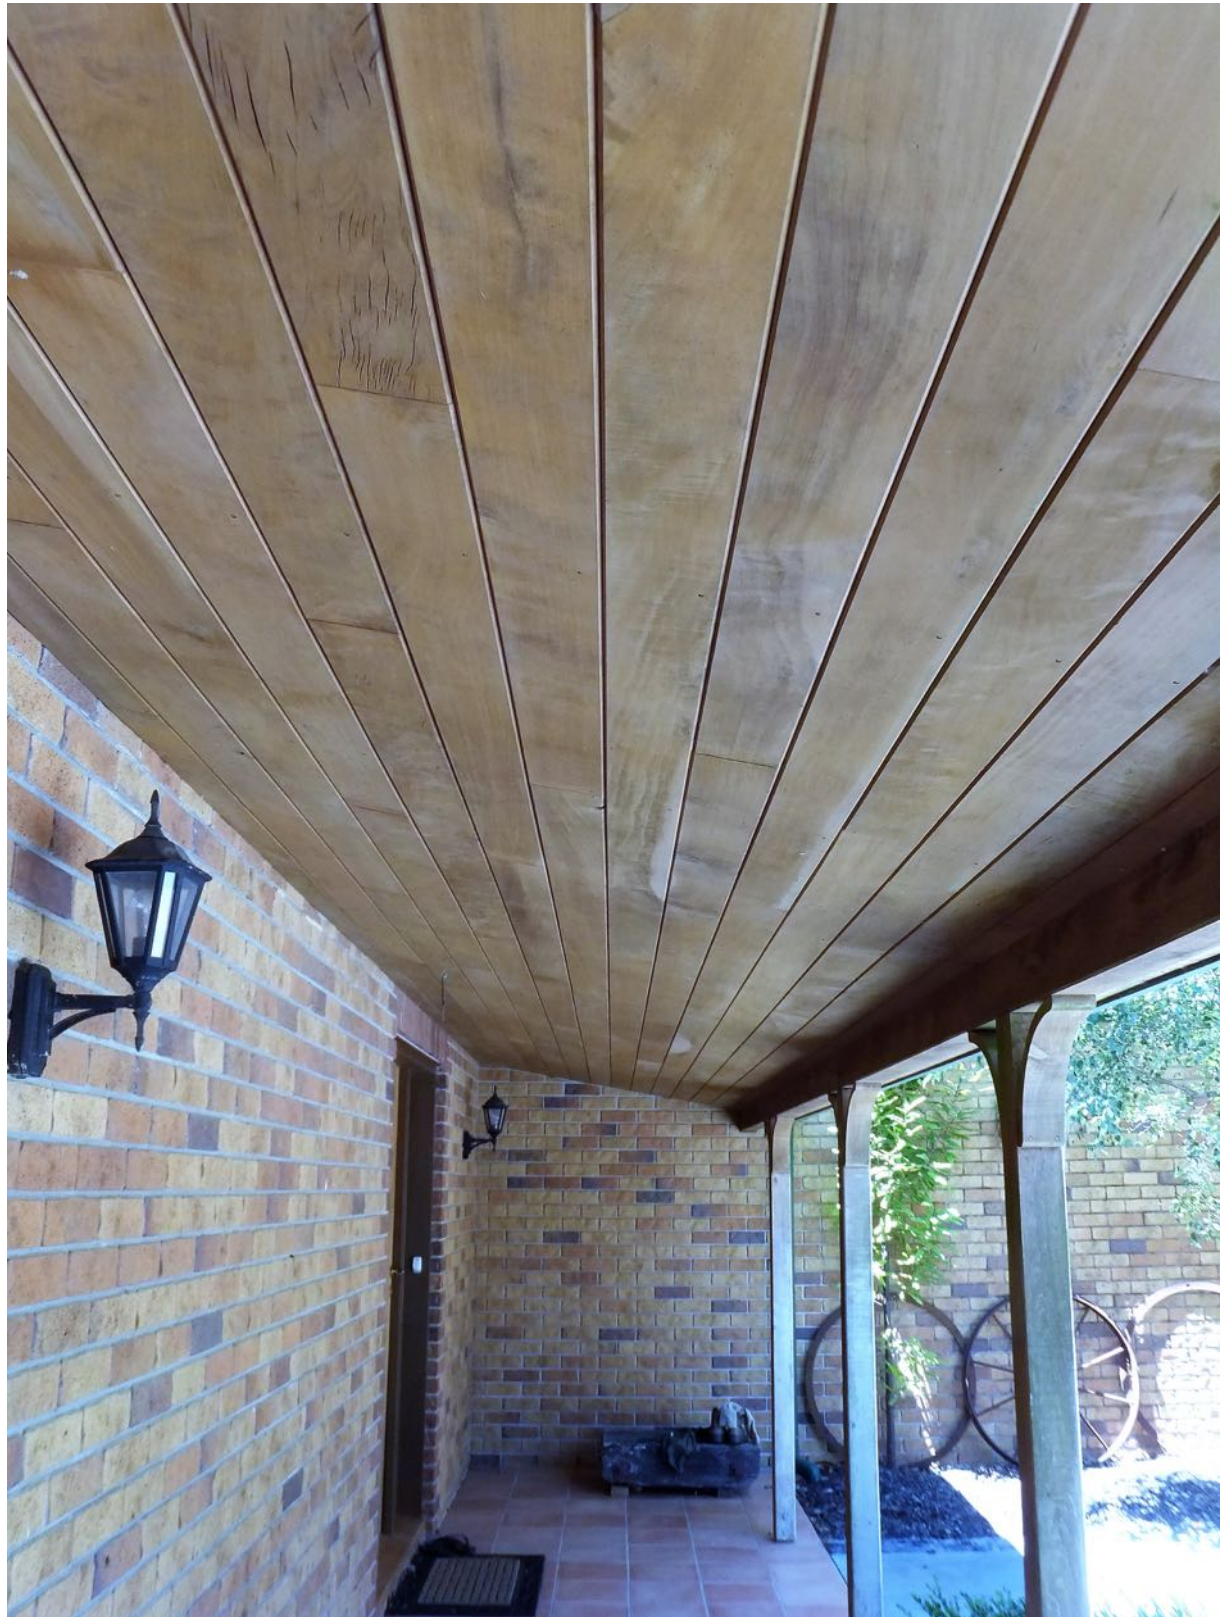
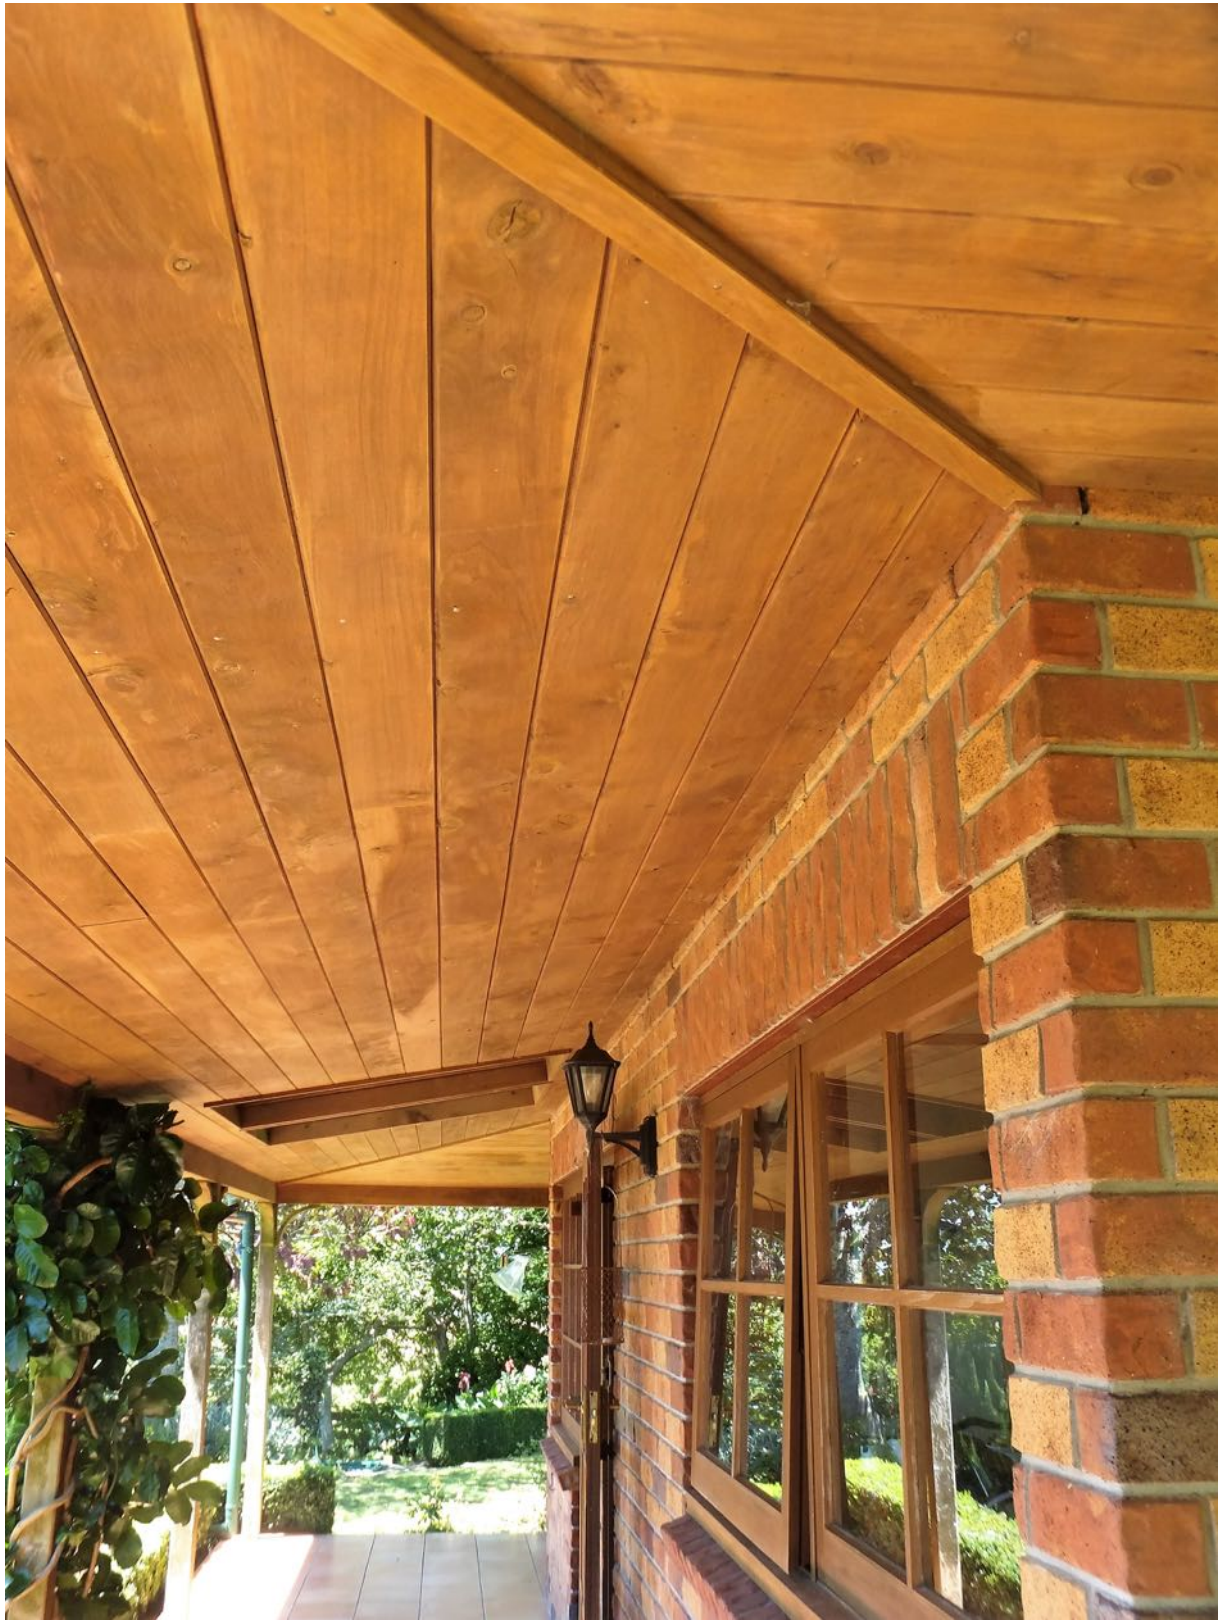
This shows T&G Macrocarpa used as a ceiling under a verandah in a large house built in an old style in 1996. It is a mixture of heart and sap. There is no evidence of borer being present. Certain defects such as tight knots were considered acceptable for this application. Location: Kaihere, elevated position western side of Hauraki Plains.

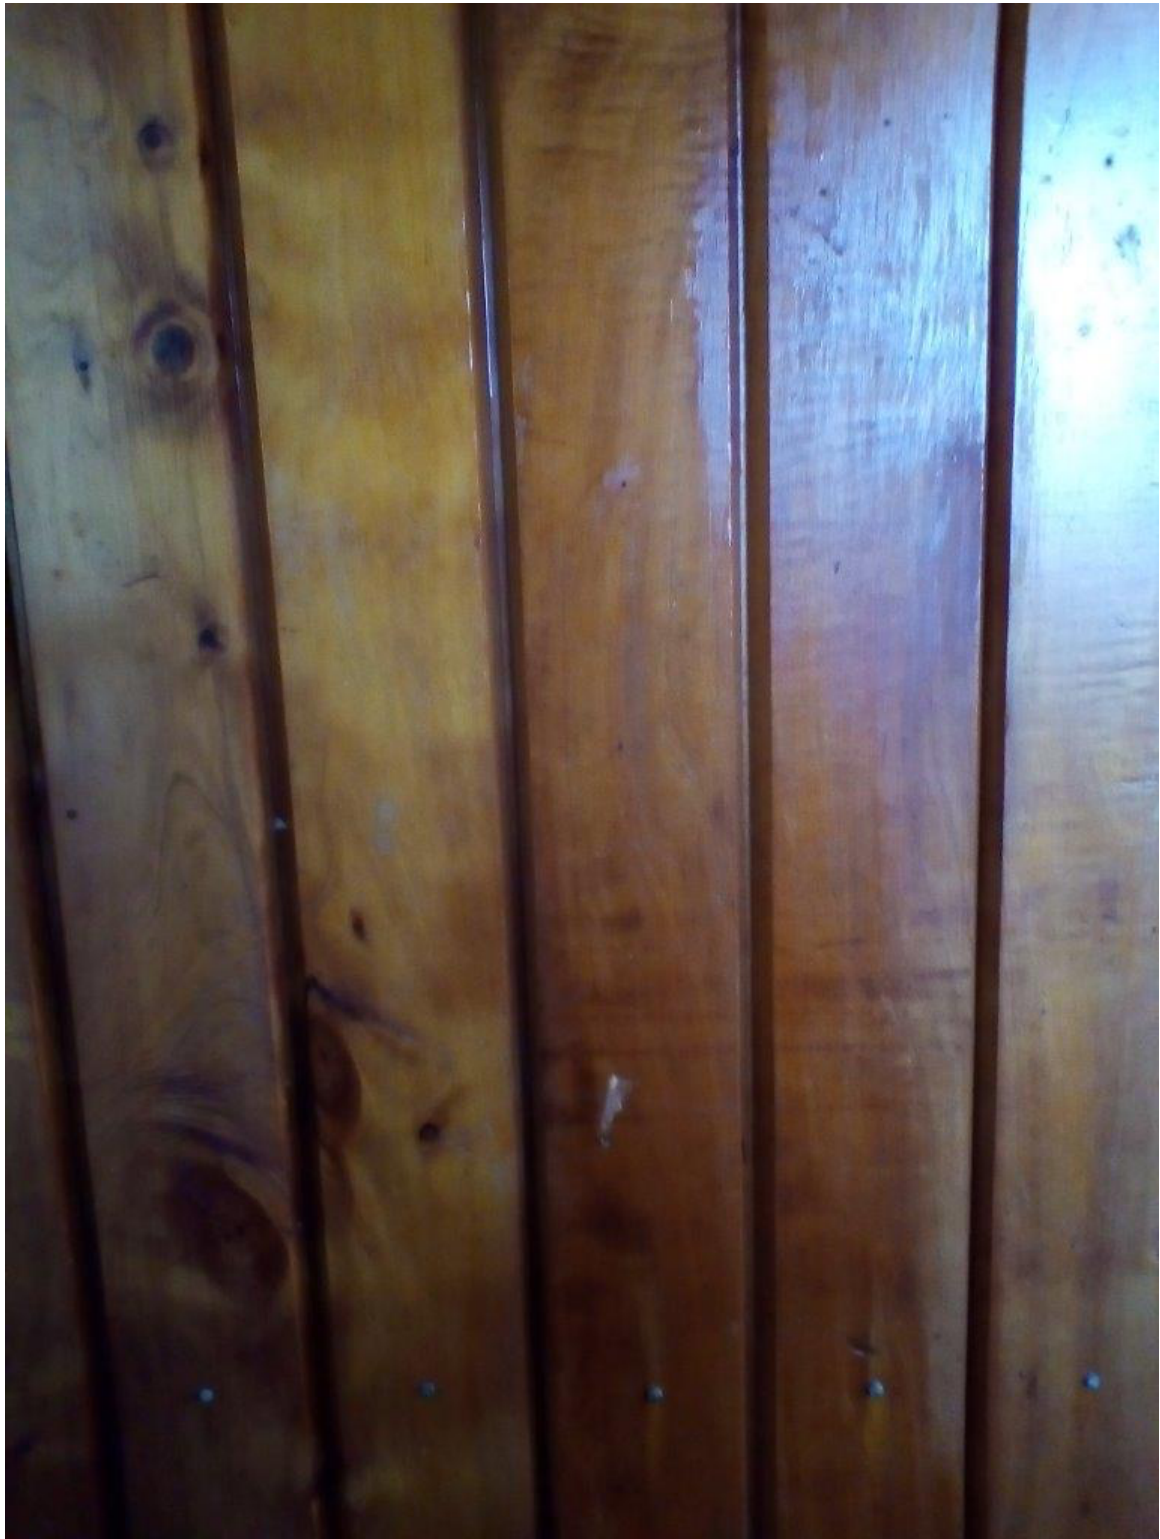
Tongue and groove panelling was installed on a porch that is open to the outside at one end but out of direct sunshine. It is coated with polyurethane. There is no sign of any borer attack on any of the three areas totalling approximately 45 sq.m.

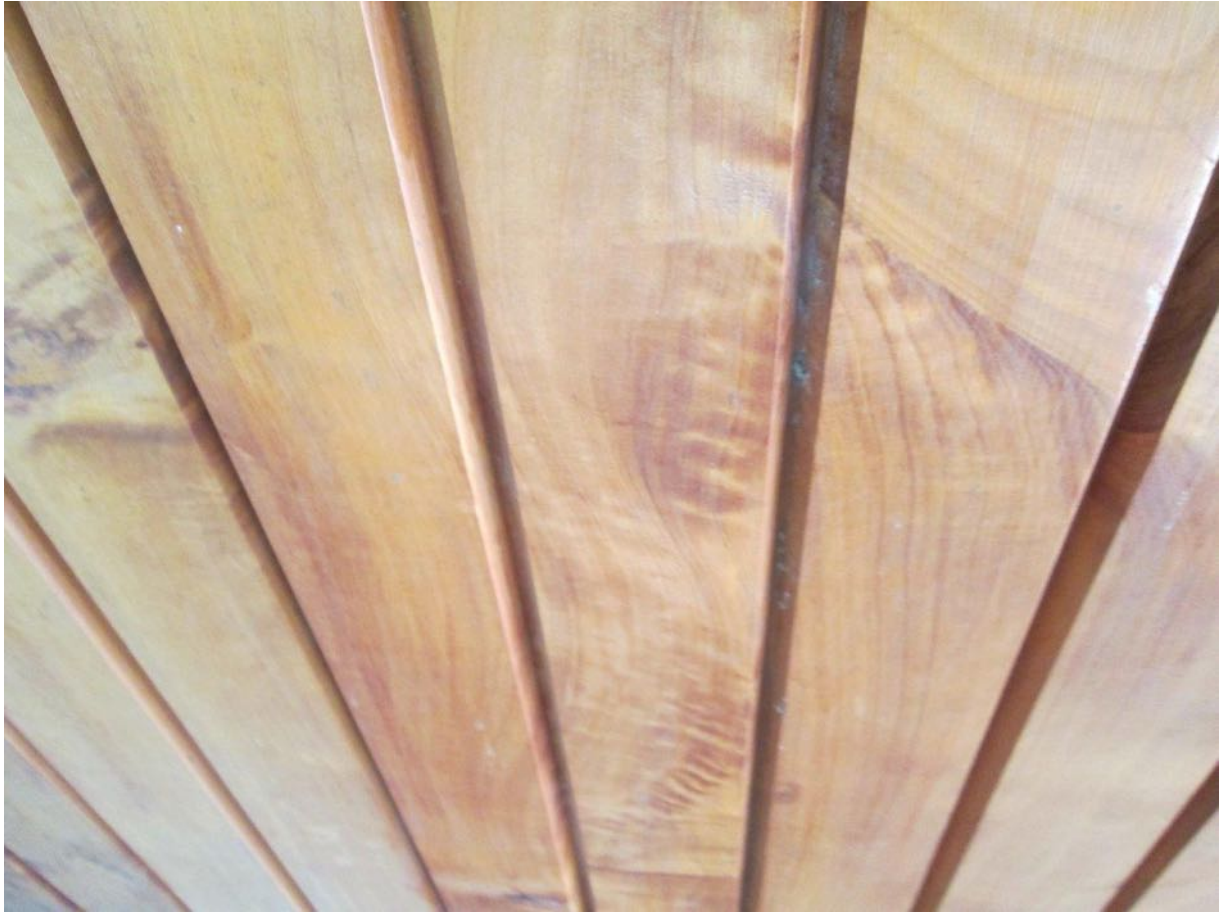
Another area of panelling inside the house also has no signs of borer present.
