**Report No. FFR- DS029**

# **Summary of Tests on Untreated Douglas-fir, Treated and Untreated Radiata pine for Use as Framing in Domestic Construction in New Zealand**

**Authors:**  
**M Hedley, D Page, J van der Waals and T Singh**

**Research Provider:**  
**Scion**

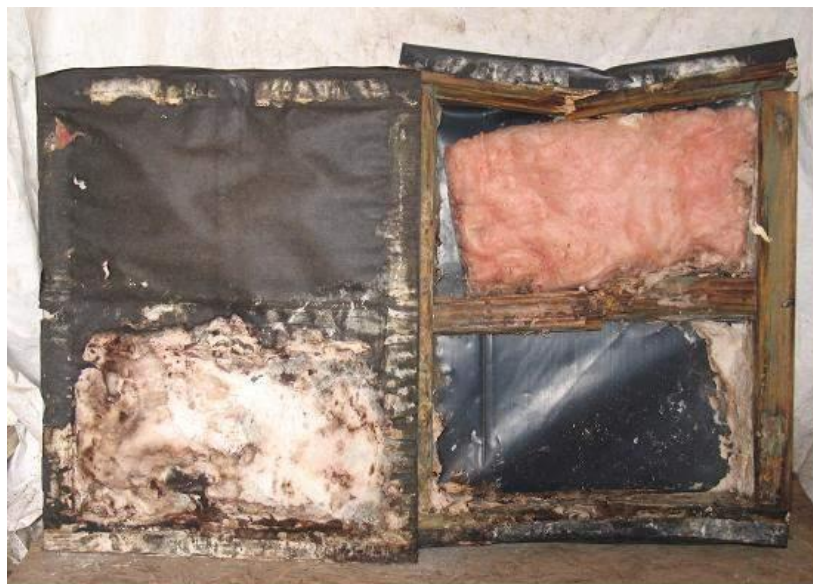
The untreated Douglas-fir units all contained moderate-severe decay in all components at the 52-week assessment. After 78 weeks exposure one unit failed along with all bottom plates and three dwangs in the remaining four units. Two more units failed after 104 weeks, one after 130 weeks and the final failure was at the 156-week assessment.

**Figure 6: Douglas-fir unit after three years' exposure showing almost complete decay**

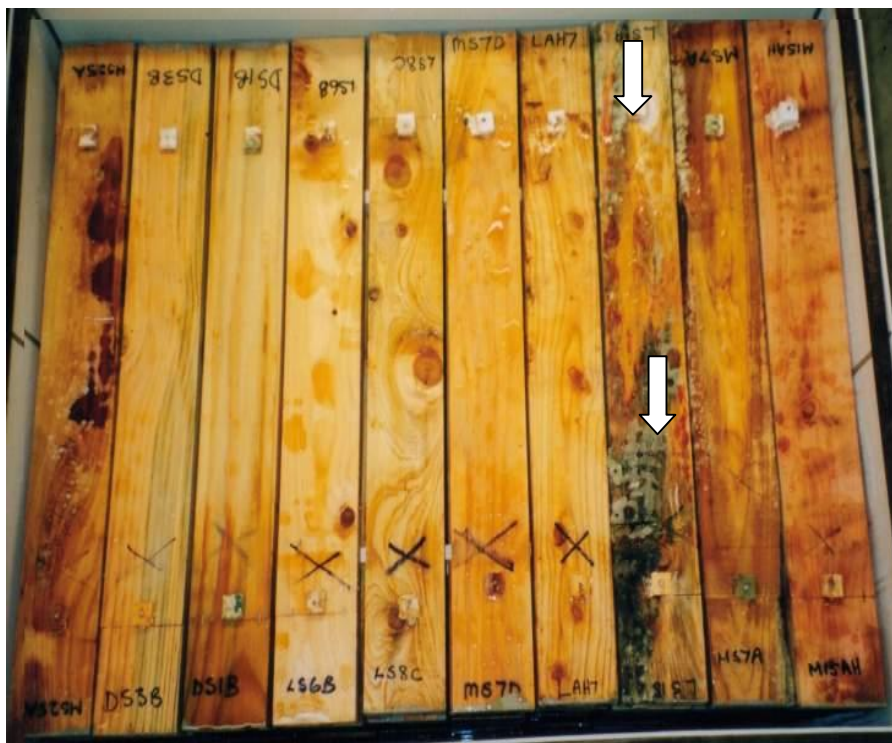
**Figure 8: After four weeks' exposure. Sapstain and mould developing on Lawson cypress sapwood samples (arrowed).**

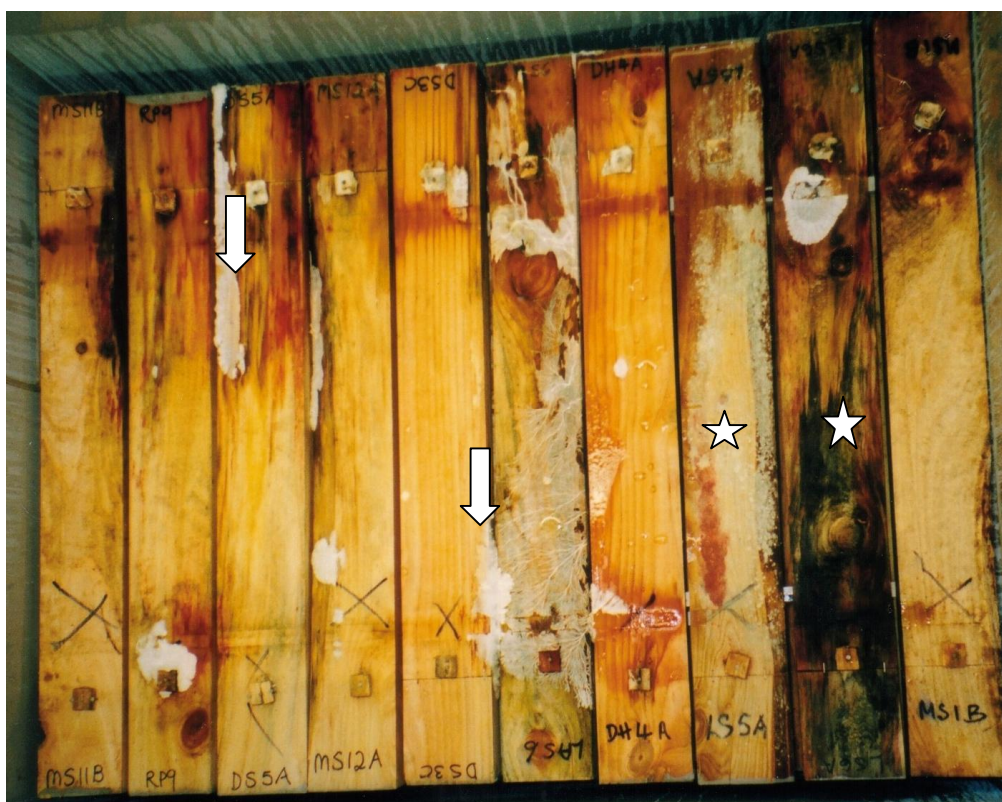
**Figure 9: After twenty-four weeks' exposure. Decay developing on Douglas-fir (arrows) and Lawson cypress sapwood (stars)**
