# The decay resistance of some wood species used as framing

## Progress report on the condition of samples

Ian Simpson and Tripti Singh

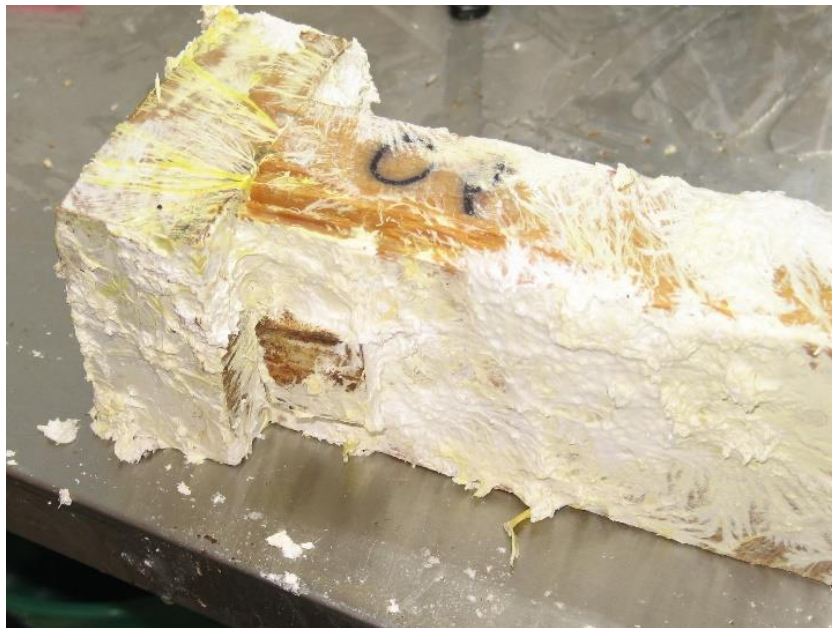
**Figure 2:** Mycelium growth on the surface of a *Cupressus lusitanica* sample after twelve months exposure (sample 206).

After twelve months exposure, extensive mycelium was observed on the surface of many of the *Cupressus luscitanica* samples (Figure 2). The presence of mycelium does not necessarily indicate the presence of wood decay. Decay was observed in most samples, either on the surface or in the joint. There were higher levels of decay in the samples with mixed heartwood\sapwood (Figures 3) than the heartwood samples (Figures 4). Low levels of mould were observed on *C. luscitanica* samples.

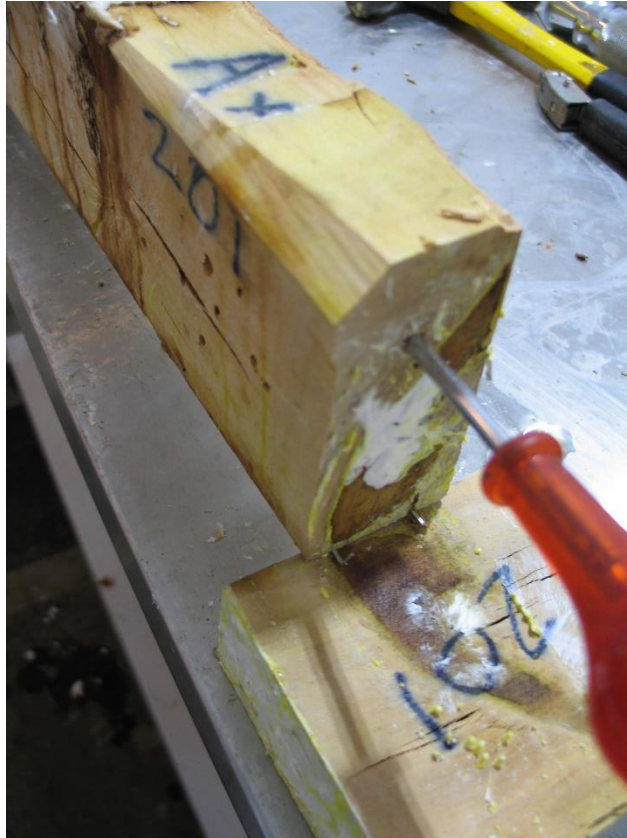
**Figure 3:** Decay on the surface and in the joint of a mixed heartwood\sapwood *Cupressus lusitanica* sample after twelve months exposure (sample 201).

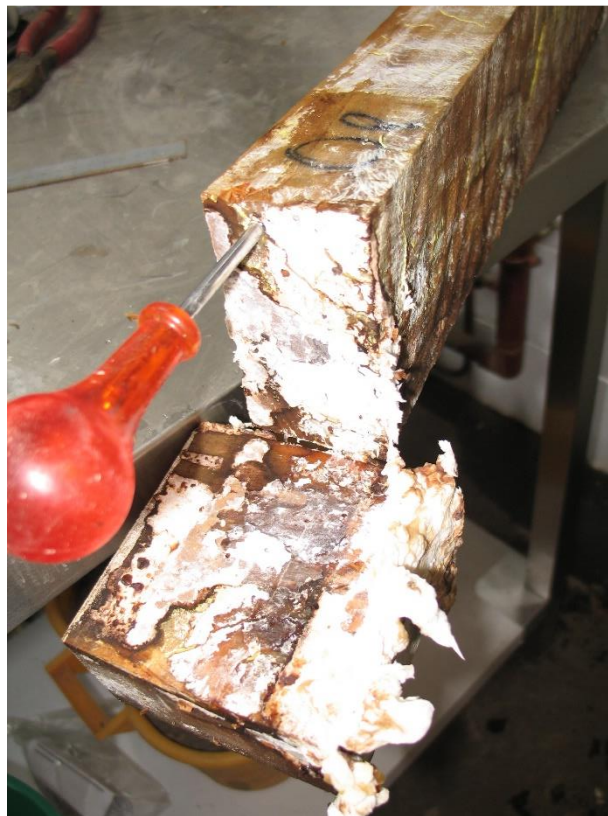
**Figure 4:** Decay in the joint of a heartwood *Cupressus lusitanica* sample after twelve months exposure (sample 235).

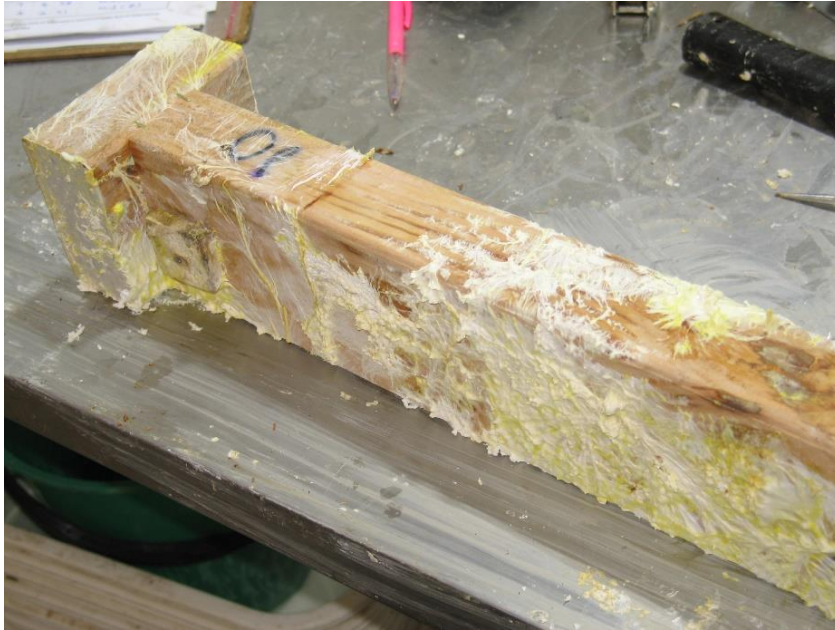
**Figure 5:** Mycelium growth on the surface of a Douglas fir sample after twelve months exposure (sample 502).

After twelve months exposure extensive mycelium was observed on the surface of many of the Douglas fir samples (Figure 5). Decay was observed in all of the Douglas fir samples with some samples having severe decay (Figure 6). On average, slightly higher levels of decay were observed in the samples that had mixed heartwood\sapwood compared to heartwood only samples

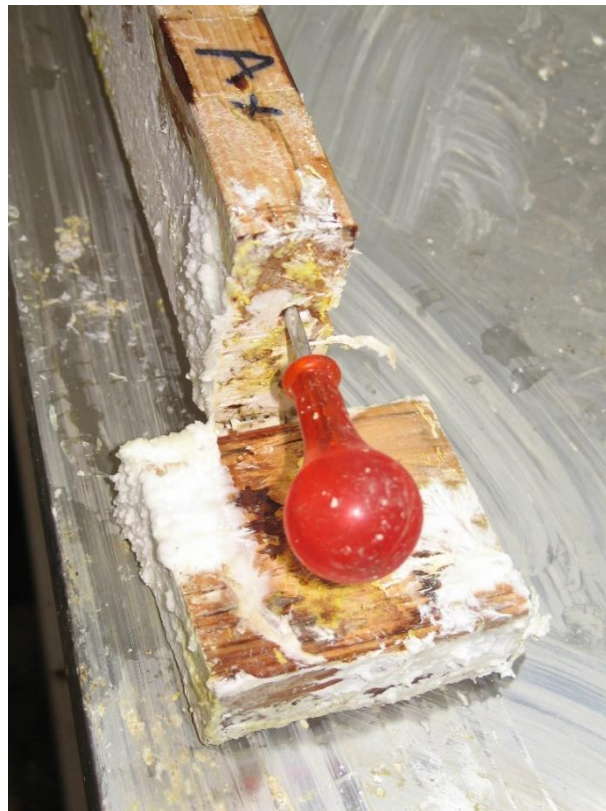
**Figure 6:** Decay in the joint of a Douglas fir sample after twelve months exposure (sample 503).

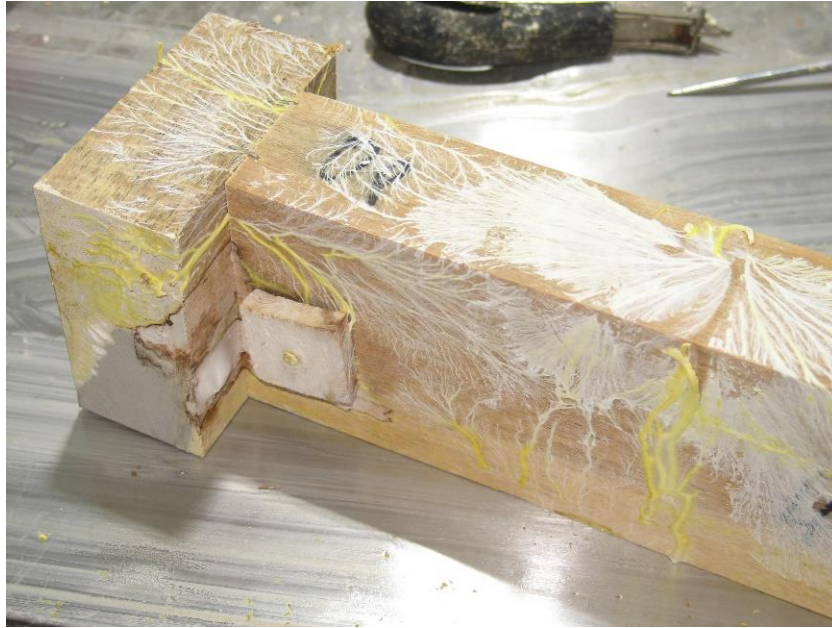
**Figure 7:** Mycelium growth on the surface of a *Eucalyptus regnans* sample after twelve months exposure (sample 409).

After twelve months exposure extensive mycelium was observed on the surface of many of the *Eucalyptus regnans* samples (Figure 7). Decay was observed in most samples either on the surface or in the joint (Figure 8). Low levels of mould were observed on *E. regnans* samples.

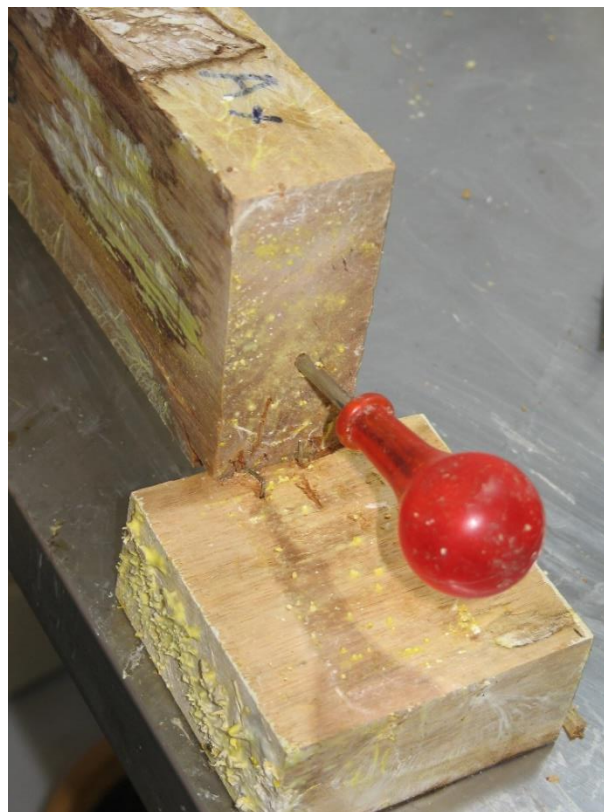
**Figure 8:** Decay in the joint of a *Eucalyptus regnans* sample after twelve months exposure (sample 408).

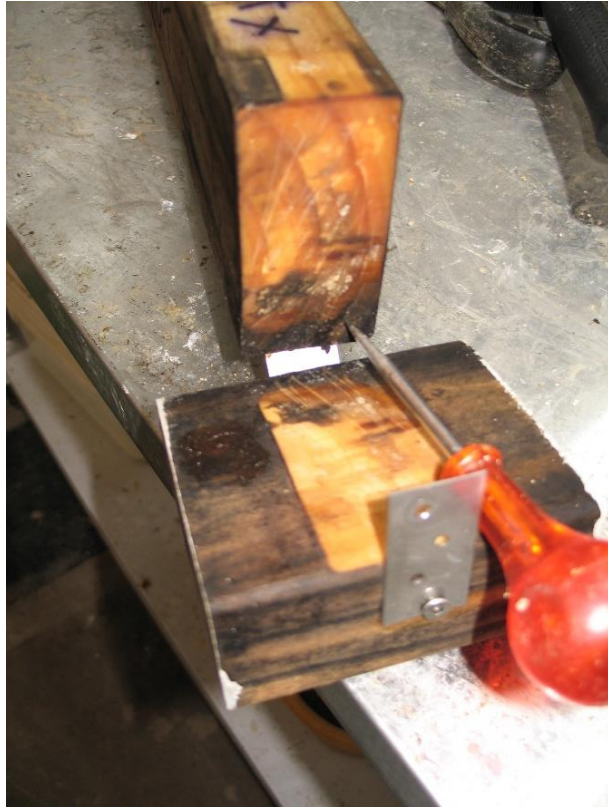
**Figure 9:** Suspected soft rot on the bottom edge of a boron treated radiata pine sample after twelve months exposure (sample 604).

After twelve months exposure low levels of mycelium were observed on the H1.2 boron treated radiata pine samples. No cross-sectional damage or decay was observed on boron treated radiata pine. An area of softening, which could not be positively identified as decay but was suspected to be soft rot, was observed on the bottom edge of one of the boron treated radiata pine sample (Figure 9). No decay was observed in the other samples. High levels of mould were observed on all of the samples (Figure 10).

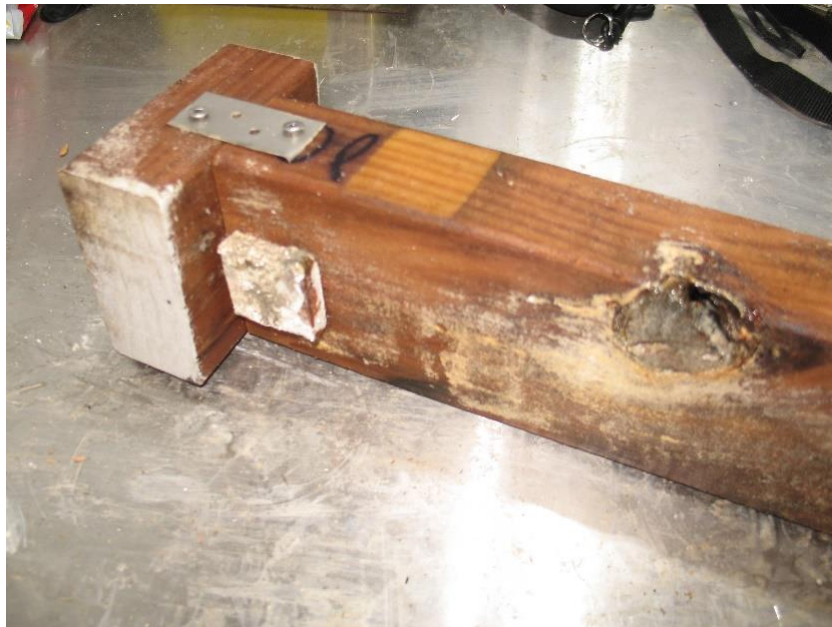
**Figure 10:** Mould growth on the surface of a boron treated radiata pine sample after twelve months exposure (sample 601).

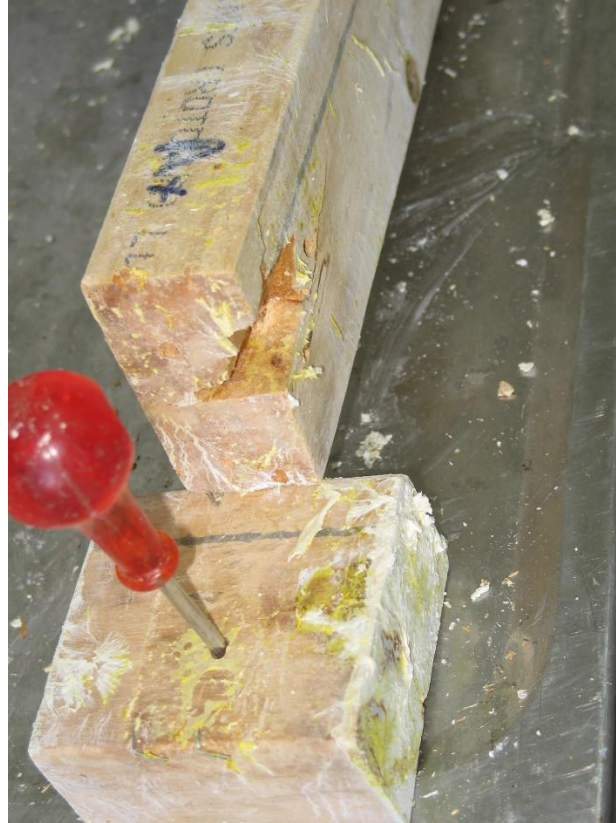
**Figure 13:** Decay in the joint of an untreated radiata pine sample after six months exposure (sample U10).

After six months exposure, extensive mycelium was observed on the surface of the sapwood of untreated radiata pine samples. Established decay was observed on the surface and in the joint of all samples (Figure 13). Extensive mould was observed on all samples.
