# **THE DECAY RESISTANCE OF DOUGLAS FIR, MACROCARPA, LAWSON CYPRESS AND EUROPEAN LARCH FRAMING SUMMARY OF RESULTS AFTER 52 WEEKS EXPOSURE**

## **Summary**

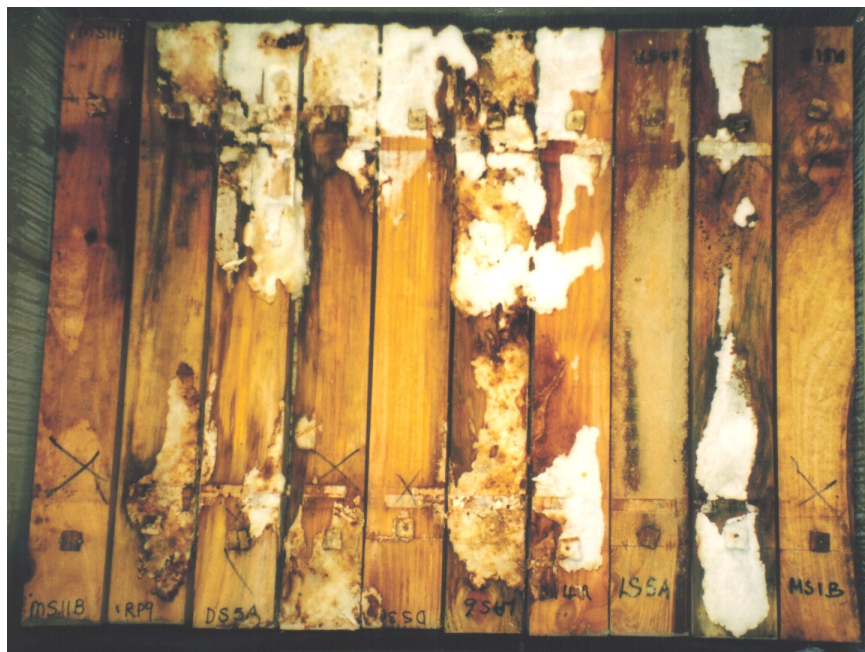
**Figure 3** – Layer 6 (2<sup>nd</sup> from top) Tank 2, after 52 weeks exposure. Extensive Auckland brown rot mycelium at both ends of mainly untreated sapwood samples, some spreading from infected samples in layers above and below. Although sample LS5A had severe mould infection and was surrounded by decaying samples, there was no decay on it.

After only one week's exposure decay mycelium had begun to spread from the feeder blocks onto the surface of the control samples. However, as the trial progressed, many of the feeder blocks became covered with moulds and there was little mycelium development from them, particularly on the preservative treated samples and the untreated heartwood samples. Mycelium spread ratings are summarised in Table 2. Where there was significant mycelium development, this tended to spread to adjacent samples and along fillets to samples in other layers. This resulted in large patches of mycelium, mainly Auckland brown rot, covering parts of several samples, including heartwood, and extending over more than one layer (Figures 3, 7, 8 and 12). There were samples where Auckland brown rot mycelium did not appear to have spread from the original feeder block but had developed away from the feeder block from an outside infection

point (Figure 3). The *Antrodia xantha* mycelium was much less visible and usually restricted to the sample that it had originally developed on (Figure 6).

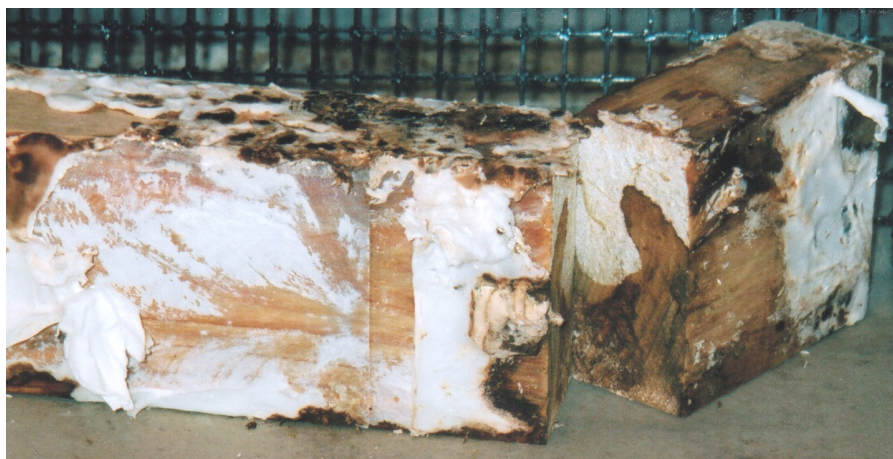
**Figure 4** – Sample MS12A, Layer 6, Tank 2 after 52 weeks exposure. Macrocarpa sapwood sample showing severe Auckland brown rot decay in the sapwood stopping abruptly at the heartwood boundary.

In the macrocarpa and Lawson cypress sapwood samples the sapwood section of the samples generally contained severe decay. However, the decay stopped abruptly at the heartwood, even where there was extensive mycelium cover over the surface of the heartwood (Figure 4). There were minor or lightly established patches of surface decay on one sample each of macrocarpa and Lawson cypress heartwood (Figures 5 and 9).

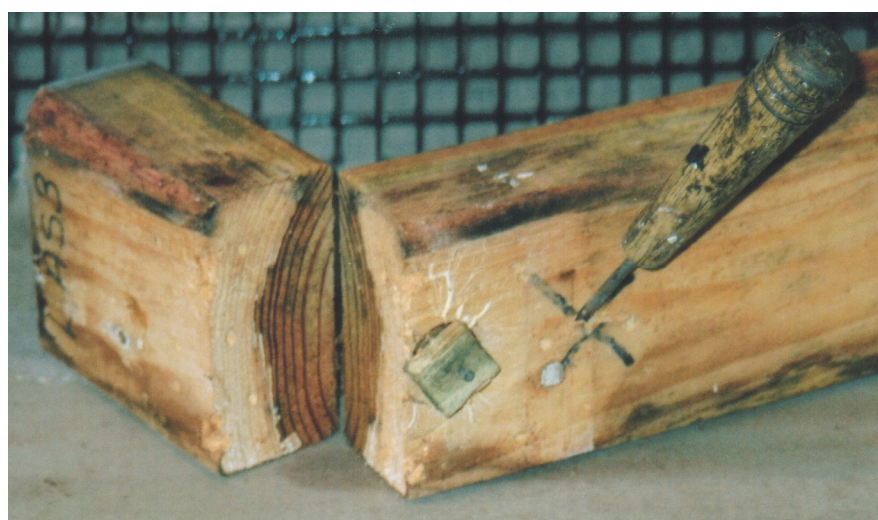
**Figure 5** – Sample LH6A, Layer 5, Tank 2 after 52 weeks exposure. This Lawson cypress heartwood sample was severely stained and largely covered by Auckland brown rot mycelium. Although there was minor patch of decay in the joint the sample was otherwise sound.

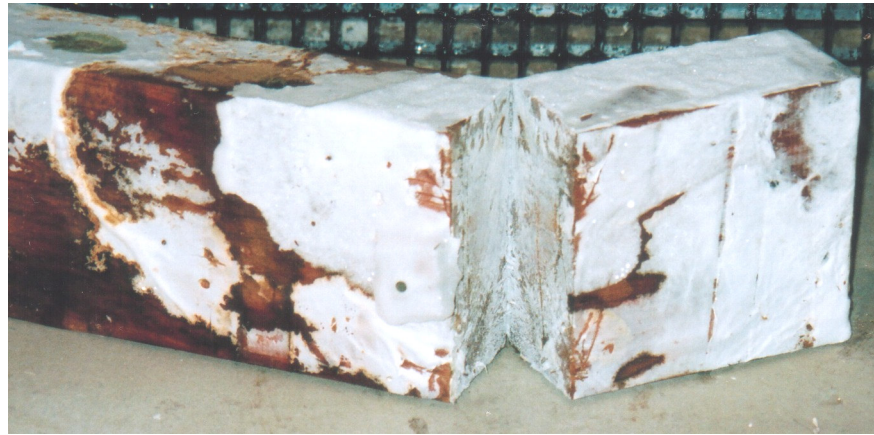
**Figure 8** – Layer 7 (Top layer) in Tank 1 after 52 weeks exposure. The sample at the right hand end is M15AH, macrocarpa heartwood. Although there was extensive Auckland brown rot mycelium on the surface, spreading from the sample underneath, there was only minor decay associated with it. The other sample with extensive mycelium on it, LS1B (Lawson cypress sapwood) was badly stained but contained very little decay.
