# **EXAMPLES OF TOTARA SAPWOOD RESISTING ATTACK BY THE COMMON HOUSEHOLD WOOD BORER (*ANOBIUM PUNCTATUM*)**

**A Report Prepared by Paul Quinlan for Tāne's Tree Trust**

**31<sup>st</sup> January 2017**

**A report prepared on behalf of the Northland Totara Working Group.**

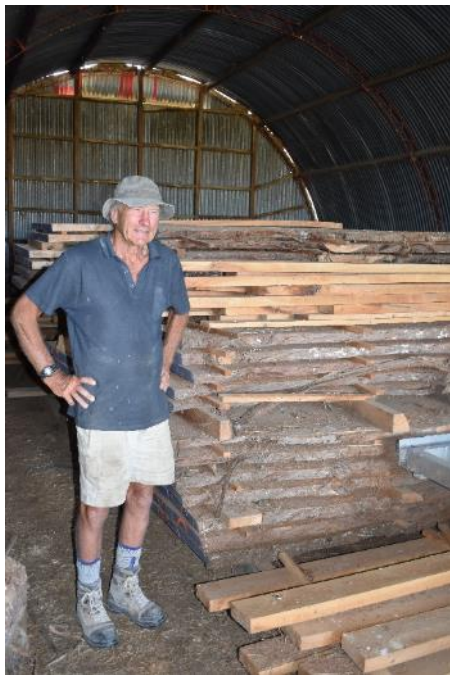
A particularly convincing demonstration of borer resistance in sawn tōtara timber is provided by this first example. In the winter of 2009, (7 ½ years ago), Geff had 50m<sup>3</sup> of farm-tōtara logs felled and milled on his Northland farm property at Kawakawa. This was part of a Northland Totara Working Group project. The harvest was executed with a milling statement for scientific purposes. A pre-harvest assessment of the tōtara stands was conducted by Paul Quinlan and Owen Lewis and each tree photographed and its timber volume estimated. The trees were representative of the farm-tōtara resource. The timber comprises a mix of slab (still with the bark on) and sawn boards, and has been stored, in-fillet, in a shed on the farm for use by the NTWG for the testing of various timber attributes etc. (Refer Figures: 1 & 2).

**Figures: 1 & 2 – Geff Cookson standing beside the tōtara timber stored for the last 7 ½ years in his half-round barn (with one open end).**

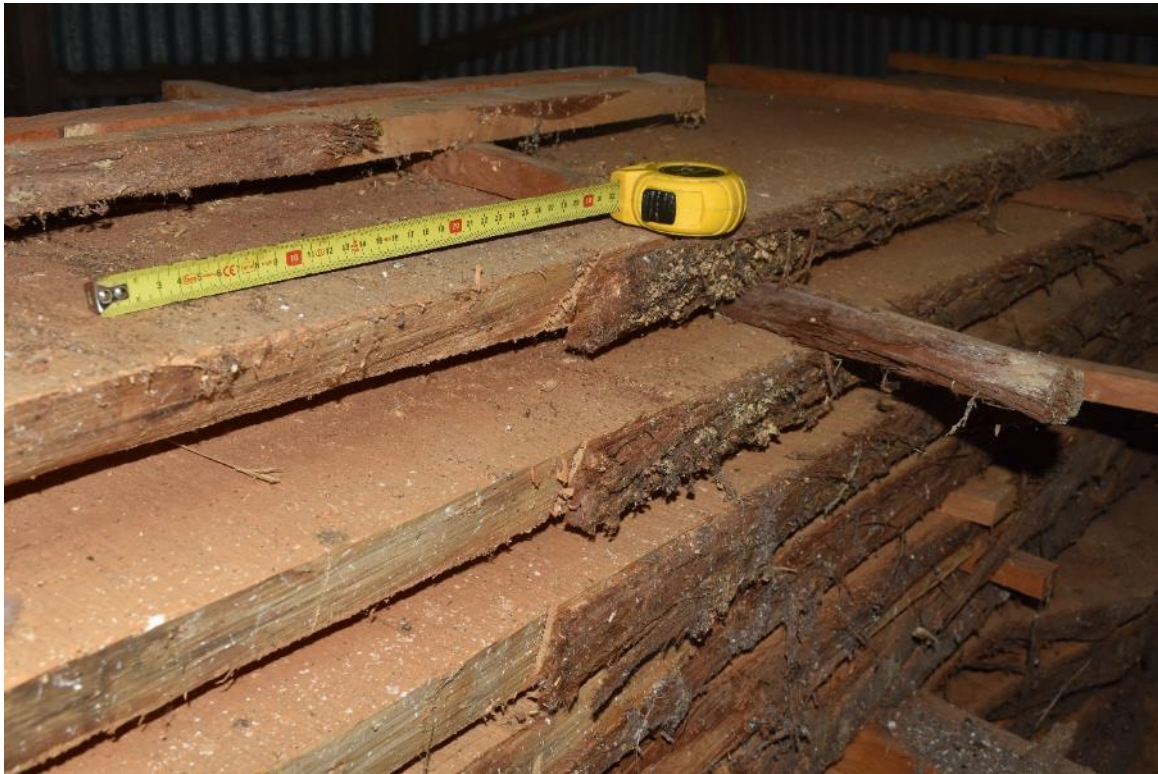
**Figure: 5 – No evidence of borer damage was observed on any of the tōtara slabs or sawn lumber stored for over 7 ½ years in the same shed as the kauri slabs that were infested with borer.**

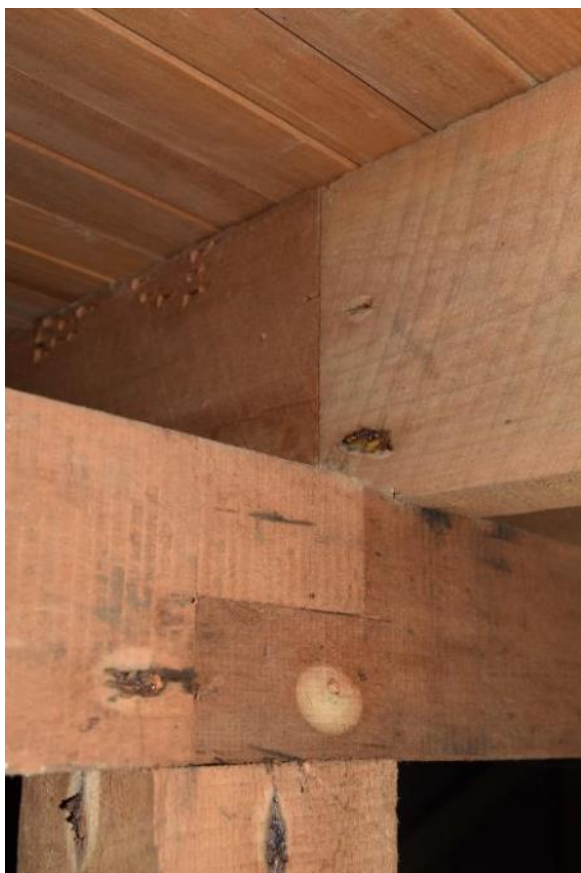
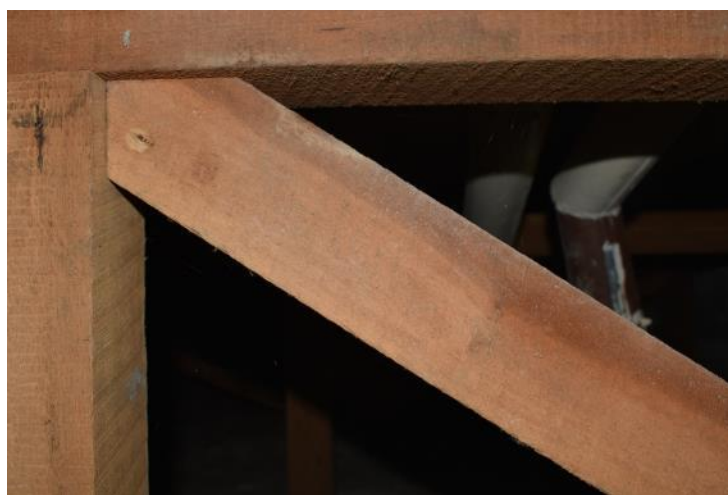
As part of this investigation, an inspection of the subfloor framing was made on the 17<sup>th</sup> January 2017. This found that although the nails and wire had mostly rusted out, the timber was in excellent condition. The only single timber defect observed was a small incidence of what is presumed to be dry-rot on an angle brace between two joists of the older house. The affected area is approximately 18cm long, 8cm wide, and 3 cm deep. It does not appear to be proportionally large enough to compromise the structural service of the timber member. No other timber defects, or incidence of borer attack, were observed in the untreated subfloor framing of either house. The untreated tōtara timber has provided excellent structural service in the subfloor framing of both houses for well over 50 years (51 & 63 years respectively).

From the careful inspection of the subfloor timber members, it appears that the builders have selected timber that is largely heartwood timber for the purpose. Some ‘coloured-grade’ timber was also observed, which is presumed to indicate pieces of timber that include a transition between heartwood and sapwood (See figures: 6-8). However, only two examples were observed that could be confidently identified as definitely comprising sapwood. One involved bark encasement (See figure: 8), the other was obvious wane (a proportion of the natural round outside surface of the tree under the bark) on an angle brace between two joists (See figure: 9). From this, it can be stated that, although predominantly heartwood, certainly the

subfloor framing also comprises a small proportion of untreated tōtara sapwood. Importantly, no evidence of borer (or other defects) was observed in these pieces of timber. Therefore, these examples demonstrate excellent structural service from untreated tōtara timber, including from some pieces that contain a portion of untreated tōtara sapwood.

**Figures: 6 & 7- Untreated tōtara subfloor framing of houses built in 1953 & 1962. No evidence of borer was observed. N.B. – the distinct colour variation on the same piece of timber (– notably the angled brace in the right-hand image) presumably indicates a transition zone from heartwood to sapwood timber.**

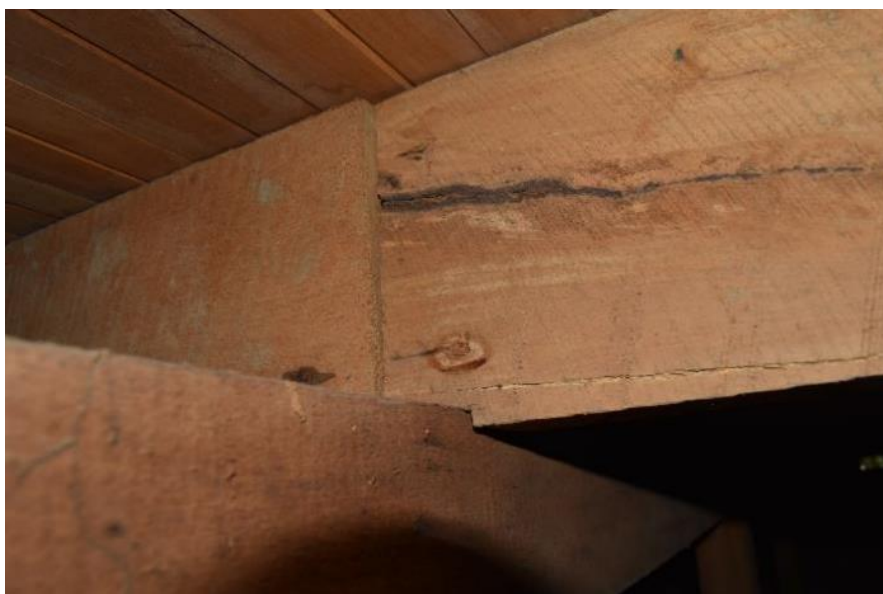
**Figure: 8 – Bark encasement on one of the timber joists is presumably associated with a portion of sapwood content on this piece of timber. No evidence of borer was observed.**

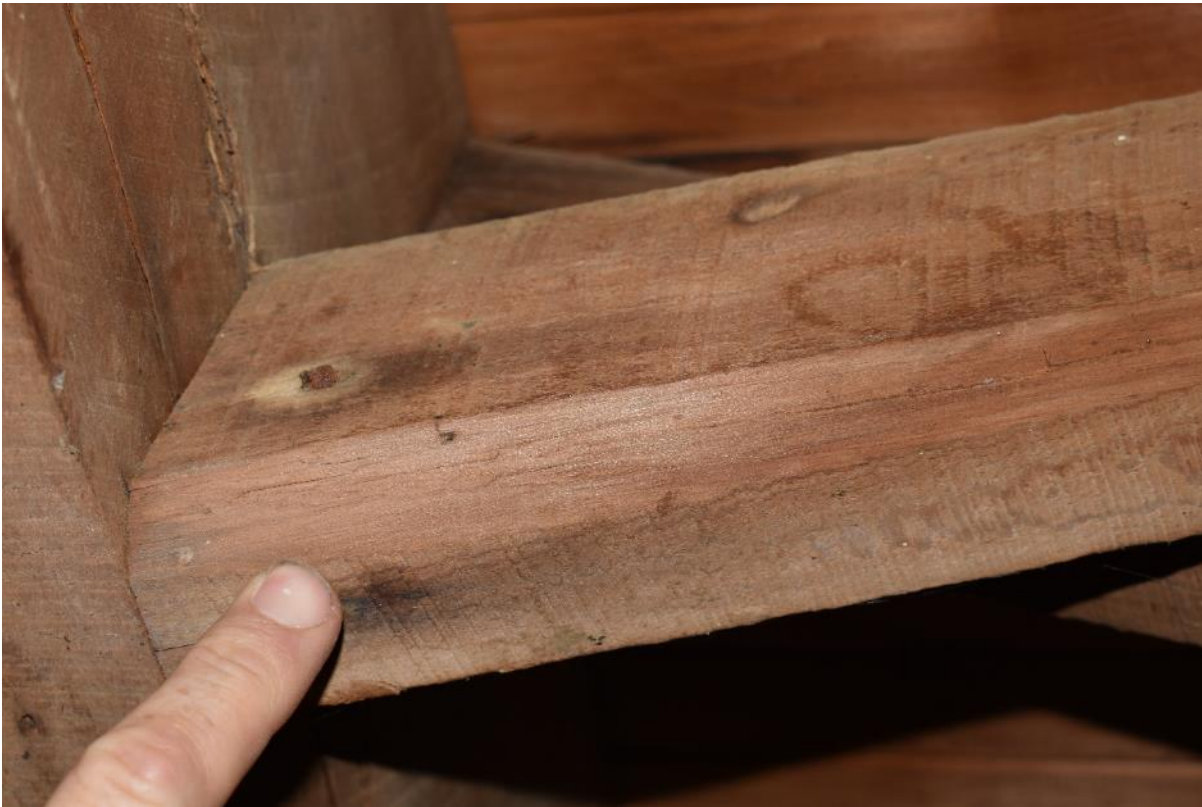
**Figure: 9 – Obvious incidence of wane indicates the definite presence of sapwood on this piece of timber (in service since 1953). No evidence of borer was observed.**

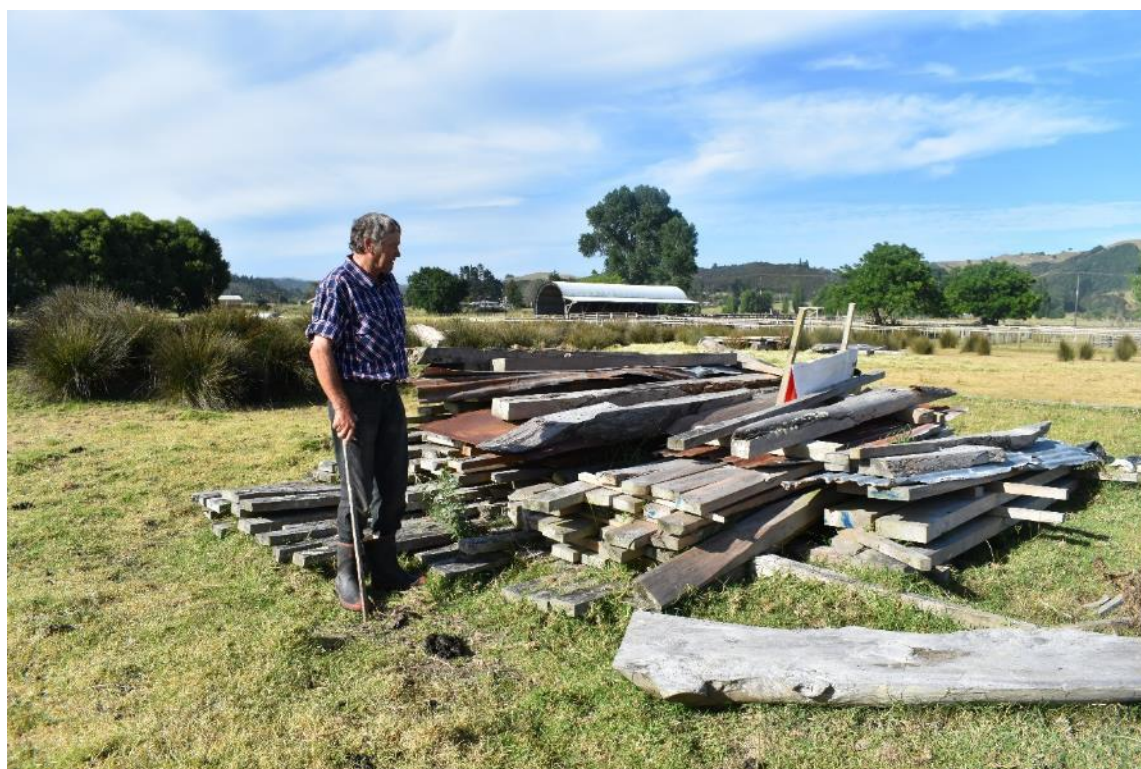
Totara logs were felled in the autumn of 2011 but lay on the ground where they were felled, until extracted to be milled at the end of the following summer March 2012 (i.e. well over 6 months). The timber has been stored in-fillet and partially covered by tin (although somewhat dislodged by livestock rubbing on the stack) since it was milled (See figure: 10). The timber includes boards that are cut to the natural wane and some even include bark on some edges (See figure: 11). This confirms that many of the boards comprise a significant portion of sapwood.

**Figure: 10 – Michael Hayes next to a filleted stack of farm-tōtara timber in a paddock.**

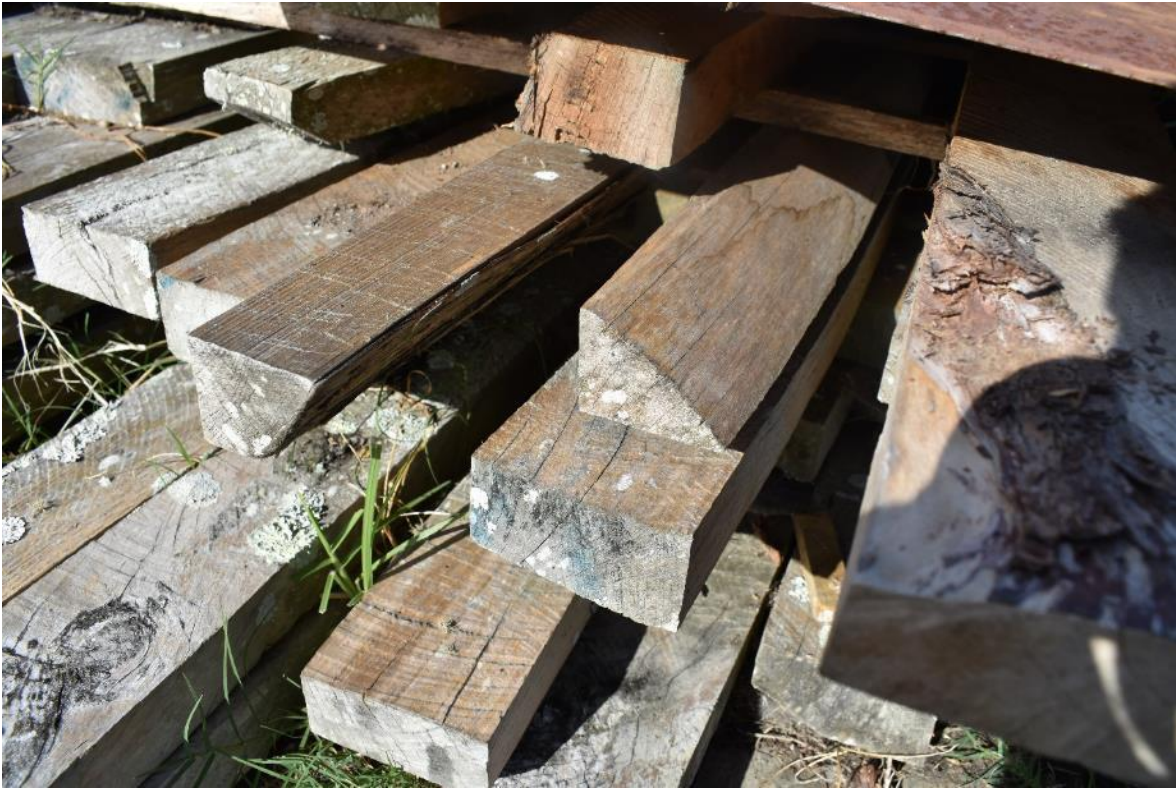
The tōtara timber has not been preservative treated. No evidence of any borer attack was observed, despite the fact that a stack of taraire timber that was milled at the same time and has been similarly stacked, less than 25 metres away, in the same paddock, shows definite signs of borer damage (See figure: 12). Even more compelling is that the taraire had been sprayed with a mixture of “Clear Metalex” (Zinc Naphthenate 60% (Zinc as metal 8%)) & thinned with mineral turpentine, but the tōtara had no such treatments applied.

**Figure: 11 – No incidence of borer was observed in the stack of untreated tōtara timber, which includes boards that clearly comprise a high proportion of sapwood timber.**

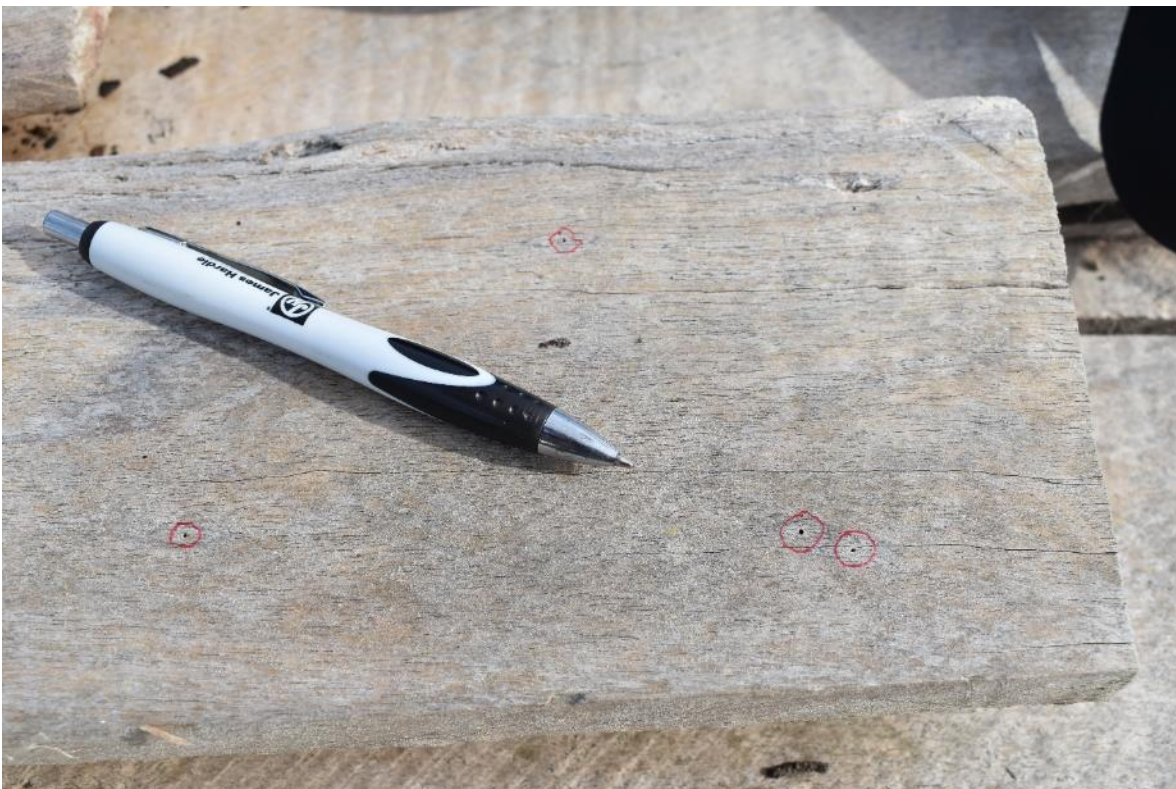
**Figure: 12 – In contrast to the tōtara, an adjacent stack of taraire timber, milled at the same time, has been damaged by the common household borer (*Anobium punctatum*), despite being sprayed with Clear-Metalex & Turps.**

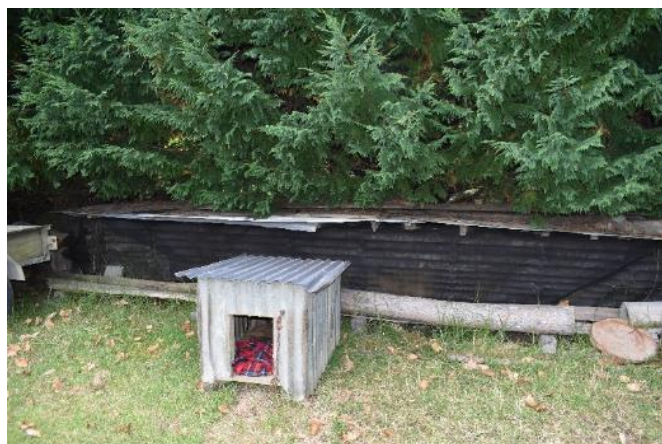
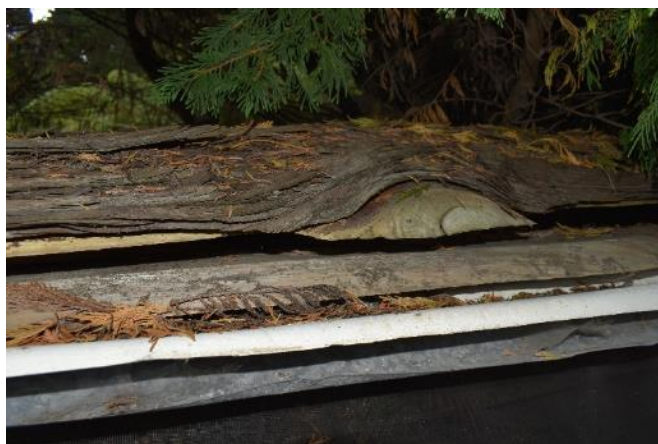
**Figures: 13 & 14– Flitches from a farm-tōtara tree milled in 2008 have been used to weigh down roofing iron that covers a stack of the filleted timber stored outside under a Leyland cypress hedge for over 8 years now. No evidence of the common household borer has been observed (See figures: 15).**

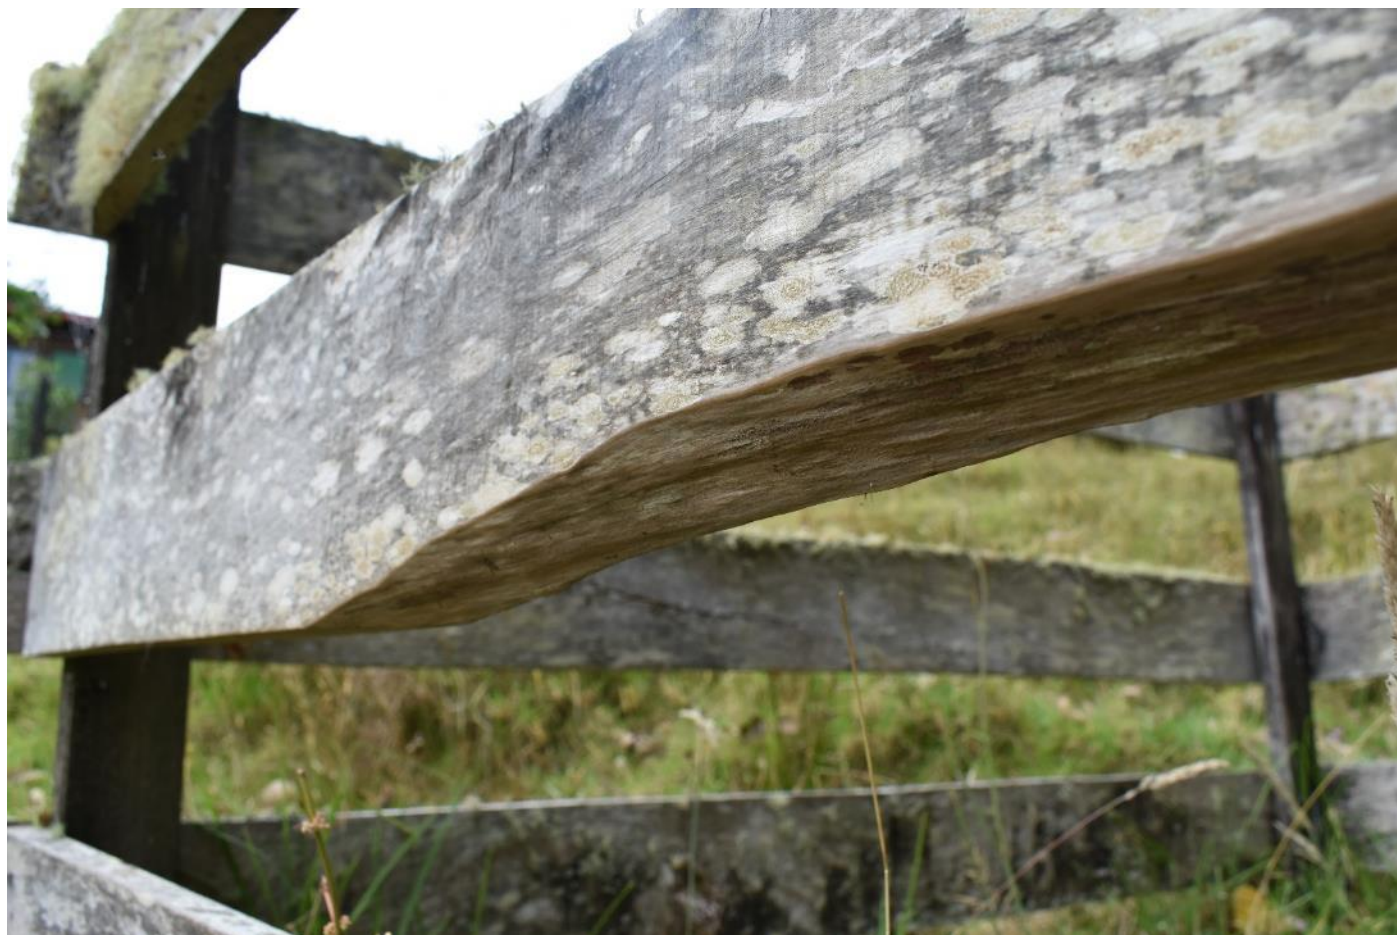
**Figure: 18 – Untreated tōtara timber rails** milled in 2008 and used in service outside since 2009 (i.e. 7 years so far). **N.B. -** many boards have wane and will therefore include a portion of sapwood. Although not expected to be durable in this exposed exterior application, no evidence of borer or rot/deterioration is yet evident.

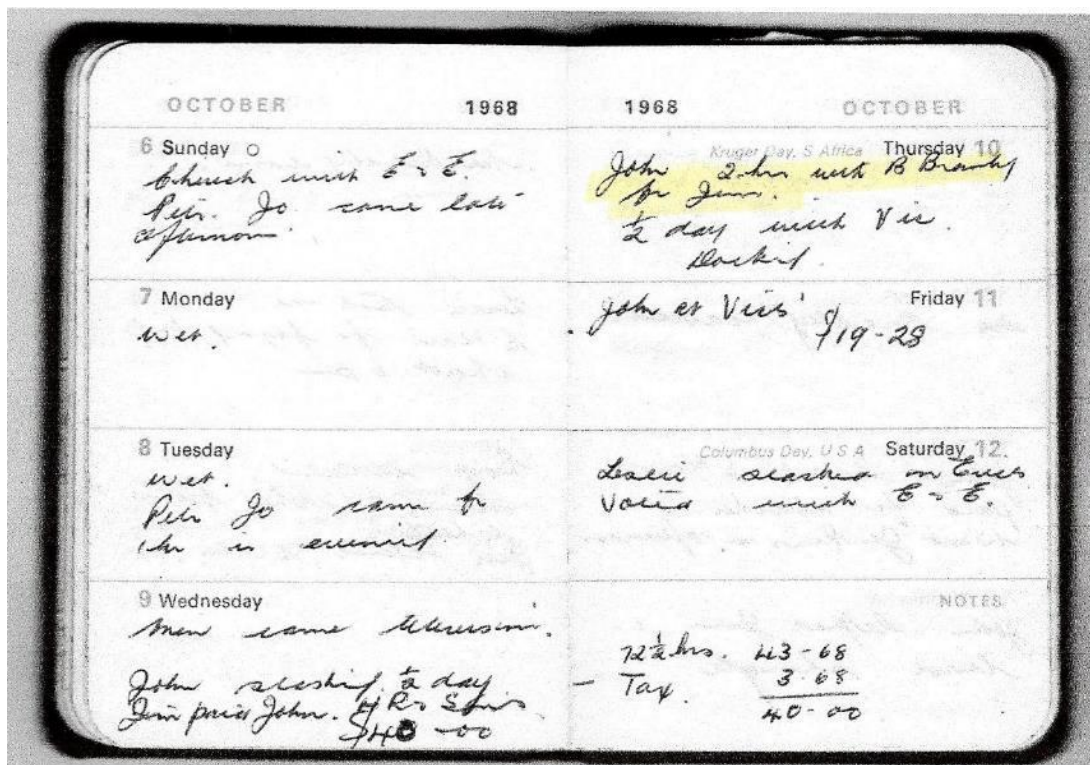
Figure: - 20 Gwen McGee's diary entry that pinpoints the installation date for the untreated green tōtara beams as being the 10<sup>th</sup> October 1968.

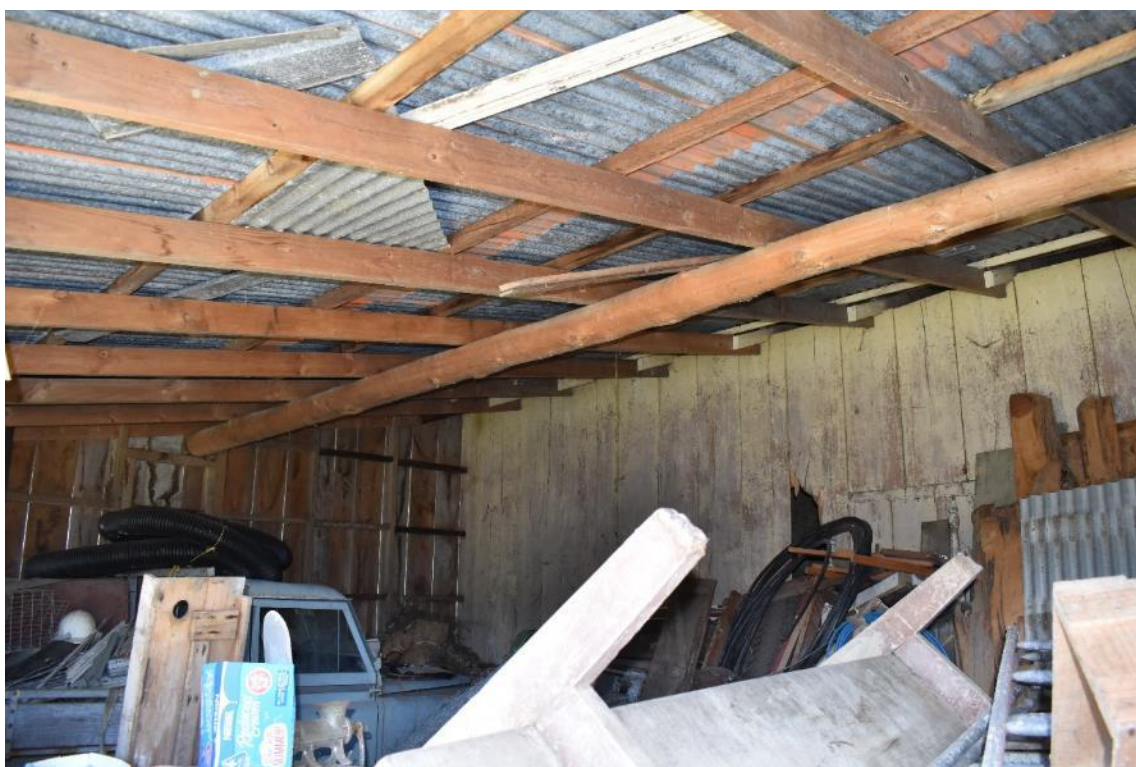
The tōtara trees were cut and used green. John cut the branches flush with an axe and the bark and was removed. The beams have been partly square-sided with the skilful use of an axe (John think's Bill Bramley did that), but for much of the length the natural round of the tree's wood immediately under the bark remains. This natural round surface, and just under, is certainly sapwood. One beam forms the lintel above the doors and the other supports the roof rafters under the mid-point of their spans. **The tōtara beams are 8.57metres long and span at least 8.37m.** The lintel has other boards fixed to it therefore its diameter could not be accurately measured although the natural round surfaces indicate that it was clearly a relatively small diameter tree. In contrast, the tōtara support beam located under the mid-span of the rafters, is fully exposed and could be more accurately measured, although the rough 'squaring' of two faces of the last 2metres near the larger end, means that the large end diameter could only be estimated (at 30cm), based on the remaining half to two-thirds of the natural round of the tree. The small end diameter was accurately measured at 160mm.

Figure: 21 The 8.57m long beam (under the rafters) has provided the mid-span rafter support since Oct. 1968, is an untreated tōtara pole, mostly still in the round form, but partly flat-sided (by axe) on top and near the butt end. The small end diameter is 160mm and the large end diameter is estimated at <30cm. The beam had the bark removed and was used green. Although borer is present in other timbers in the shed, no borer attack was observed at all in this (or the other) tōtara beam.
