# The development of accelerated test methods to evaluate the durability of framing timber

Tripti Singh\*, Dave Page, Jackie van der Walls

Scion, Private Bag 3020, Rotorua, New Zealand

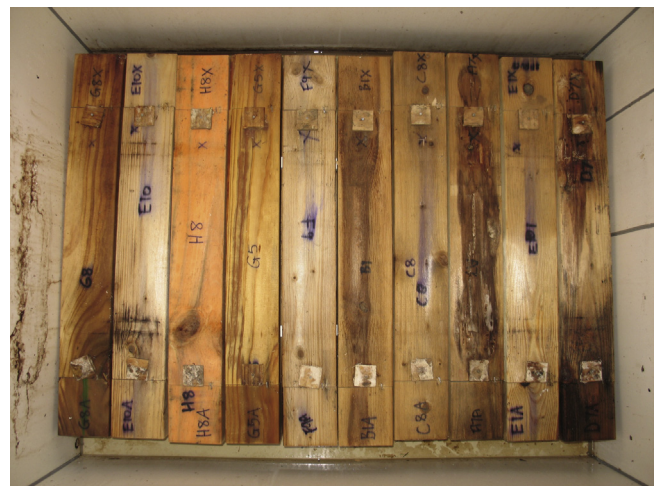
Fig. 1. Samples in an enclosed tank test. The decay feeder block at the far end was *Antrodia xantha*, while at the near end it was infected with *O. placenta*.

The enclosed tank method was established to compare a large number of treatment variables for resistance to decay in framing. The tanks were plastic, approximately 1 m long, 750 mm wide and up to 800 mm deep. They had a drain hole about 20 mm above the bottom and a tight fitting lid. Samples were placed on 40 mm thick bearers in the bottom of the tank with subsequent layers separated by 20 mm thick fillets (Fig. 1). A rigid panel was placed on fillets on top of the stack and a 40 mm thick foam plastic blanket fitted between that and the lid. The bottom of the tank was filled with water to a depth of about 20 mm and the foam blanket was saturated with water to maintain a humid atmosphere in the tanks. The tanks were kept in the controlled conditions facility (25 °C and 95% RH), or outside and regularly opened (usually weekly) so that the samples could be sprayed with water.

In tests where rates of strength loss and decay were to be compared, samples were 950 mm long and a single decay feeder block, containing *O. placenta*, was attached mid-length on one edge of the samples. Samples without feeder blocks were also included. Assessments were more frequent at 2–8 week intervals and included weight, deflection as a plank under constant load (Singh et al., 2013) as well as decay development ratings.

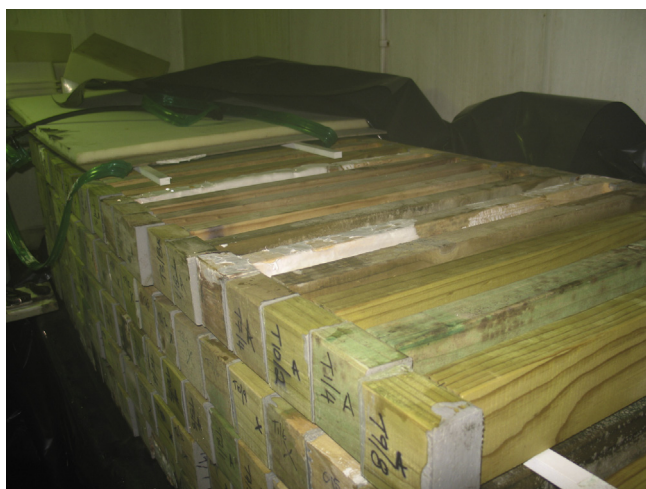
Fig. 2. “I” samples in an exposure stack. The decay feeder blocks visible on the right were *O. placenta*. The feeder blocks at the left end were on the reverse face and were infected with *A. xantha*.

The enclosed tank method did not contain the most common joint found in traditional wall framing, i.e., where a treated longitudinal grain surface is in close contact with a freshly cut end. To simulate this joint a 90 mm long block was cut from each end of 900 mm long framing samples. The ends of the blocks were sealed with epoxy paint. These blocks were then placed across the end of the sample that they were cut from and stapled in place so that the treated surface was in contact with the freshly cut end-grain of the main sample. This formed an “I” shaped assembly.

Samples were pre-wetted and decay feeder blocks were attached to the main sample on the faces, immediately adjacent to the end block. The *O. placenta* feeder block at one end was on one face and the *A. xantha* feeder block at the other end was on the opposite face. Samples were placed on edge in a filleted stack, with the epoxy painted ends of the end blocks in contact (Fig. 2). Along the top of the stack, two rows of soaker hose were attached with the perforations in the hose facing down. Fibre cement sheets were placed on fillets over the top of the stack and a 30 mm thick foam plastic blanket was placed on top of those sheets. The stack was completely enveloped in polythene film in a controlled condition room where the temperature was 27 °C and the relative humidity about 85%. The spray system was turned on for 10 min every 7–10 days and surplus water from the spray was able to drain slowly from the bottom of the stacks.

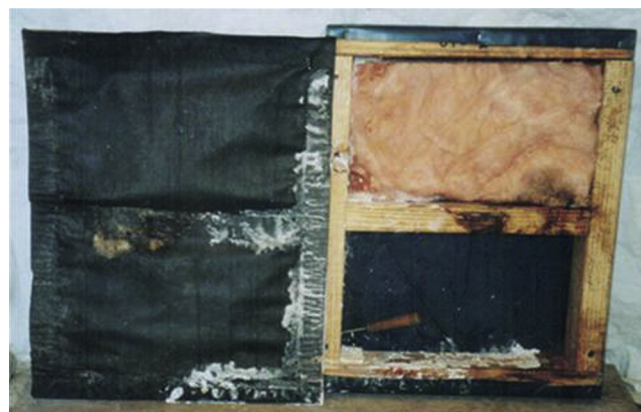
Fig. 3. An untreated wall unit after twelve weeks exposure. The fibreglass insulation has been removed from the lower half to allow assessment of decay. Mycelium from the *O. placenta* feeder blocks (on the left) was spreading through the fibreglass insulation and on the surfaces of the framing. *C. puteana* mycelium (on the right) had spread up the right stud across the dwang into the fibreglass and across the building paper.

Decay spread rapidly from the feeder blocks in the untreated control units. The framing in these started to decay within 12 weeks of installation (Fig. 3).

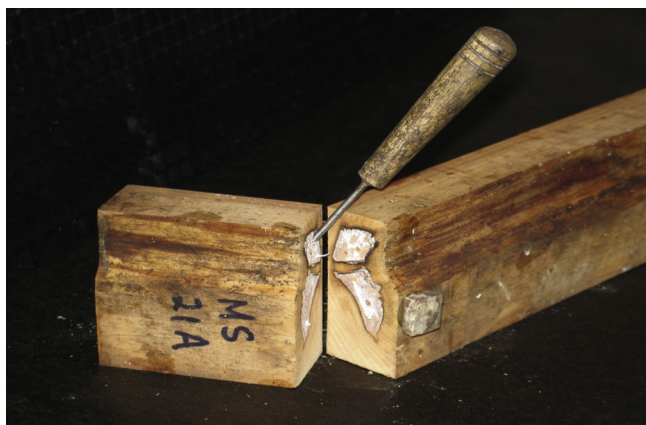
**Fig. 7.** The joint surfaces in treated macrocarpa where preservative penetration was incomplete, after 18 months exposure in an enclosed tank. There was no decay on the outside of this sample but there was severe internal decay in the sapwood.

In test where end blocks were cut off and stapled back, decay developed rapidly in untreated pine framing and framing treated with products that did not contain a fungicide. It also developed in the centre of the end block joints on samples with incomplete preservative penetration and in tests of species other than radiata pine where preservative penetration was incomplete in sapwood (Fig. 7).
