The decay resistance of Poplar in an accelerated framing test

The condition of samples after 12 months exposure

Ian Simpson and Tripti Singh

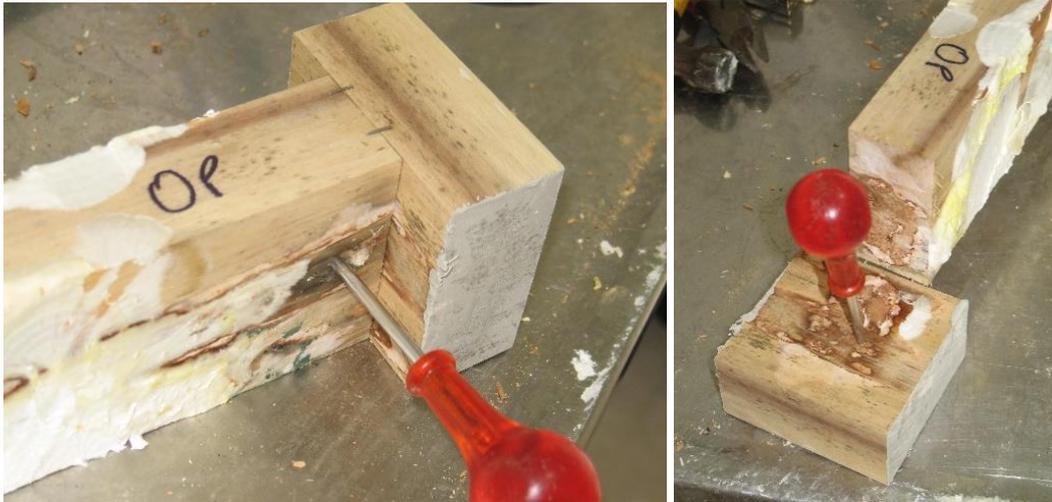
Figure 1: Untreated Poplar sample with established decay on the surface and in the joint at the Op end. (sample 19).

The decay were observed on the surface of Poplar samples at the Op feeder blocks and established decay was observed at the Ax feeder blocks. A similar trend was seen for decay in the joint, with more decay seen at the Ax end of the samples (Figure 1). Extensive mould was observed on many of the untreated Poplar samples (Table 1).

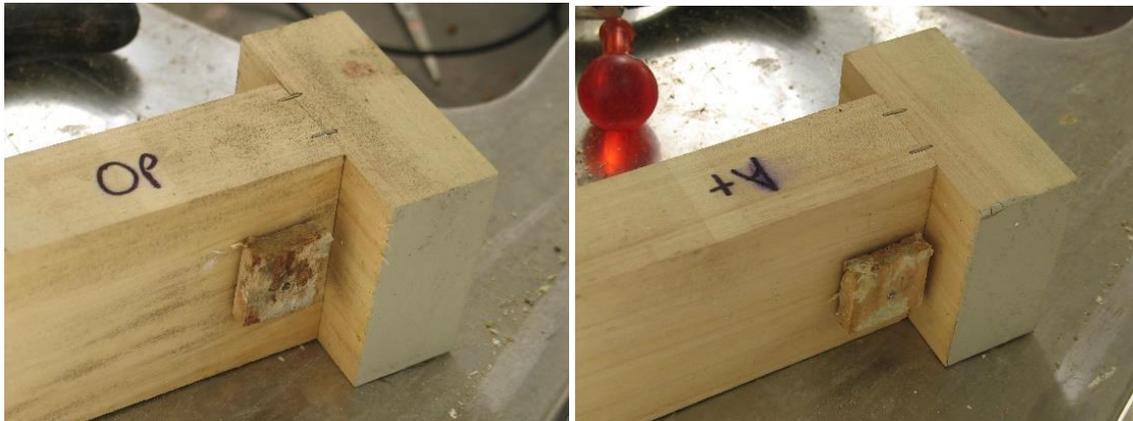
Figure 2: Boron treated Poplar sample with light mould and no mycelium at either feeder block (sample 6).

The boron-treated Poplar samples did not have mycelium on the surface (Figure 2). No decay was observed on any of the boron-treated Poplar samples (Figure 3). Minor mould was observed on some of the boron-treated samples (Table 1)

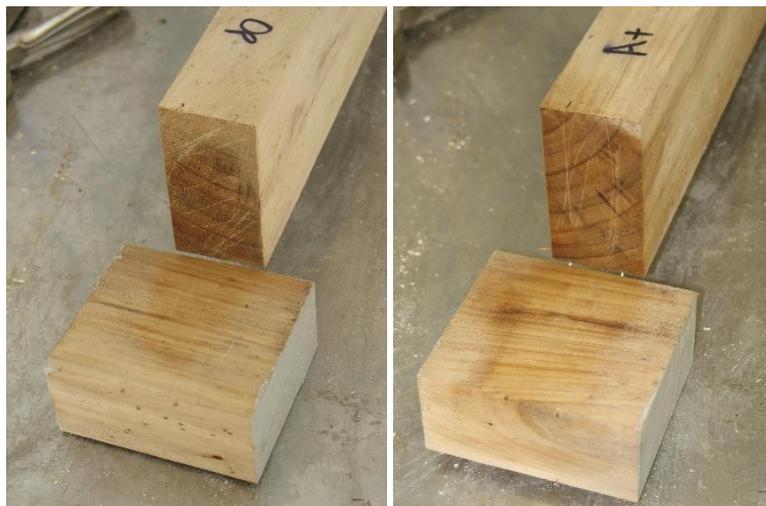
Figure 3: Boron treated Poplar sample without decay in the joint at both ends (sample 1).

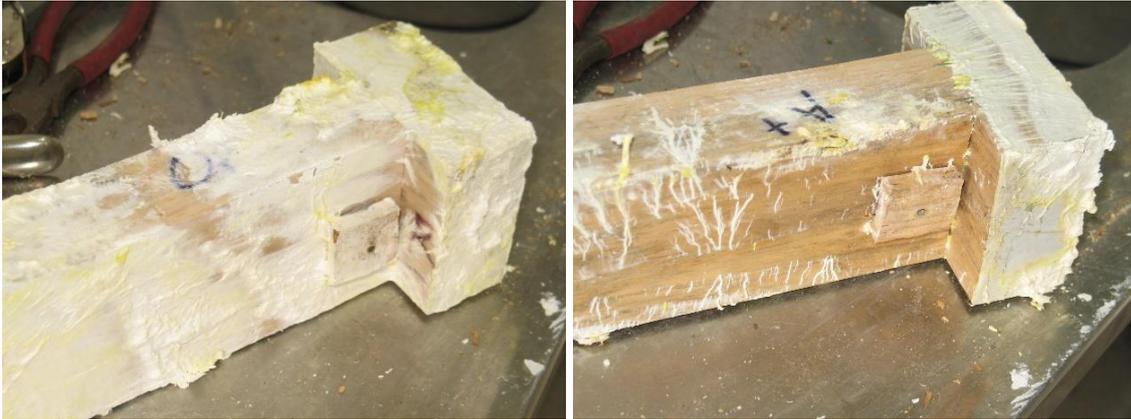
Figure 4: Severe mycelium on both ends of a sample of untreated radiata pine from Northland (sample 31).

The untreated radiata pine supplied from Northland or Central North Island had extensive mycelium at both feeder blocks (Figure 4). Established decay was observed on most of the samples at the Ax feeder block. Less decay was observed on the surface of samples at the Op end (Figure 5). Decay in the joint followed the same pattern with more decay in the joint at the Ax end than in the joint at the Op end. Extensive mould was observed on many of the samples (Table 1).

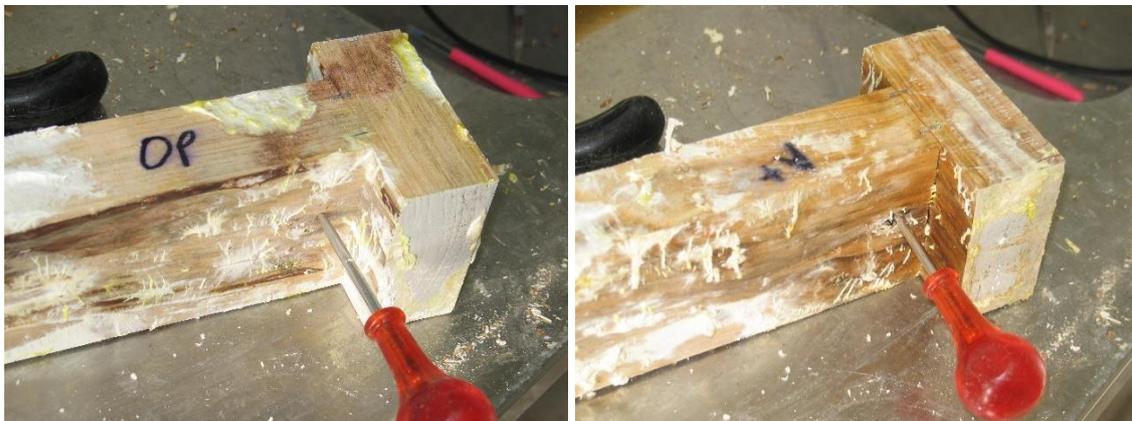
Figure 5: Established decay at the Op end, and severe decay at the Ax end a sample of untreated radiata pine from Northland (sample 38).

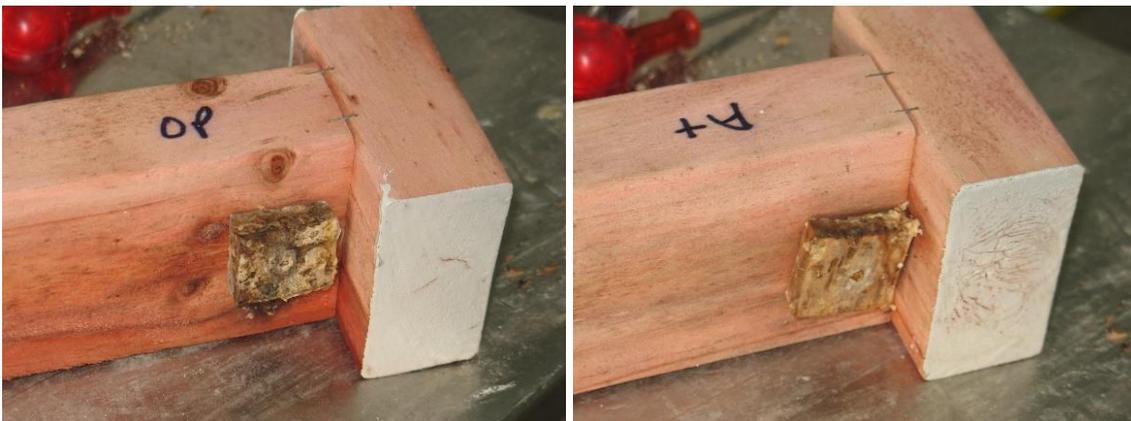
Figure 6: No decay or mycelium observed on boron treated radiata pine sample (sample 25).

The boron-treated radiata pine samples did not have mycelium on the surface. No decay was observed on any of the boron-treated radiata pine samples (Figure 6). Minor mould was observed on some of the boron-treated radiata pine samples (Table 1).

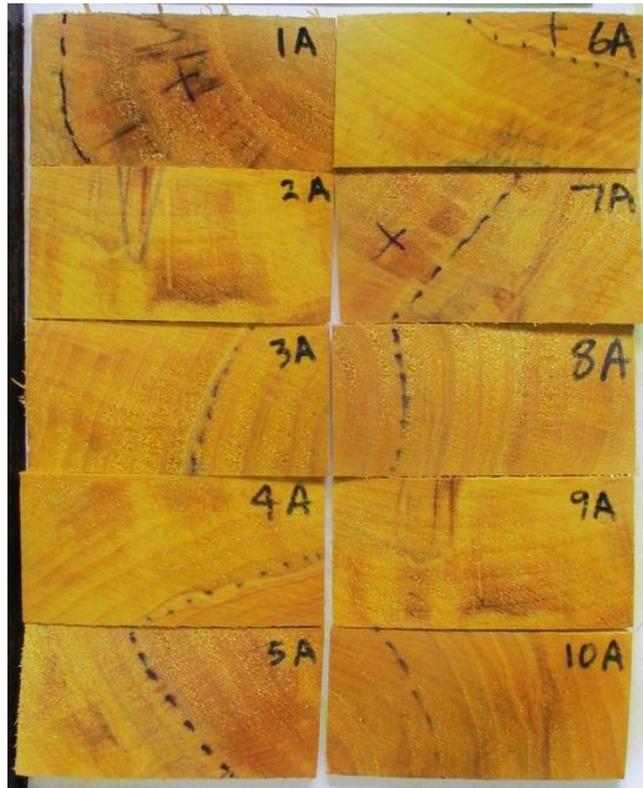
Figure 8: Heartwood\sapwood spot tests for Poplar boron treated 90 x 45 mm

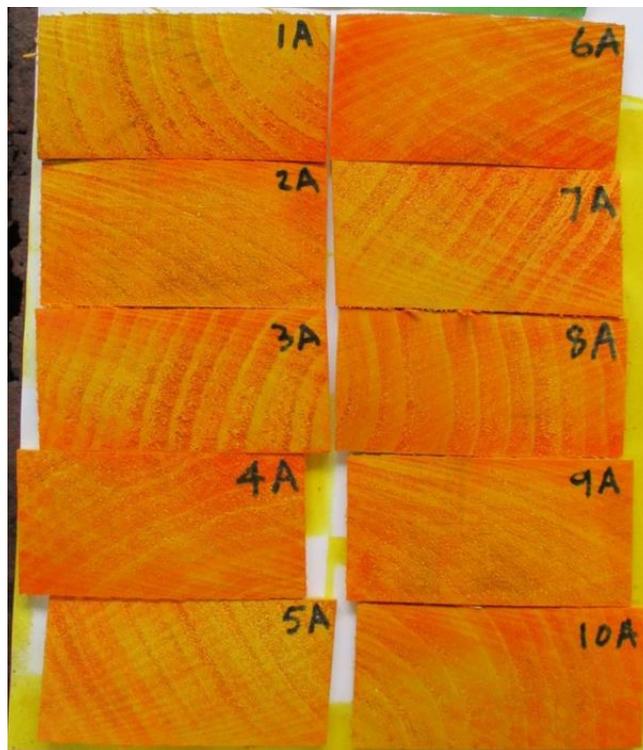
Figure 9: Penetration spot tests for Poplar boron treated 90 x 45 mm

Note: Boron penetration and heart\sap wood distribution needs to be determined on actual samples, photographs should be considered as indicative only as colour will vary with the image collection device, printer and computer screen used (this note applies to all spot test images).

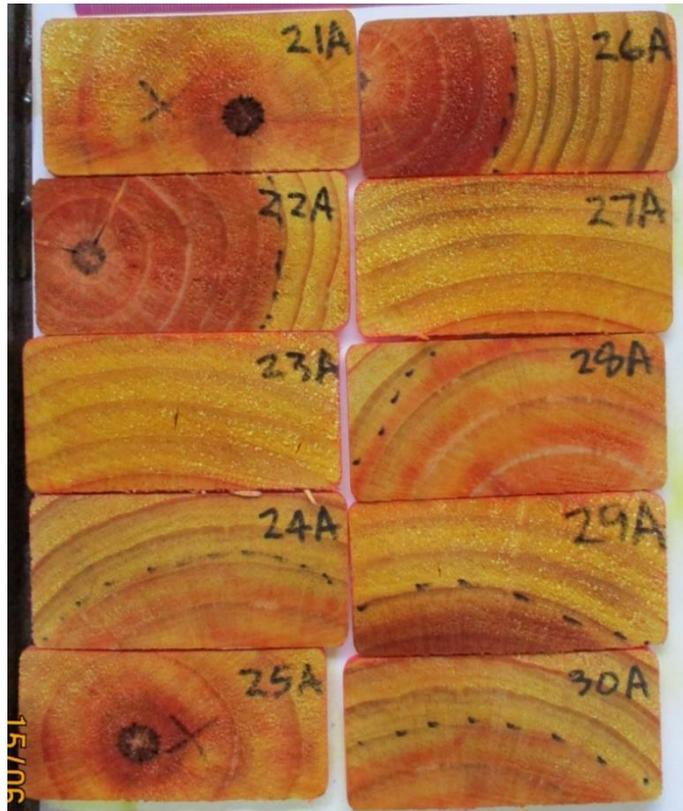
Figure 10: Heartwood/sapwood spot tests for radiata pine boron treated 90 x 45 mm

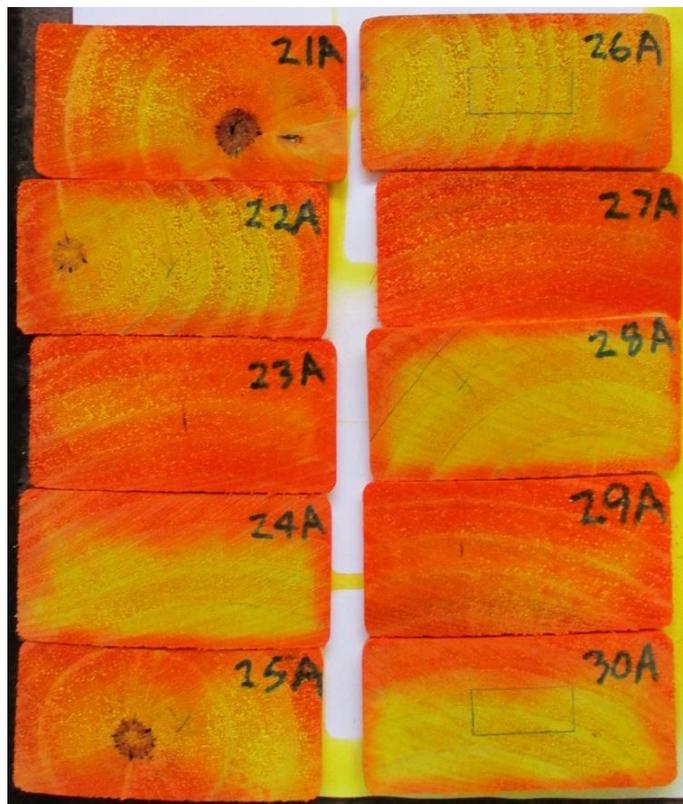
Figure 11: Penetration spot tests for Poplar boron treated 90 x 45 mm
