**The durability of manufactured structural building materials**

Tripti Singh and Dave Page

Paper prepared for the 47<sup>th</sup> IRG Annual Meeting  
Lisbon, Portugal  
15-19 May 2016

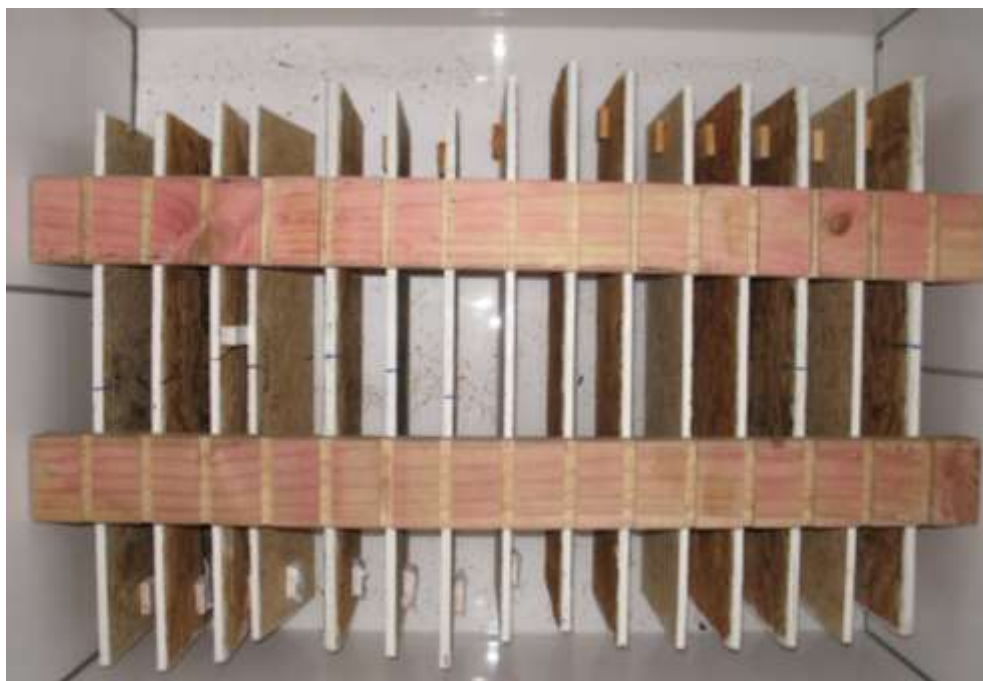
**Figure 1** – Samples of OSB in slotted bearers in the exposure tanks. The *O. placenta* feeder blocks were on one face at one end of the samples, the *A. xantha* feeder blocks were on the reverse side at the other end.

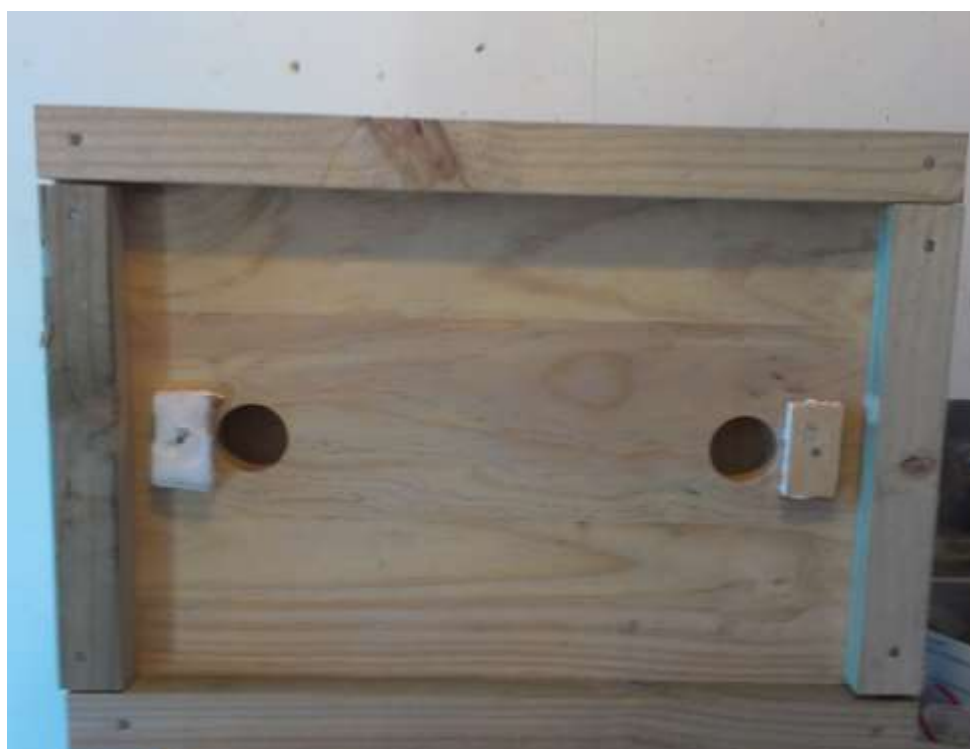
**Figure 2** – A sample of CLT showing fungal inoculum of *O. placenta* and *A. xantha* at the opposite end close to 50 mm diameter holes that were bored after treatment.

Battens using CCA treated radiata pine to H3.2 specification were fixed around the edges on the face and back of each CLT sample. The area between the battens and the holes at the end of each face was swabbed with ethanol. An *Oligoporus placenta* decay feeder block was fixed to the face at one end of the sample, an *Antrodia xantha* block on the face at the other end (Figure 2).

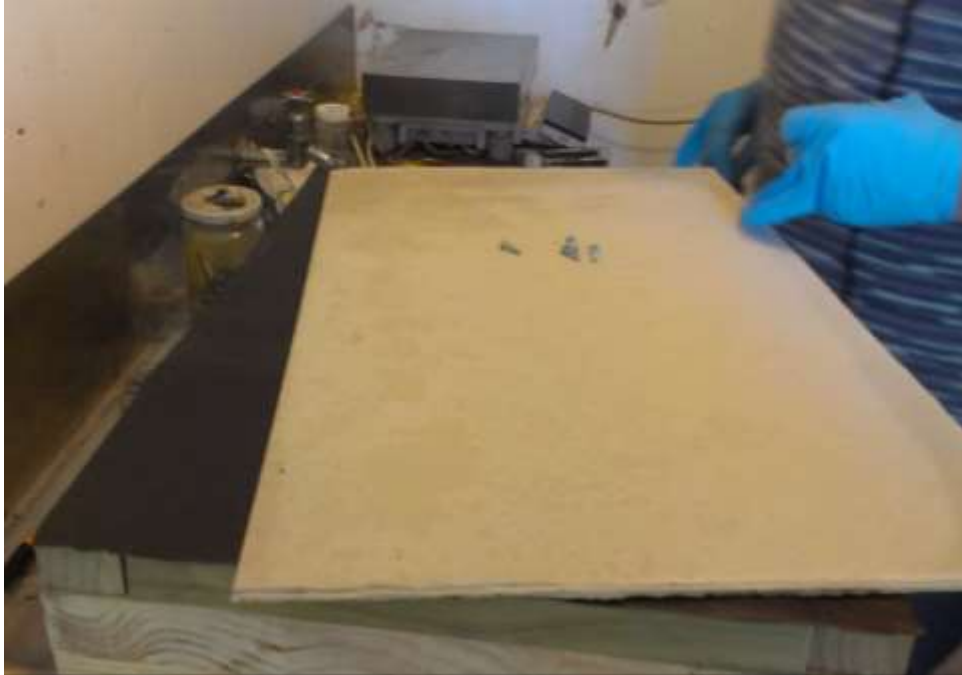
**Figure 3** – Unit preparation of a CLT sample after fungal inoculation. Fibre cement panels and building paper were fixed on top of H3.2 treated CCA battens on each side of the sample.

Bituminous building paper and a fibre cement panel were then fixed to the battens on each side of the sample (Figure 3). Assemblies were weighed before and after fixing of the battens and sheathing panels. They were stood on end, on 15 mm thick fillets, on the floor of a controlled

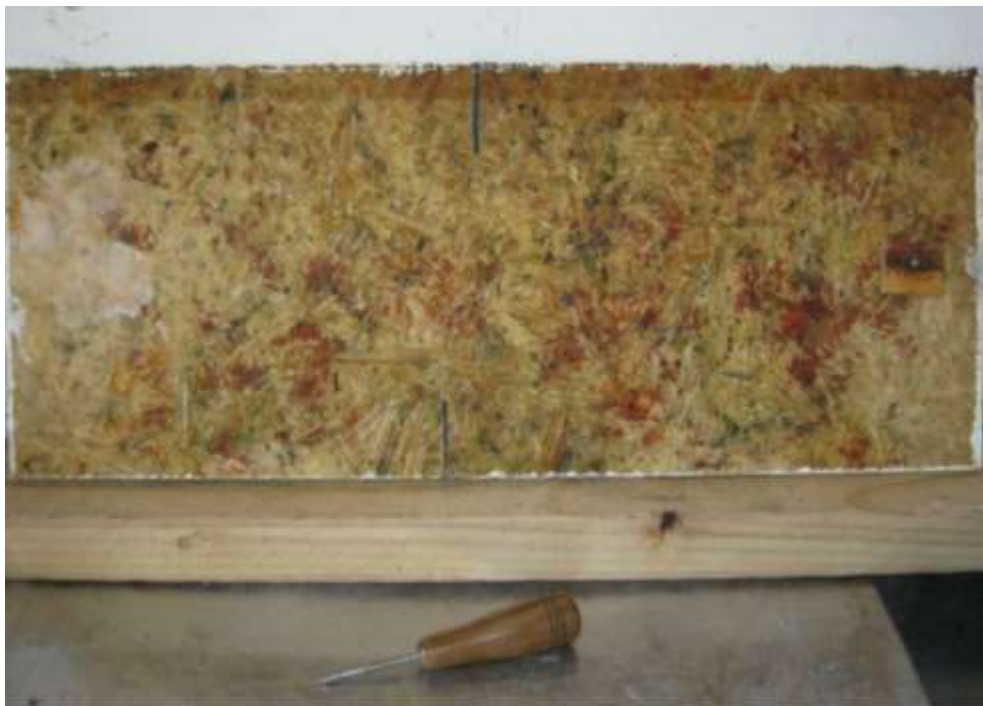
**Figure 4** – *A. xantha* decay feeder block near the right end on the reverse of a leached NZSB sample SL8 after six weeks exposure. There was no mycelium development from the feeder block but mycelium from the *O. placenta* feeder block on the other side of the sample had penetrated the sample towards the left end. There were extensive moulds over the whole of the sample.

At six weeks assessment, mycelium was extending out from the *O. placenta* feeder blocks on all of the boards and had extended through to the other side in most cases but there was no obvious mycelium spreading from the *A. xantha* feeder blocks (Figure 4). There was no decay on the imported OSB samples that had no feeder blocks on them. Moulds had continued to develop and were relatively extensive on all boards.

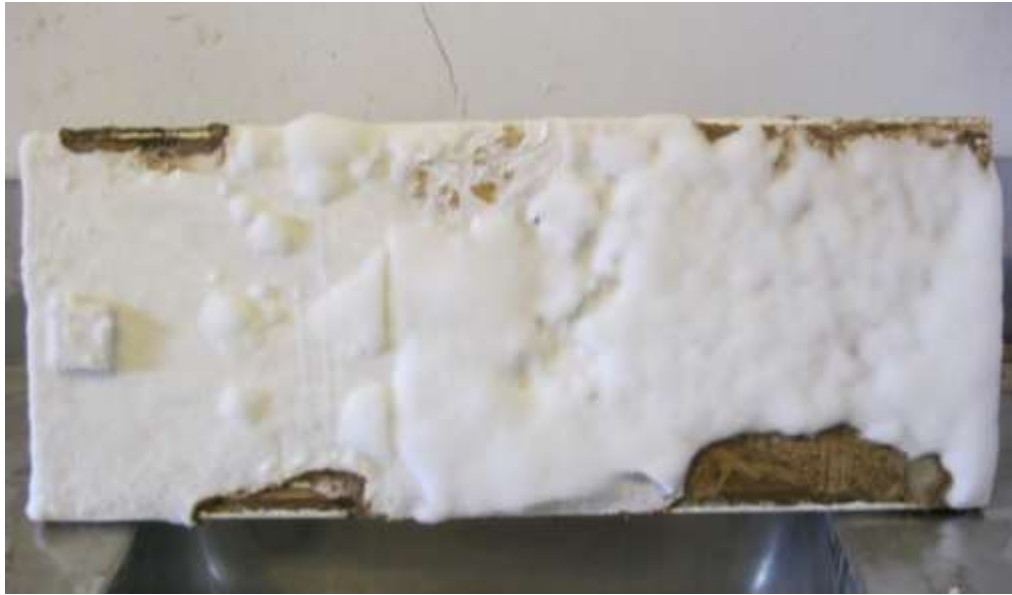
**Figure 5** – Widespread *O. placenta* mycelium covering the reverse of sample SO3, imported OSB which had not been leached, after 26 weeks exposure. The mycelium had completely covered the *A. xantha* feeder block. There was no mycelium or decay in the areas immediately adjacent to where the sample was in contact with the boron treated bearers

Mycelium spread and decay ratings after 26 weeks are summarised in Table 1. Decay mycelium had extended over the whole of both surfaces of the samples with decay feeder blocks on them by the end of the trial (Figure 5). This mycelium appeared to be all from the *O. placenta* feeder blocks and not from the *A. xantha* feeder blocks. Some degeneration of the mycelium close to the *O. placenta* feeder blocks appeared to have occurred over the period between the 14-week and 26-week assessments (Figure 6).

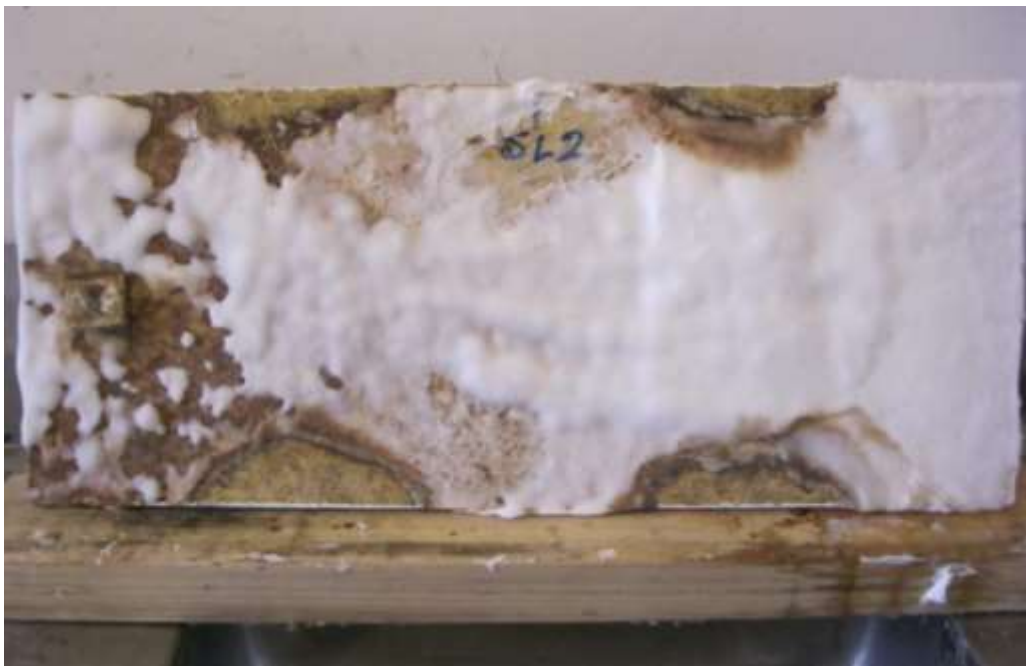
**Figure 6** - Widespread *O. placenta* mycelium covering the face of sample SL2, NZSB which had been leached before exposure, after 26 weeks exposure. The mycelium around the feeder block had degenerated since the 14-week assessment. Severe decay was present throughout the board, except close to the bearers.

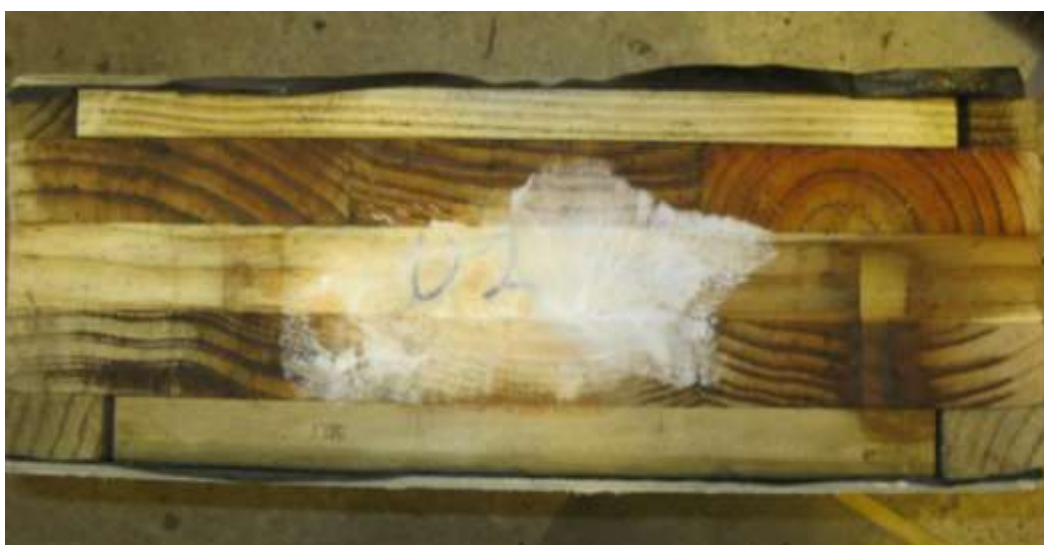
**Figure 7** – The lower end of untreated unit (U2) after 12 weeks in the exposure room. The mycelium from the *O. placenta* feeder block had penetrated under the treated batten and was developing on the outer surface of the assembly.

After 12 weeks, assembly weight indicated that the moisture content was in the range of 22-34%. In the untreated units mycelium from the *O. placenta* feeder blocks was visible on the outside of the assemblies (Figure 7). Under the exterior covers there was extensive mycelium and established decay in the CLT from the *O. placenta* feeder blocks. The *A. xantha* feeder blocks appeared largely inactive and mouldy. In the treated units, both leached and unleached there were patches of mould or mould spots on individual boards and there was no mycelium spread from the feeder blocks.

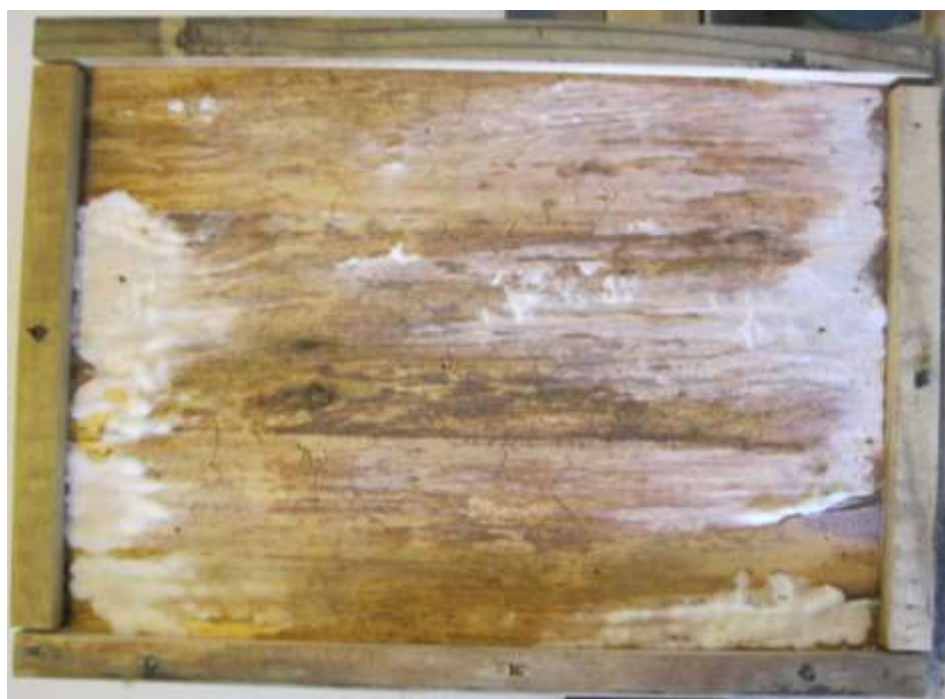
**Figure 8** – The reverse side of untreated, assembly U1 after 28 weeks exposure. The fibre cement sheathing and building paper have been removed. Decay mycelium had spread across the whole of the surface. While the white mycelium appeared to be from the *O. placenta* feeder blocks there was dark, lace-like mycelium also on the surface suggesting infection by an outside decay fungus, possibly *Coniophora puteana*.

*Oligoporus placenta* mycelium was widespread on the face and back of the untreated units and was associated with decay to 15 mm deep. In two of the samples fine black lacy mycelium similar to *Coniophora puteana* was also widespread (Figure 8). There was no mycelium development or decay in any of the treated leached and treated unleached units (Figure 9).

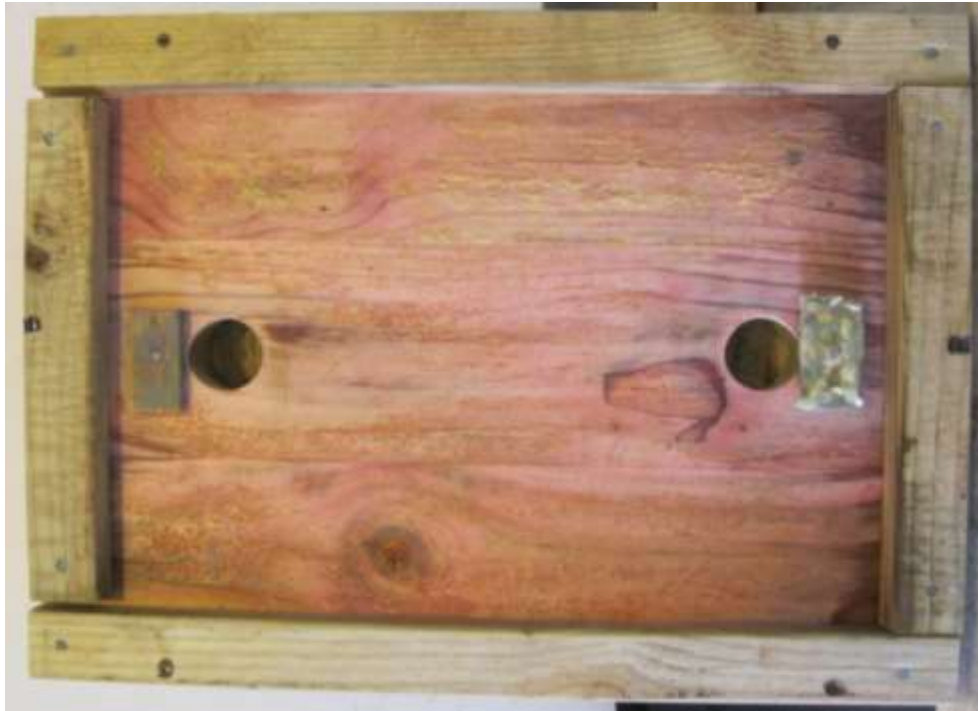
**Figure 9** – Treated, unleached assembly T2 after 28 weeks exposure. There was no decay mycelium from the feeder blocks but there was extensive mould on the surface and the feeder blocks.

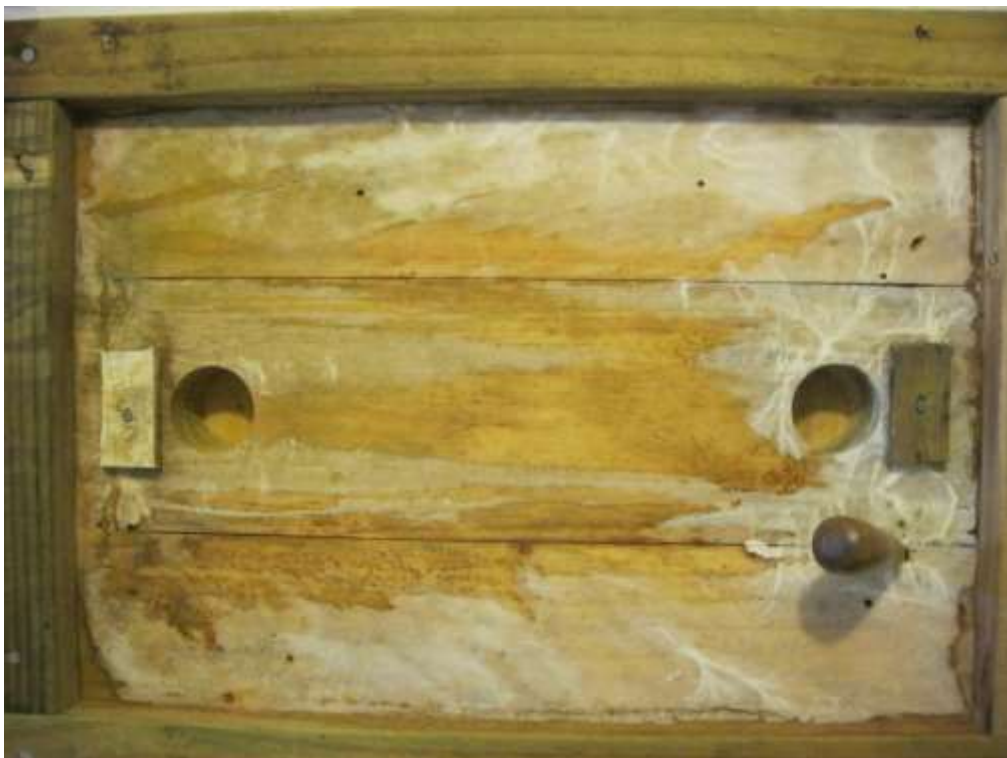
**Figure 10** – The face of untreated unit (U5) after 56 weeks in the exposure room. There was extensive decay mycelium and deep decay over the whole of the face.

A summary of mycelium and decay rating is shown in Table 4. All of the untreated units contained severe decay, particularly at the lower end which remained wetter due to close proximity to the wet concrete floor (Figure 10). *Oligoporus placenta* appeared to be responsible for most of the decay although there was also widespread fine, dark, lacy mycelium in three units. This infection was from an outside source and appeared to be predominant on the back of the units where there was less mycelium from *O. placenta*.

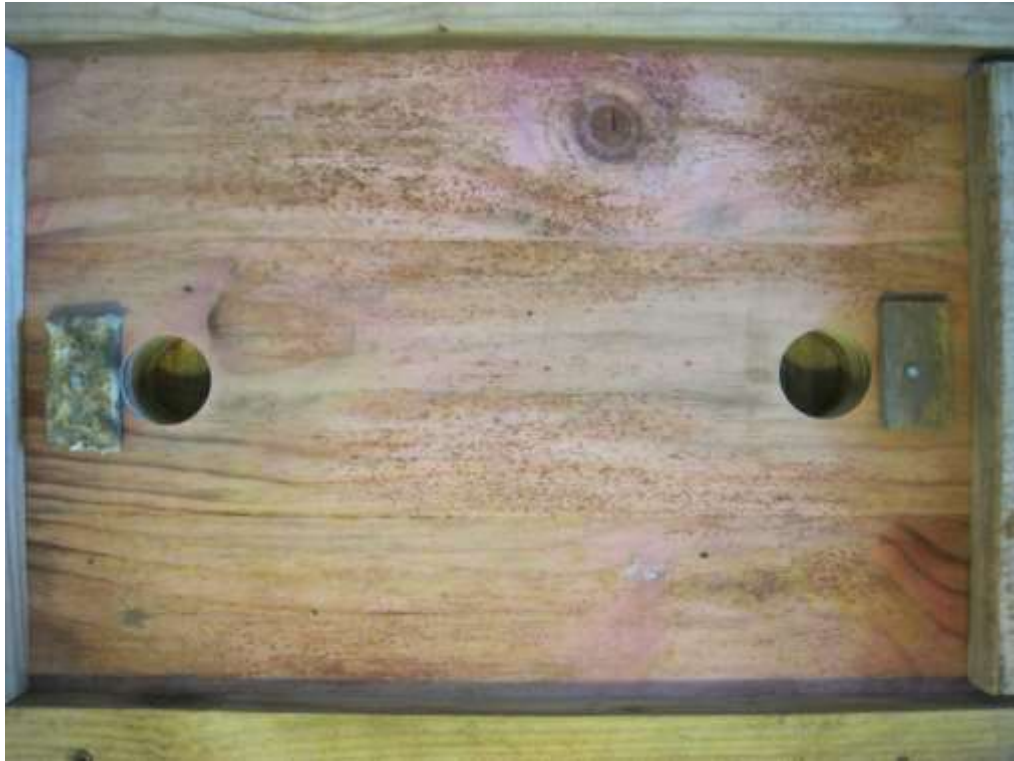
**Figure 11** – The face of treated (not leached) unit (T2) after 56 weeks in the exposure room. There was no decay but there was extensive mould across the face and on the decay feeder blocks.

All of the boron treated units were free from decay (Table 4) but had severe mould (Figure 11). Also, some darkening in the treated samples, both leached and unleached, suggested the early stages of soft rot fungi infection in the wettest areas.
