# **A Method for Studying Boron Redistribution and Leaching in Timber Framing**

The International Research Group on Wood  
Protection, 8 -12 May 2011

J A Drysdale\*, N Marston\*\*, M E Hedley\*\*\*

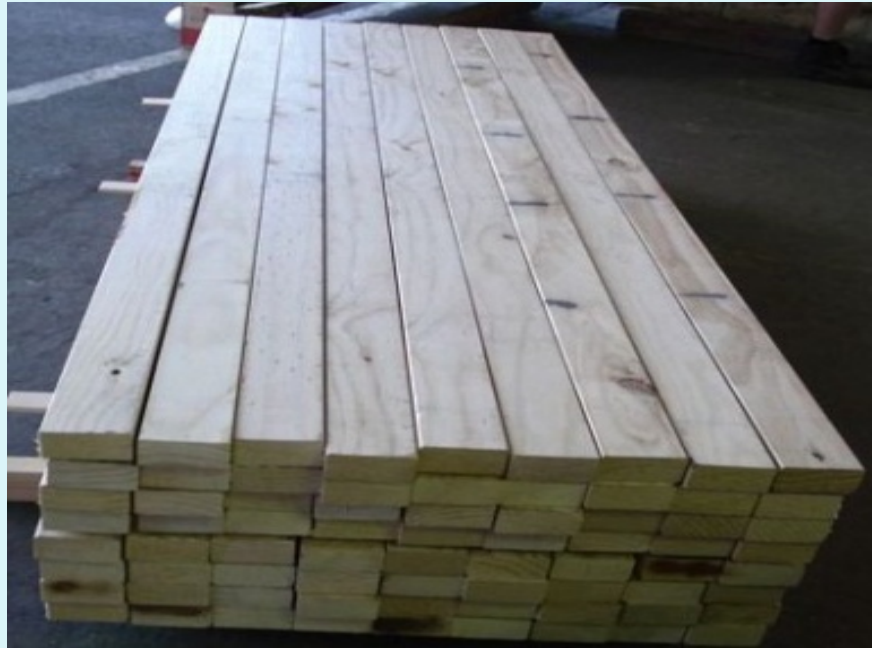
## Selection of timber

Commercial production

Kiln dried, machined, stress  
graded

Selected for high proportion  
of sapwood and minimal  
defects (knots)

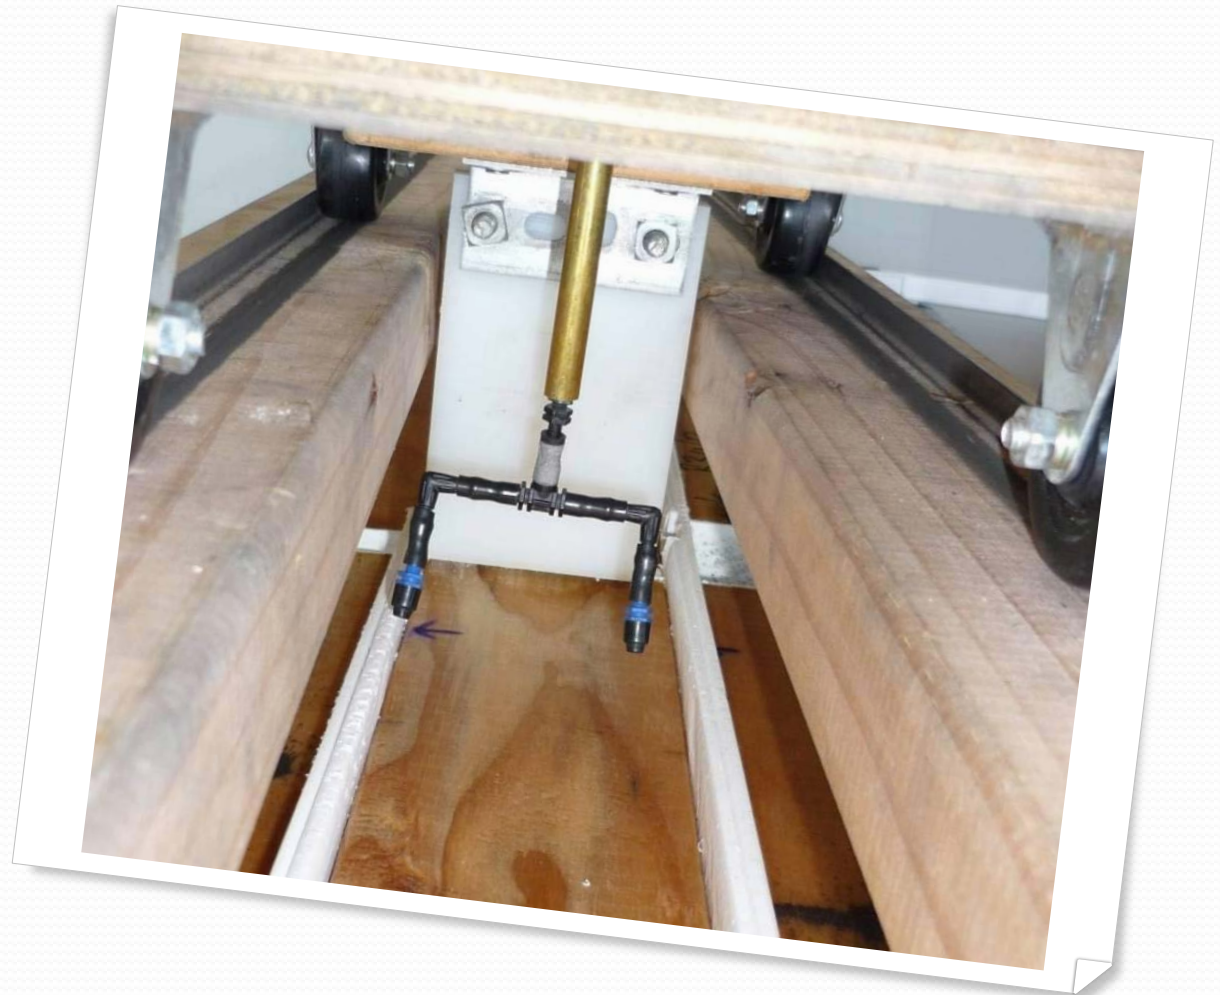
## Wetting apparatus

100 g water/1 metre

Every 4 days

Sampling at 1,2,3,6,9,12 &  
18 months

Moisture content and BAE  
concentrations (cross-  
section, central 1/9<sup>th</sup> core,  
surface zone)

- Methodology was able to simulate a leak event
  - leaching could occur
  - the moisture content increased
  - moisture level would be suitable for decay to develop
- Boron redistributed within the timber cross-section
- Losses from surface zone where water applied to edge
- Overall, a BAE loss of approximately 30% from cross-section over the first 6-8 months of the testing then the BAE levels levelled off
